nzsee
NEW ZEALAND SOCIETY FOR
EARTHQUAKE ENGINEERING

Post-earthquake building safety evaluation training, Palu, Indonesia

M.J. Fox, T. Pettigrew & A. Baird

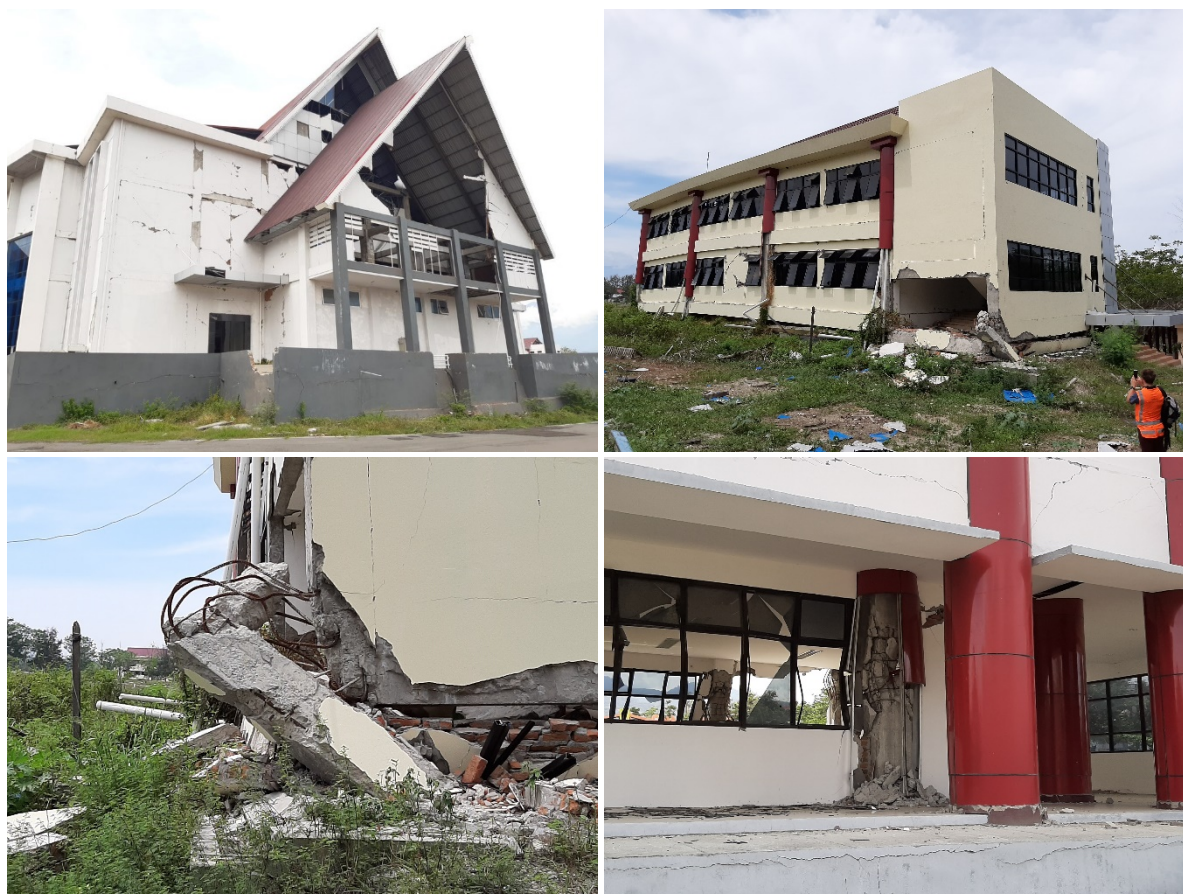
Figure 2 shows three of the more significantly damaged buildings on the campus. The auditorium is a large reinforced concrete frame building with clay brick masonry infill. No clear damage was observed in the frame elements; however, the interior could not be viewed due to the risk from falling debris. The majority of damage was observed to relate to non-structural elements – in particular, masonry infill, glazing and lightweight cladding. One of the unreinforced masonry gables had completely collapsed, which was not surprising given its very large out-of-plane span (see Figure 2).

Figure 2: Field observations at Universitas Tadulako. Auditorium with out-of-plane failure of large unreinforced masonry gable (top left), Faculty of Forestry with complete collapse of ground floor (top right), Faculty of Forestry joint shear failure (bottom left), and Faculty of Law ground floor column shear failure (bottom right).

The Faculty of Forestry is a three-storey reinforced concrete frame building used for meetings and lectures. During the earthquake it completely lost its ground storey while the upper two storeys remained relatively intact. Although it is not possible to identify the mechanism that initiated collapse, it would appear that the lack of horizontal joint reinforcing, resulting in joint shear failure, was a significant factor. A near identical building, the Faculty of Law, was located nearby but exhibited markedly different behaviour. Complete collapse did not occur in the Faculty of Law building; however, it appeared to have very little residual capacity. In this case the most obvious failure mechanism was shear failure in the ‘short columns’ on ground level, adjacent to masonry infill. Severe damage to the exterior beam-column joints was also noted.

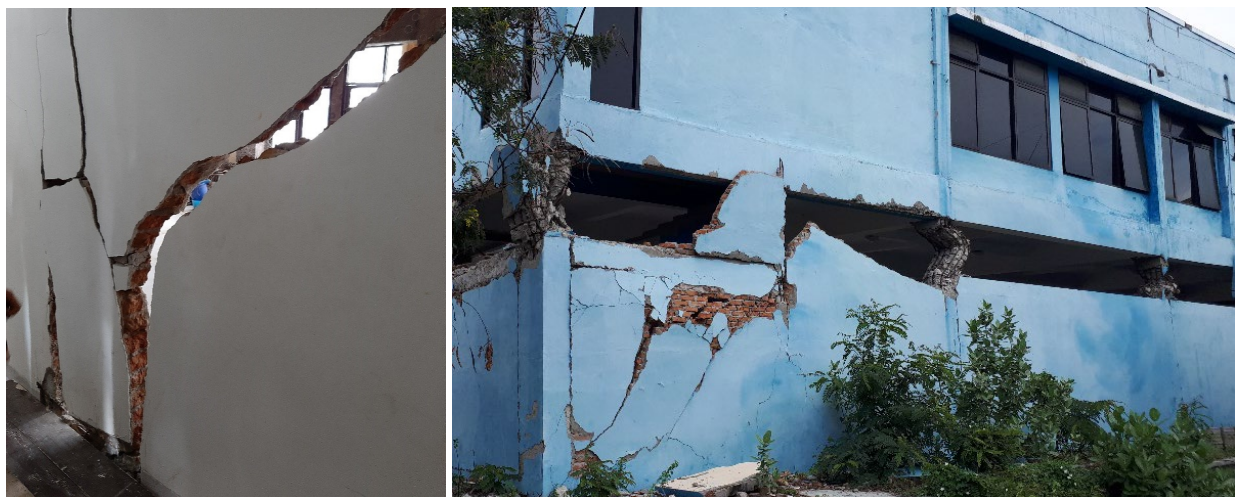
The Mayor’s Office is a two storey RC frame building with masonry infill. It has an approximate figure eight shape in plan and is split into several seismically separate units. Minimal damage was observed from the exterior and was similarly limited in the interior, except at the location of seismic gaps. Masonry infill was typically constructed across the gap, thus resulting in significant damage to the infill, which in itself potentially poses a life safety risk. The area adjacent to the most significant damage was no longer being used, but the remainder of the building was occupied.

The Fire Station is a two storey RC frame and masonry infill building. On the road-facing elevation at ground there is no infill (to allow vehicle access) and on the opposite elevation there is partial height infill. This configuration resulted in virtually all lateral load being carried by ‘short columns’ on the stiffer side of the building. As shown in Figure 3, these columns appeared to be on the verge of losing their axial load capacity.

Figure 3: Field observations of government buildings. Large crack in a masonry partition wall crossing a seismic joint in the Palu City Mayor’s Office (left), and failure of ‘short’ columns in the Main Palu Fire Station (right).
