# Seismic Strengthening of Te Whare o Rehua Sarjeant Gallery in Whanganui

*P.M.F. Yong & A.J. Forlong*

*Paper 41 – Seismic Strengthening of Te Whare o Rehua Sarjeant Gallery Whanganui*

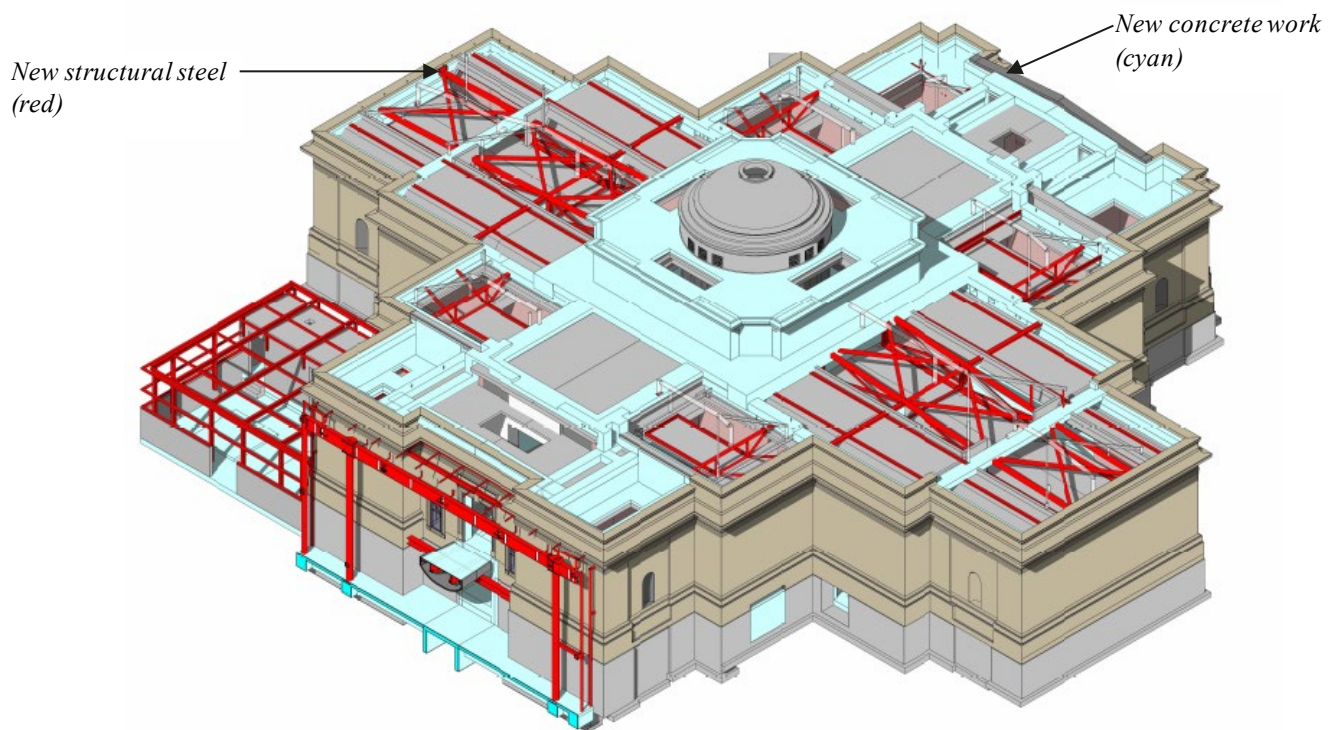
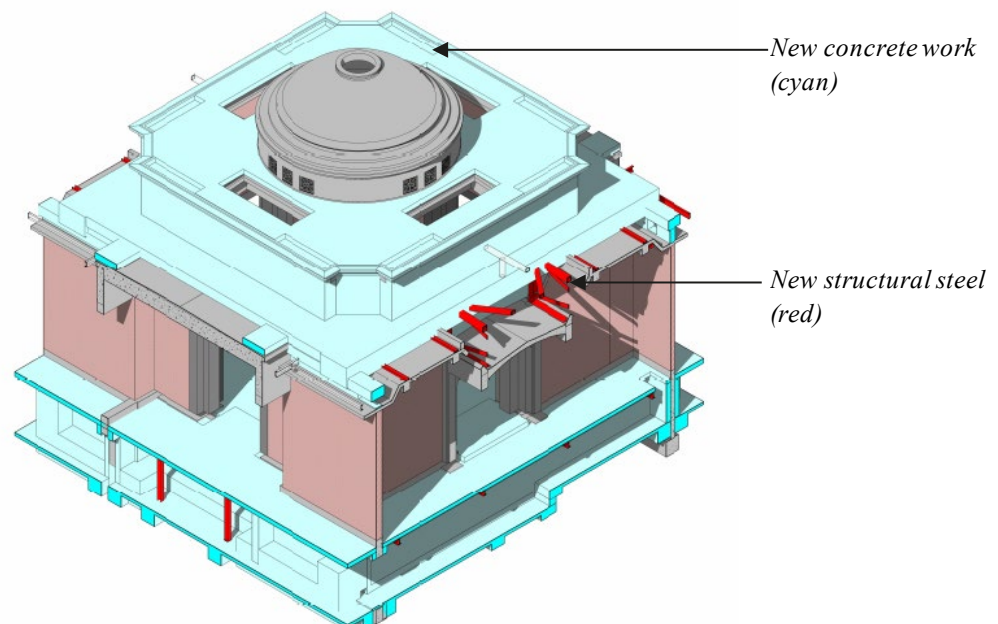
*Figure 7: 3D Image of the Overall Strengthening System showing the new structural elements.*

*Figure 8: 3D Image of the Overall Strengthening System showing the new structural elements.*

The load then transfers into the 4 portions of circular drum wall beneath the dome which transfer the load down to the Upper Roof Level. The seismic load from the dome and upper roof is transferred out to the main core lines by the Upper Roof Diaphragm. The Upper roof has large original reinforced concrete beams beneath it to support the upper roof, drum walls and dome. A new 200mm thick reinforced concrete slab was constructed on the top of the upper roof to transfer the seismic load from the dome and upper roof loads to the main core walls and also to increase the strength and stiffness of the upper roof. Refer Figure 7 and Figure 8 below showing the overall strengthening elements for the entire building and also for the central core area.

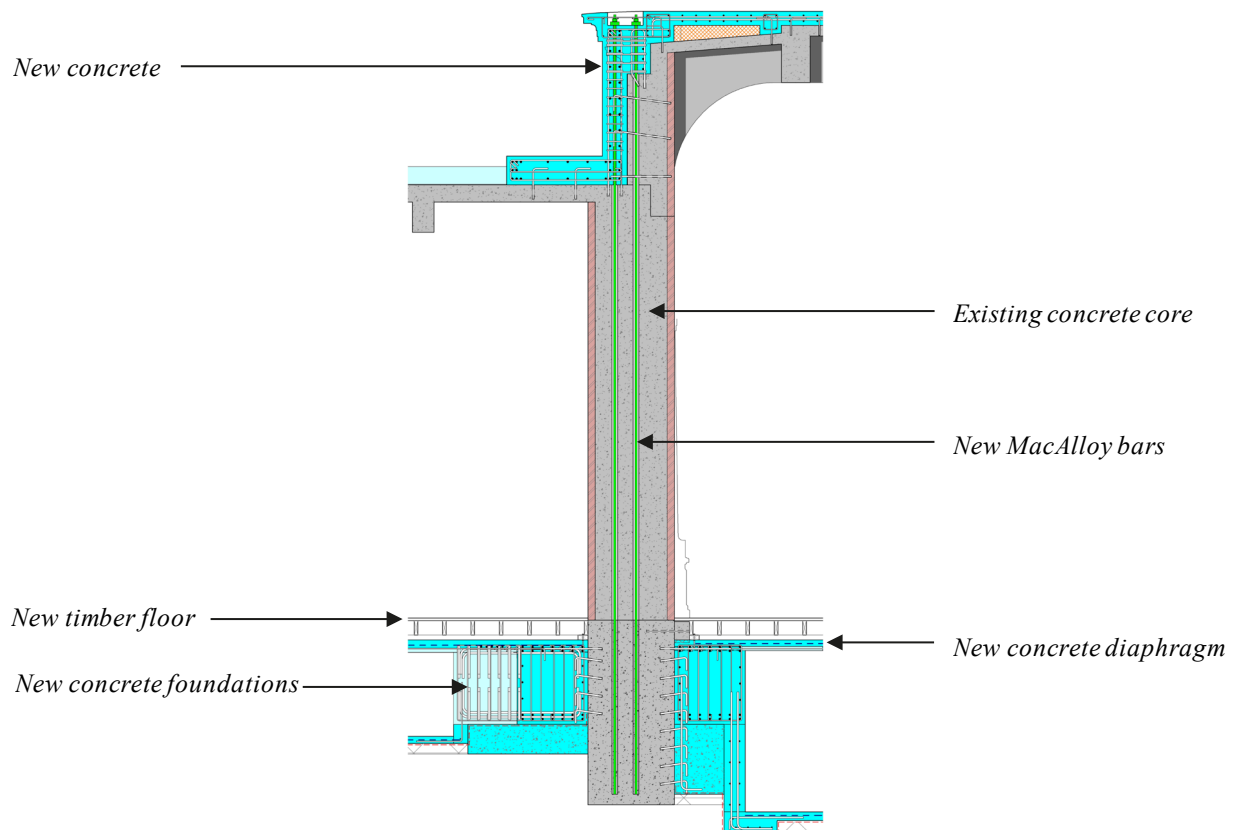
*Figure 9: Central Core Strengthening Section*

The main central core has 1.2m thick unreinforced concrete walls with large openings on all four sides. The central core walls were strengthened using post-tensioned Macalloy Bars between the basement wall and the upper roof, as seen in Figure 6 below. The wall and spandrels beneath the perimeter of the Upper Roof were strengthened using 350-millimetre-thick reinforced concrete. This strengthened the walls themselves and provides coupling action between the central core walls. These were also provided with anchorage details for the Macalloy post tensioning. At the main roof level, the core walls went from approximately 1.2m thick to 0.55m thick, enabling the Macalloy bars to be installed approximately central to the main 1.2m thick core walls

New reinforced concrete ground beams were designed on both sides of the main core walls, with reinforced concrete skin walls extending up to the underside of the main gallery floor. The ground beams were designed to couple the main core walls together at ground level to enable the entire core structure to rock in an earthquake. The reinforced concrete skin walls were extended up to the underside of the main gallery floor level to provide a load path for developing the load from the post-tensioned Macalloy bars into the new ground beams.

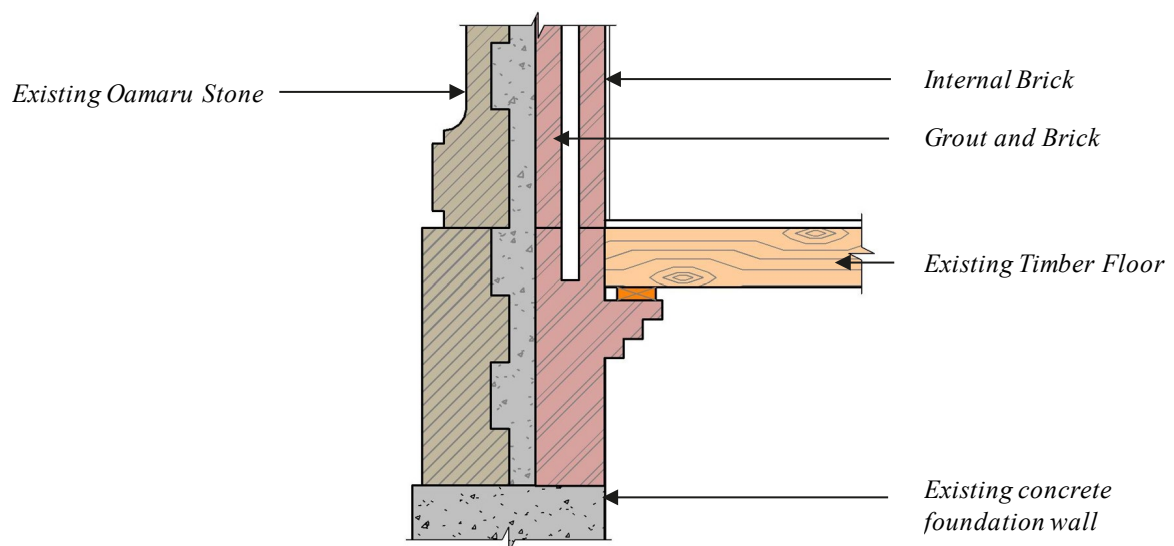
*Figure 10: Make-up of External Wall at main floor level*

Investigations carried out indicated that the external wall is typically comprised of an external layer and inner layer separated by a cavity. The outer layer is a composite of Oamaru Stone, Grout and Brick. The inner layer comprises of a single wythe thick brick wall, with wires in the bed joints connecting the outer and inner layers of walls.

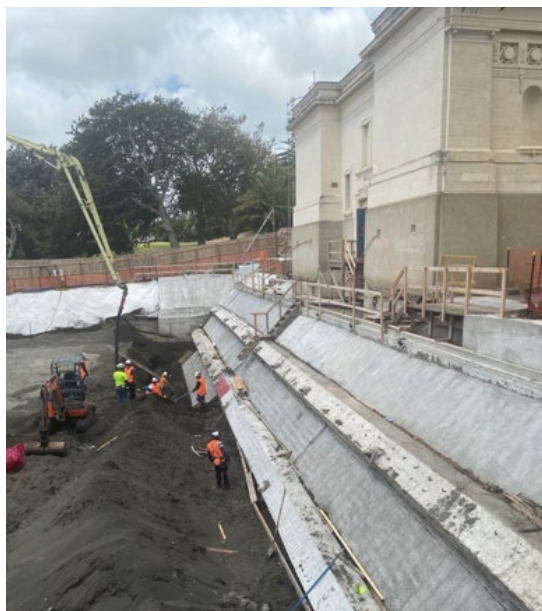
*Figure 12: Temporary anchored wall to support the adjacent basement excavation*

On the North side of the Sarjeant it was necessary to dig down approximately 4.5m to construct the basement for the new extension building. Due to the relatively high gravity bearing loads (225 kN/m) on the perimeter wall and the strip footings being supported on sand, particular care was necessary to prevent collapse of the building into the excavation and potential excessive settlement causing damage to the existing building.

Through discussions with IRBA, a temporary staged excavation support was developed which involved a reinforced concrete apron, Titan Ischebeck anchors and regular monitoring of the movement. The excavation and supporting apron were undertaken in 3 vertical and 5 horizontal stages to help manage risk.
