# Damage Observed in Chilean Hospitals during the 2010 $M_w$ 8.8 El Maule Earthquake

*R. Calcagno*

*R. Retamales*

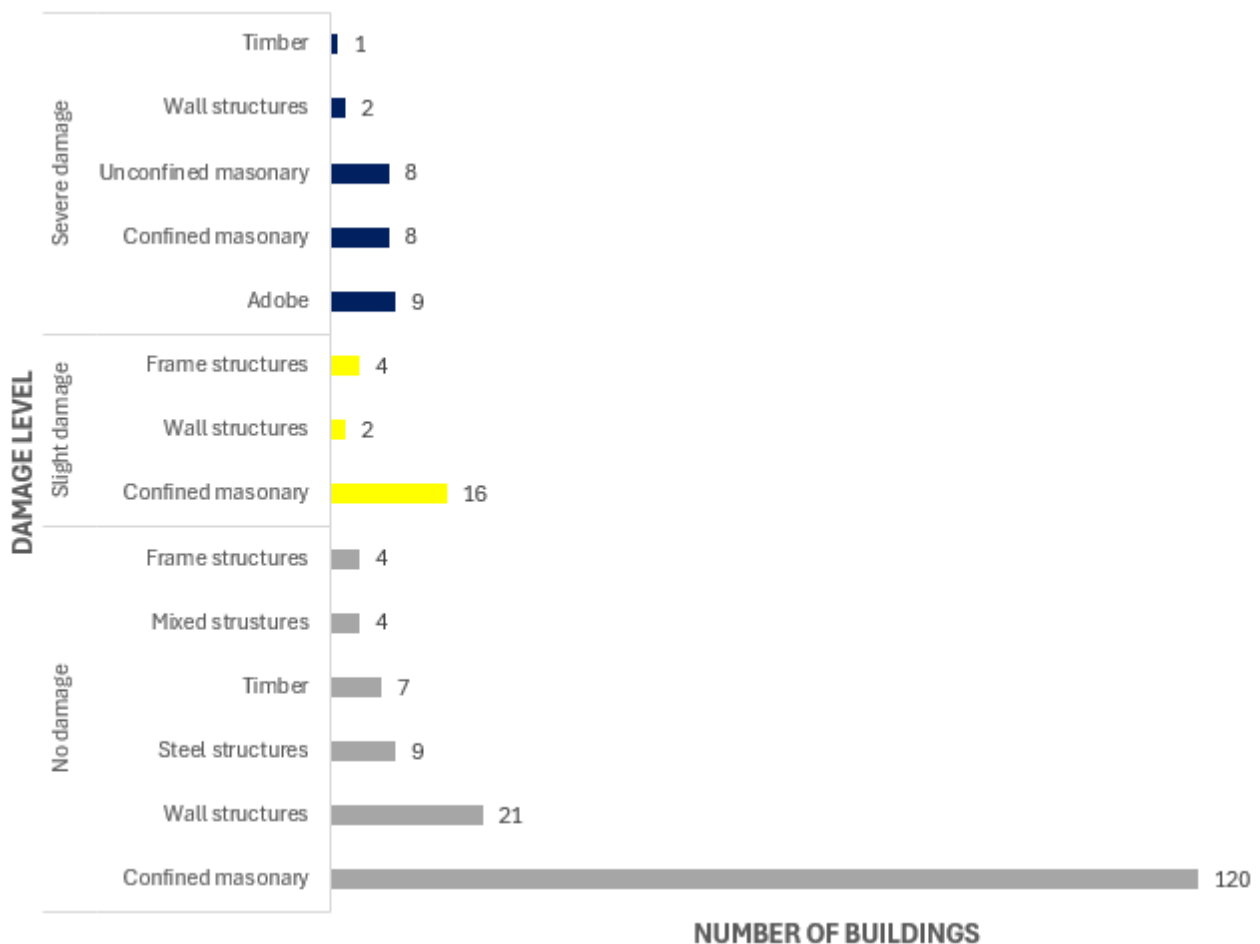
*Figure 1: Structural system and observed damage*

In general, the one- and two-storey level hospital buildings performed well during the earthquake. The most affected buildings were the oldest and the ones with structural systems that do not fulfill design standards, such as adobe and unconfined masonry constructions. It is worth highlighting the good performance of the confined masonry structures in this earthquake and during the seismic events that occurred in 1965, 1971, and 1985.

Figure 1 presents a summary of the level of damage of the buildings under study, these levels are classified as:

**Slight damage:** Correspond to those structures where some damage was reported. The damage was observed in a few elements, and it does not affect the stability of the structure or the continuity of operation of the building.

**Severe damage:** Correspond to those structures where a large amount of damage was reported. The damage observed affected the continuity of the building's operations, and they had to be evacuated to be subsequently demolished.

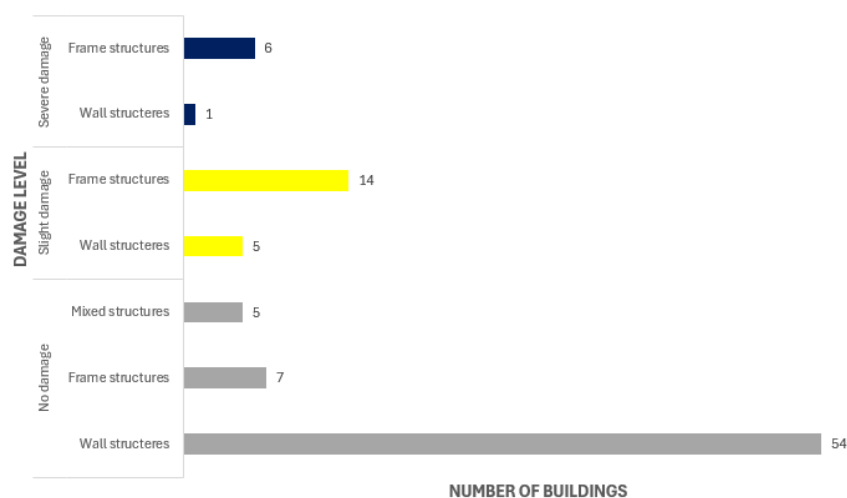
*Figure 3: Structural system and observed damage*

The structural behavior of reinforced concrete buildings can be observed in Figure 3. In Figure 3 it can be observed that the RC moment resistant frame buildings presented a higher level of damage in comparison to reinforced concrete bearing shear wall systems. The only RC shear wall building that presented severe damage was a 6-storey building that exhibited differential settlements caused by soil liquefaction. Due to the

visible resulting inclination, this building had to be evacuated. The repair project consisted of the execution of a new pile system which was estimated complex to be executed and unfeasible from the economic point of view. The building had to be demolished.

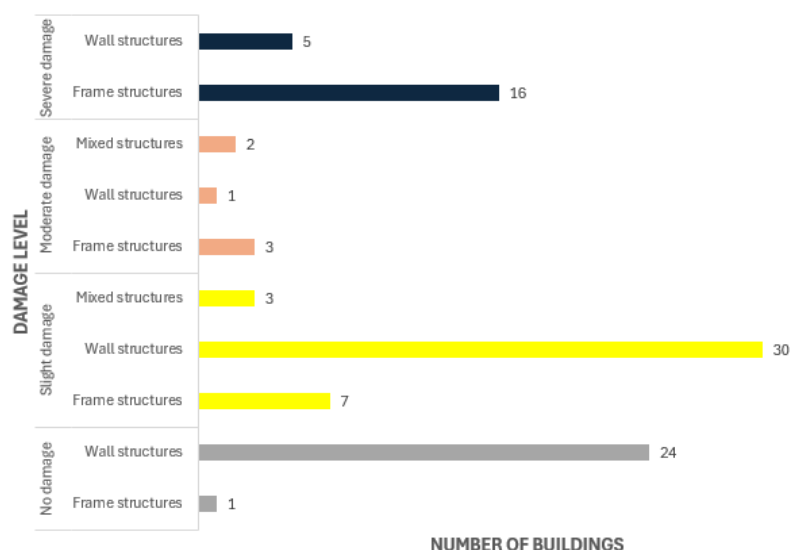
*Figure 4: Non-structural damage per structural system type*

Figure 4 shows the damage observed in non-structural components and systems in terms of the structural system considered.

As in the case of structural damage, moment resistant frame buildings are the ones that exhibited the greatest damage of non-structural components and systems. Sixteen out of 27 RC moment resistant buildings exhibited severe damage and had to be evacuated.

Five hospital buildings with shear wall structural system presented severe damage: In three cases the damage was caused by differential settlements.
