# Damage to demolition – challenges and findings from inspection of damaged hollowcore floors

*H.S. McKenzie*

## ABSTRACT

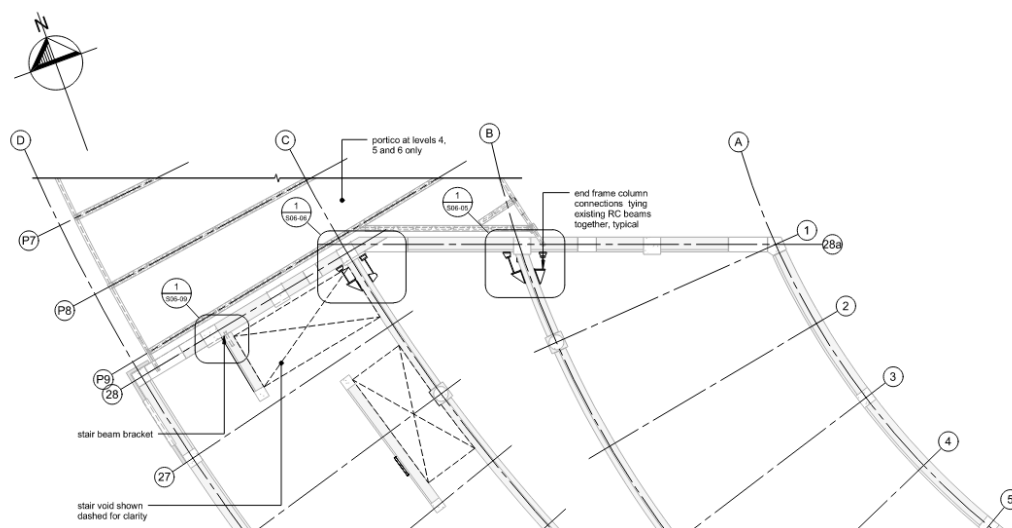
Following the Cook Strait Earthquakes, WCC agreed to progress with a staged seismic securing programme, with stage 1 including removal of the Portico structure and installation of positive tie connections between the internal gravity beams (on grid B, C and adjacent north end stair) and the end moment frames on grids 11 and 28. A plan of these north end frame connections at grid 28 are shown in figure 3. These stage 1 works were undertaken in a very timely and proactive way between November 2013 and March 2014.

*Figure 3: 2013-14 seismic securing frame connections – CAB north end*

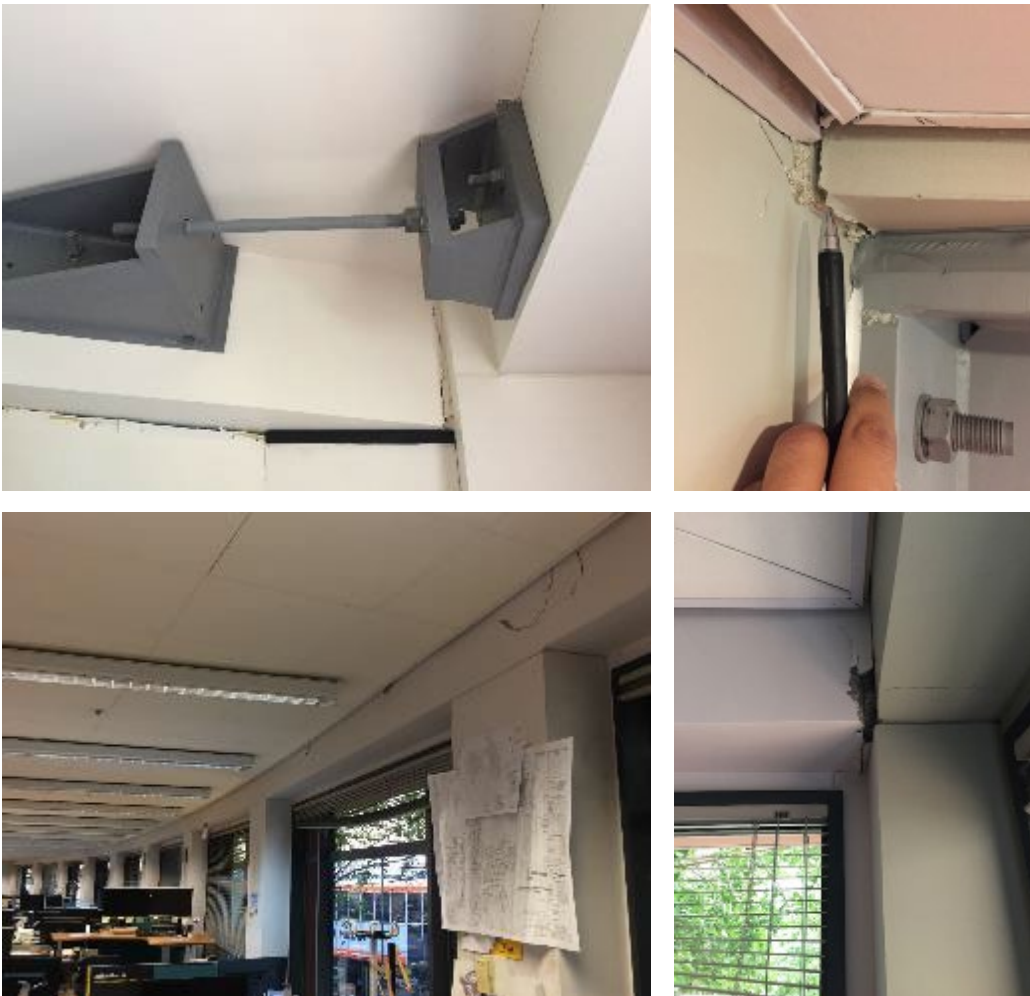
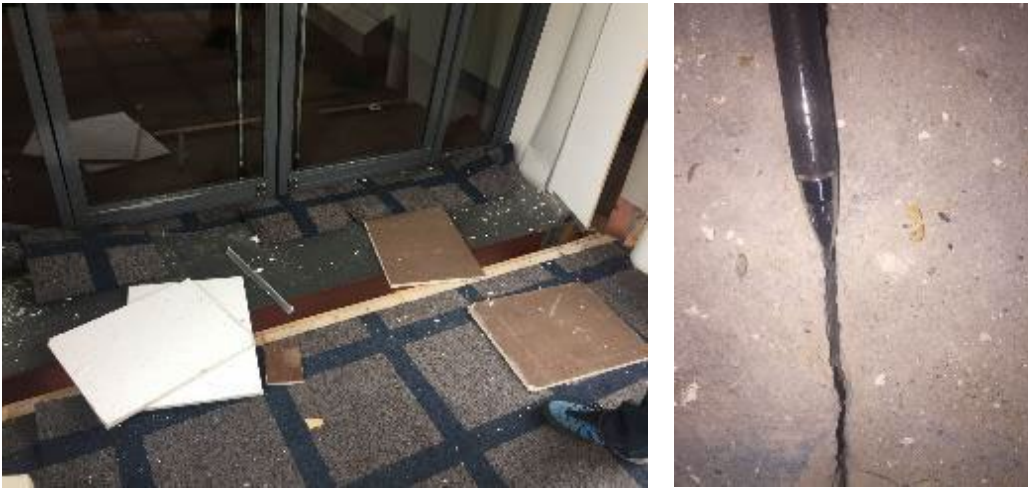
Whilst damaged observed as part of the RBA process was not excessive, findings from this initial visual inspection, evidence of significant seismic displacement (up to ~150mm at level 5 at MOB bridge joint, or ~0.8 – 1% inter-storey drift), combined with our prior knowledge of the building and DSA, and given the specific characteristics of the Kaikōura earthquake, we concluded that a more thorough inspection regime was warranted. We also advised that the yellow Y1 restricted access status should remain in place until that TDE process was undertaken. A selection of relevant photos from the RBA visual inspections are shown in figures 4-9.

*Figures 4-9: A selection of photos taken during rapid building inspection(s)*

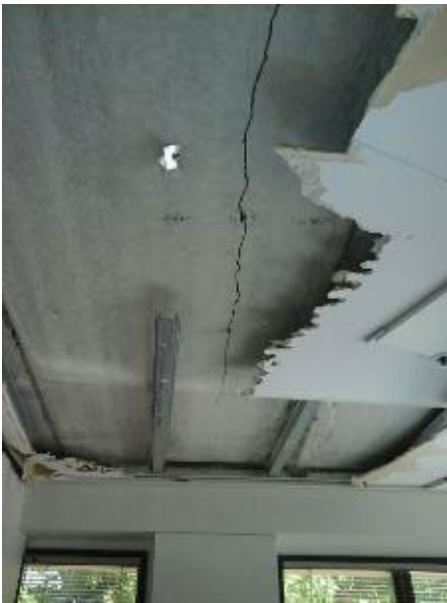
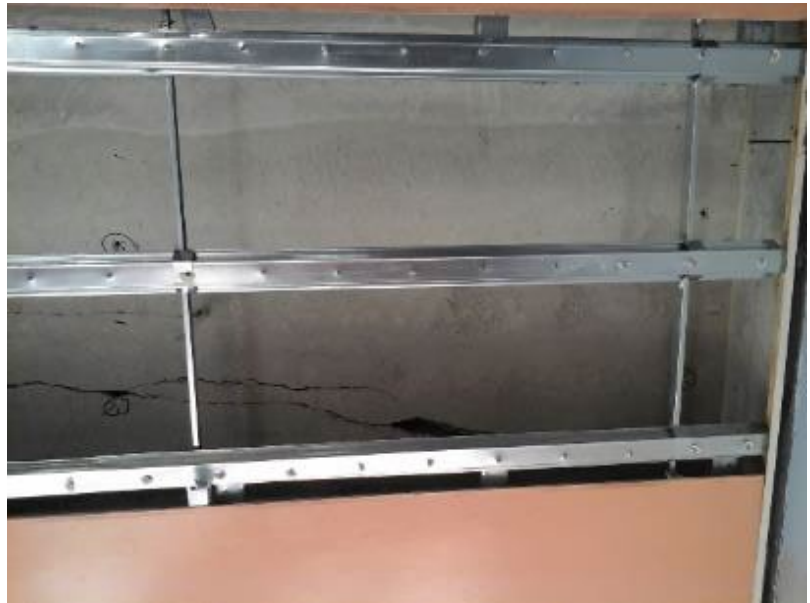
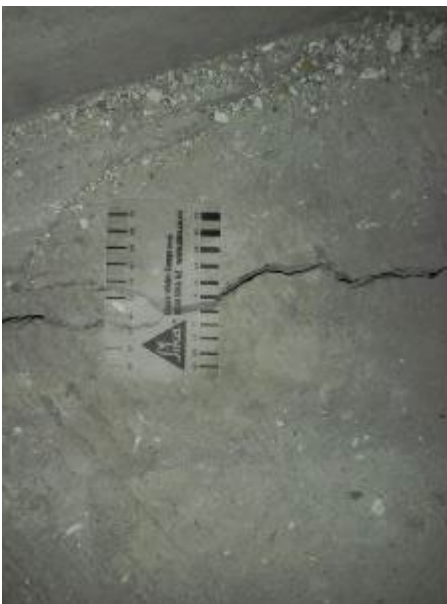
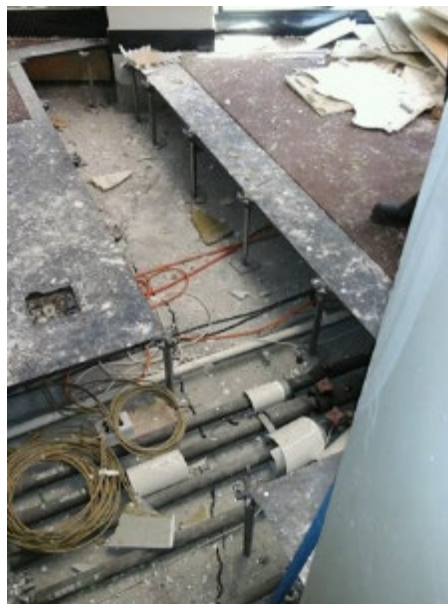
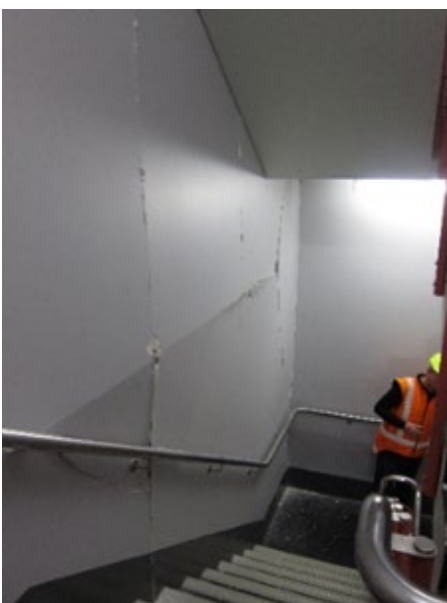
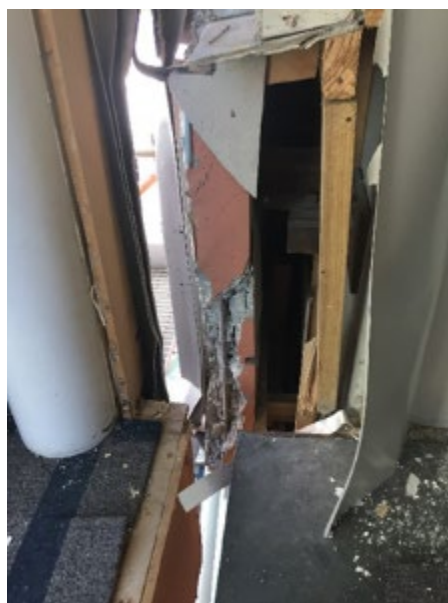
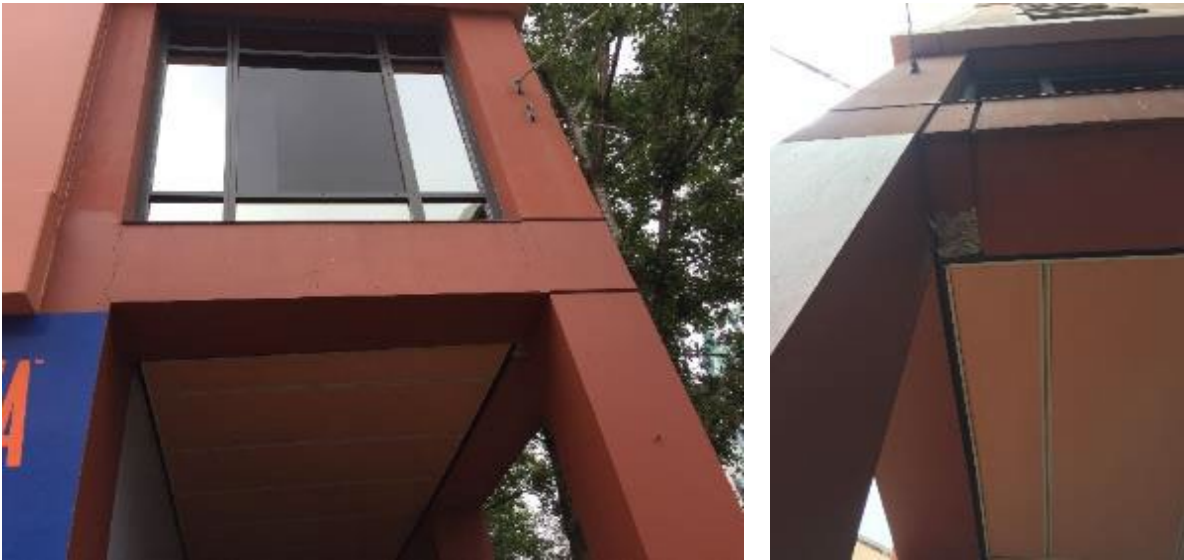
Soon after these more intrusive investigations got underway, far more extensive diaphragm and hollowcore flooring damage was discovered. This included large concrete cracks between hollowcore units (3-10mm wide) and fractured topping slab mesh reinforcing. This led to a recommended change in the buildings access status to yellow Y2, restricted access – short term only with engineering supervision. A temporary short term access management plan was also developed. A more comprehensive TDE process was also initiated with further inspections and documentation of damage undertaken through December 2016 and January 2017 and a final rev2 TDE (Holmes 2017) report issued in mid-February 2017. Damage was also categorised in accordance with the critical damage states outlined in the Engineering Guidelines for Targeted Damage Evaluation ver1.1 (NZSEE and SESOC 2017). A summary of critical damage observed included:

- Damage to a number of hollowcore flooring units
- Some minor beam hinging, typically concentrated as one single crack at the face of columns
- Movement of end frame relative to internal gravity beams and the effectiveness of recently installed securing beam-column brackets/ties.
- Minor precast panel damage and damage to precast frieze panel adjacent the Municipal Office Building seismic joint

*Figures 10-17: A selection of photos documented in the TDE report*

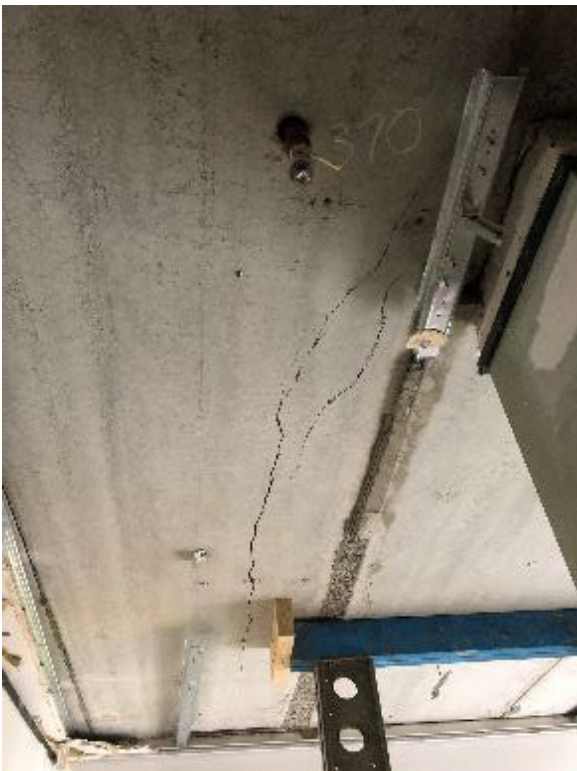
In early 2020 Aurecon undertook further visual inspection of the underside of the Level 2 floor slabs, from the Level 1 floor slab level. No access equipment was used and crack widths/lengths were not measured. Crack map plans and descriptions were summarised in Aurecon correspondence dated 13 March 2020 (Aurecon 2020). This visual mapping was consistent with and built on the findings of the earlier TDE report. This information, together with further floor assessment and damage repair documentation formed the basis for the insurance settlement for the building which was concluded in November 2020.

*Figure 18: Photo from the Aurecon L2 soffit mapping adjacent northern stair void (grid 27)*

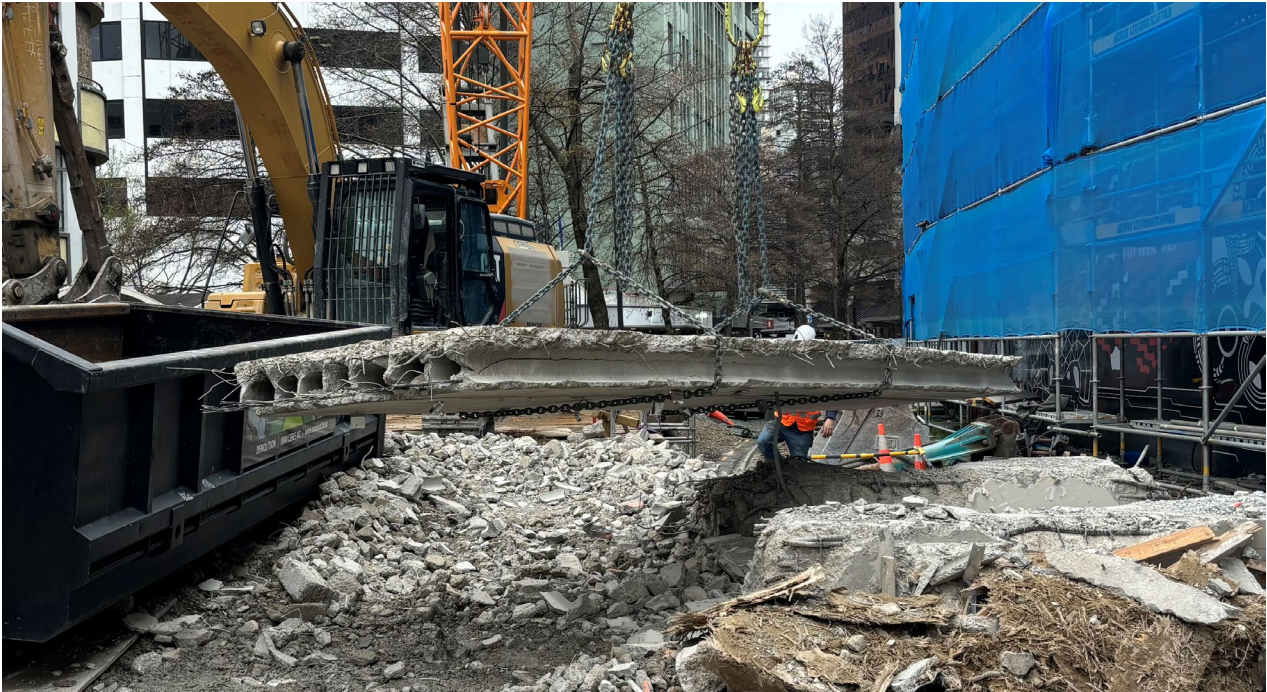
Demolition of the CAB only commenced in 2024 without further involvement from either Aurecon or Holmes. However, as part of a chance encounter whilst passing the demolition site on 13<sup>th</sup> September 2024 the first author noticed significant horizontal web splitting in a hollowcore flooring unit being craned from the building as part of the demolition process. A photo of this unit was taken through the site perimeter fence and is shown below in figure 19.

*Figure 19: Chance view of hollowcore web splitting during demolition removal, 13 Sept 2024*

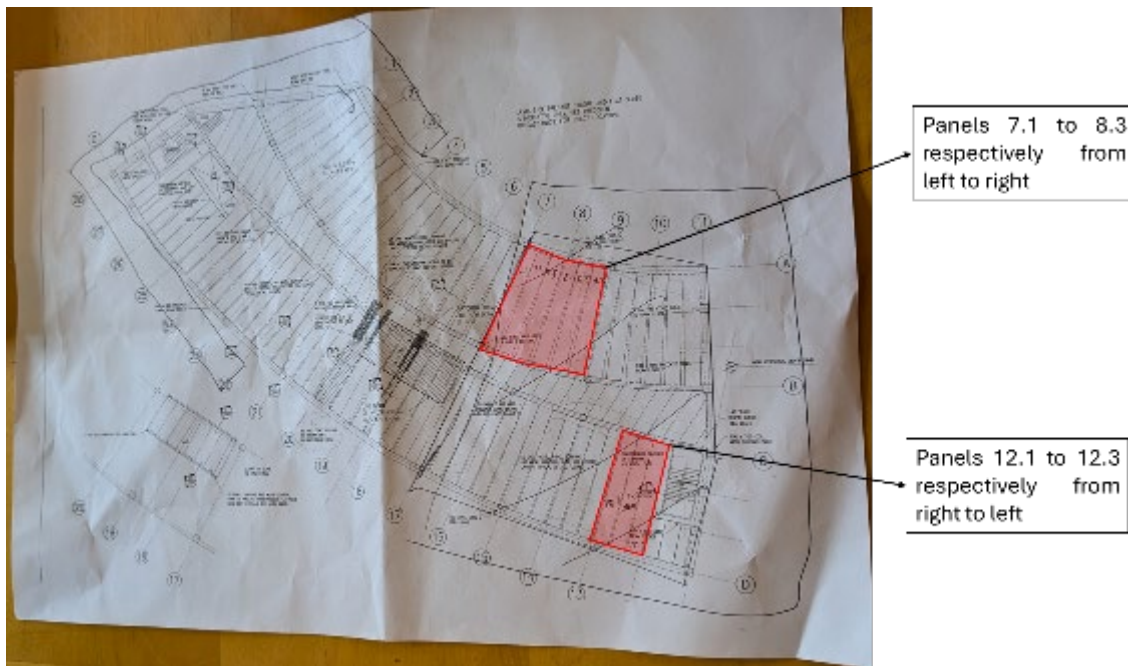
*Figure 20: Annotation of the panels surveyed for observable damage following the demolition of CAB. There are three hollowcore units between each grid line (for example, three units between grid line of 7 and 8, and referred to as 7.1, 7.2, and 7.3 respectively).*

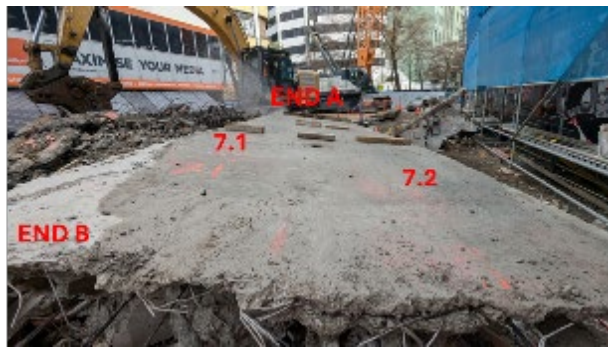
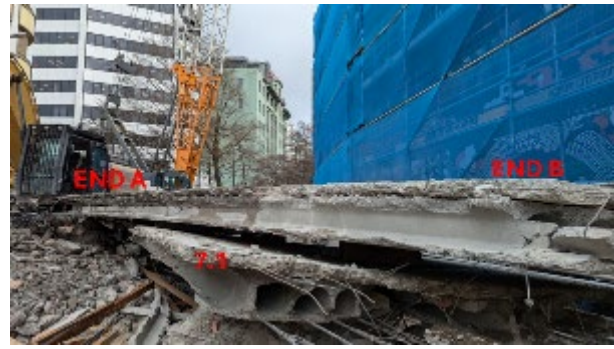
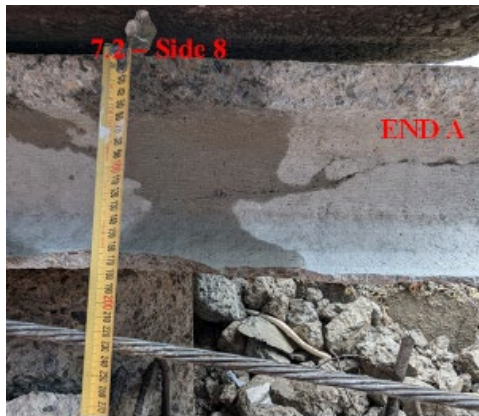
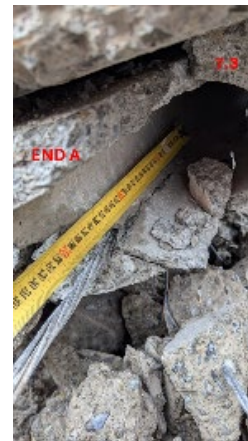
*Figure 21: Damage observation and annotations of units 7.1, 7.2, and 7.3*

The floor panel 7, made up of hollowcore units 7.1, 7.2, and 7.3, exhibited varying degrees of damage across its those units. In unit 7.1, nominal web splitting cracks across the ends of the broken hollowcore webs were observed on End B as annotated in Figure 21, while a crack approximately 500mm long was noted along the

side web of End A (in Figure 21), which was only partially accessible. The sides of unit 7.1 were inaccessible for further inspection.

Unit 7.2 showed more extensive damage, with cracks observed both along the side webs and across both broken ends of the hollowcore unit. Unit 7.3 displayed the most significant damage, with cracks along and across the hollowcores on both ends and cracks along the web exceeding 150mm in depth. The exposed side (towards panel 7) was heavily damaged, featuring cracks running across the web and an angular crack forming on End B, where the damage was notably more severe than on End A.

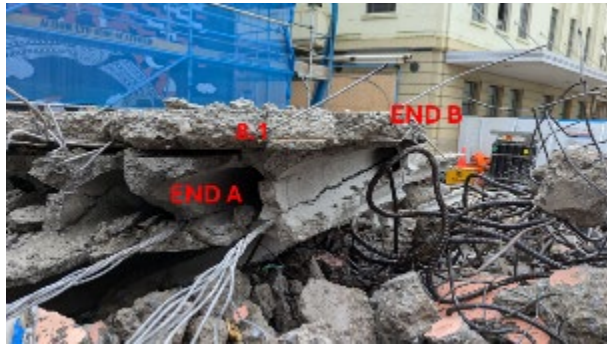
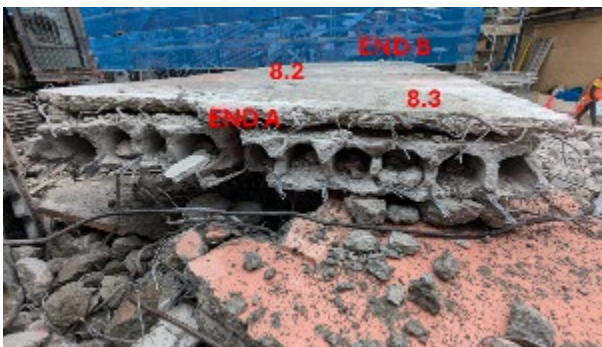
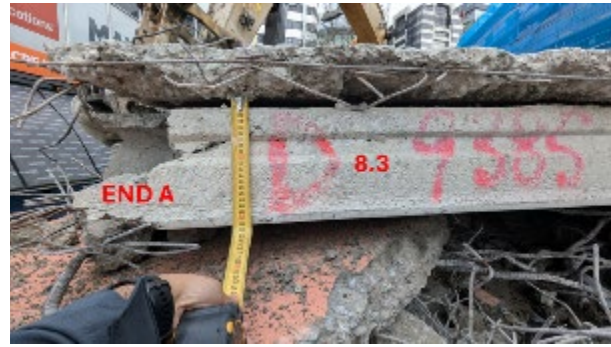
*Figure 22: Damage observation and annotations of units 8.1, 8.2, and 8.3*

The floor panel 8, divided into units 8.1, 8.2, and 8.3, showed considerable damage across all sections. In unit 8.1, cracks were observed along and across the hollowcores on both ends, while the exposed side (towards panel 9) was completely damaged, featuring two cracks running across the web on the top and bottom, spaced 80–90mm apart (top and bottom of web). These two cracks converged at an angle 220–240mm from End A as annotated in Figure 22. Unit 8.2 also displayed cracks along and across the hollowcores on both ends, with cracks along the web forming angular patterns at a depth of approximately 80–100mm. Although the sides of this subpanel were inaccessible for measurement, significant damage was evident. Subpanel 8.3 experienced severe damage, with cracks along and across the hollowcores on both ends. Concrete spalling was noted from End A on the exposed side (towards panel 9), where cracks extended approximately 600mm, accompanied by an angular crack forming at a depth of 280mm and 60mm from the top.

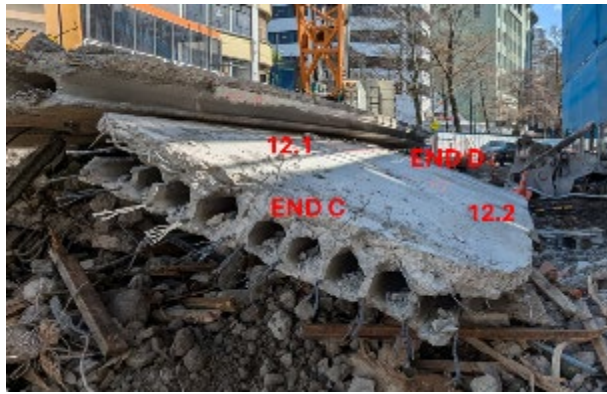
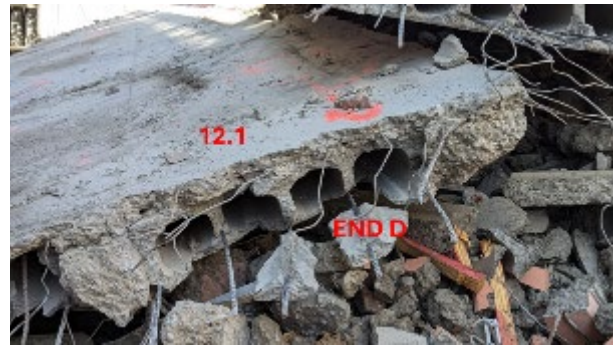
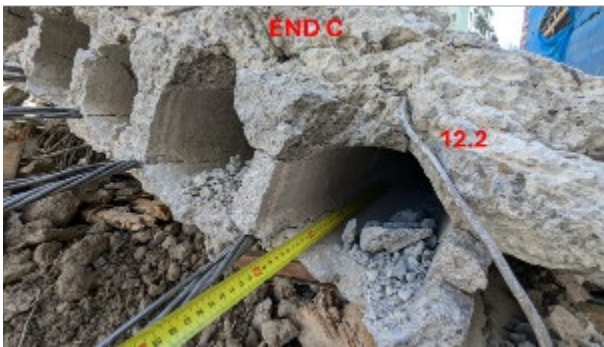
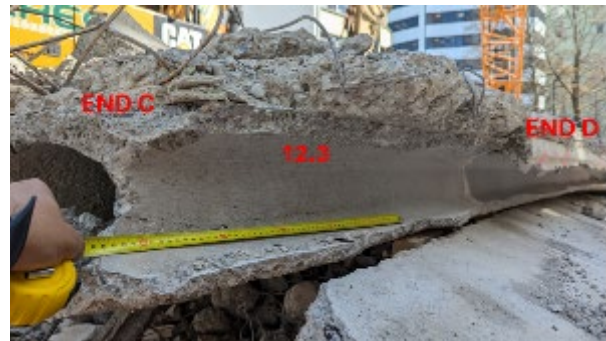
*Figure 23: Damage observation and annotations of units 12.1, 12.2, and 12.3*

The floor panel 12, divided into units 12.1, 12.2, and 12.3, exhibited varying levels of damage across its sections, as annotated in Figure 23. In unit 12.1, cracks were observed along and across the hollowcores on both ends, as well as through the web. Although all sides of the panel were inaccessible for measurements, the extent of the cracks along the web appeared to be consistent with other panels, approximately 80–100mm from the top of the hollowcore panel and projecting into the core. Unit 12.2 had cracks along and across the hollowcores on both ends, with the exposed side (towards panel 13) completely damaged, possibly exacerbated by the manner in which it was lowered. Longitudinal cracks spanning the length of the panel were also observed. Unit 12.3 experienced significant damage, with cracks along and across the hollow cores on both ends. The cracks along the web ranged from 500–800mm deep, and angular cracks through the web of the hollow cores extended 500–600mm deep, forming angles approximately 150mm from the top.
