# Observed damage from 17 Dec 2024 M7.3 Vanuatu earthquake

*L.A. Whitehurst*

Holmes NZ, Wellington, New Zealand.

## ABSTRACT

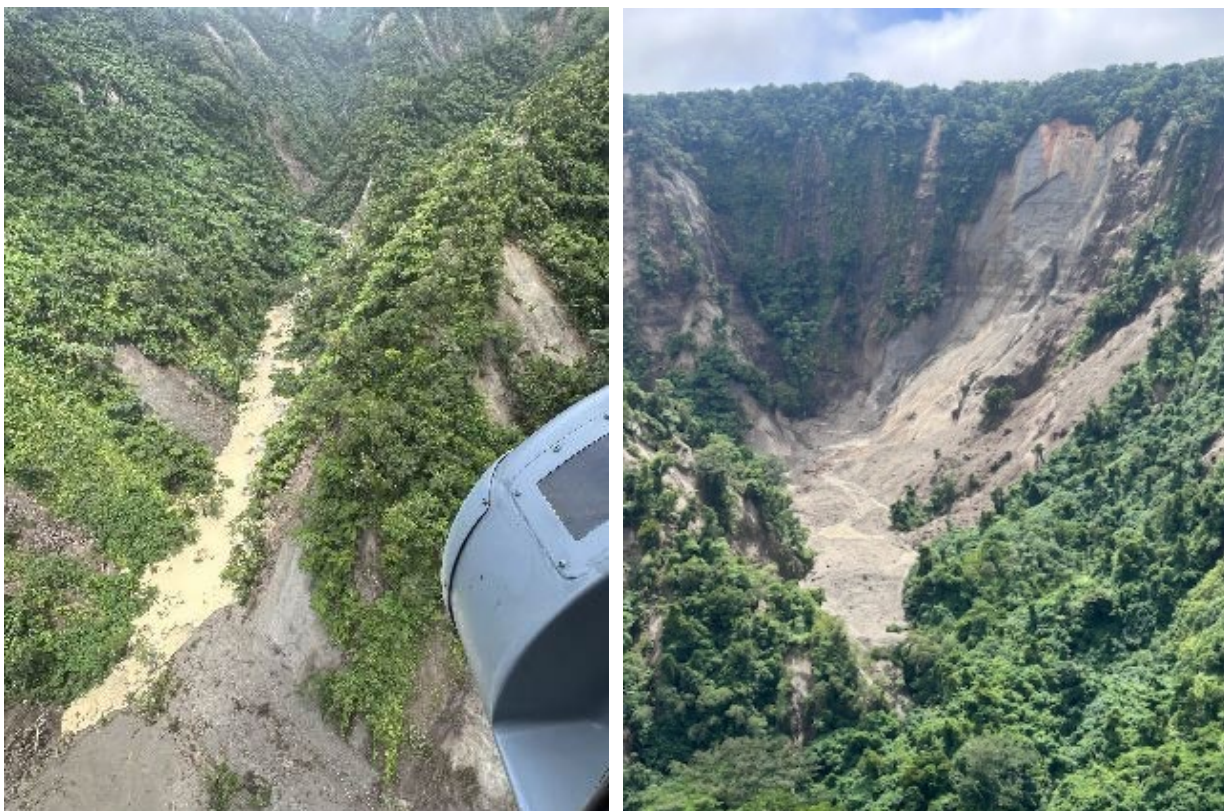
Most of the landslides occurred in areas sparsely populated such as the high catchments of the La Colle River north of Mele; while not immediately damaging, the enormous volume of pumice, debris and resulting landslide dams (see Figure 2) within the river courses created a potentially delayed hazard in the form of debris flows and flash flooding events downstream.

*Figure 2. Landslide dams forming in catchment of La Colle river*

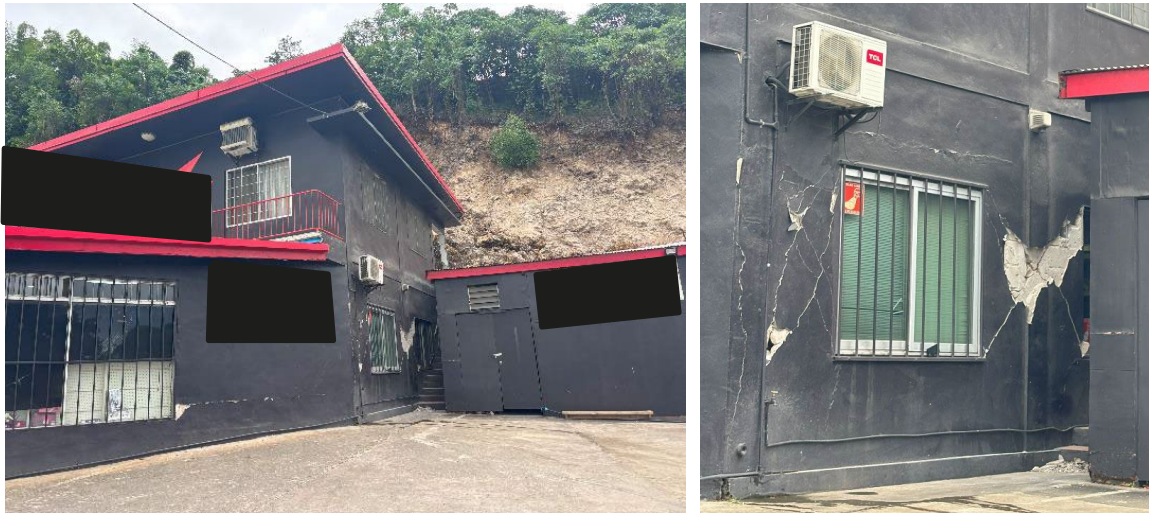
*Figure 3 and Figure 4. Landslide behind building. Major damage to concrete columns. Ongoing risk due to further ground movement. Damage to concrete columns and infill masonry due to inertial shaking and impact of landslide.*

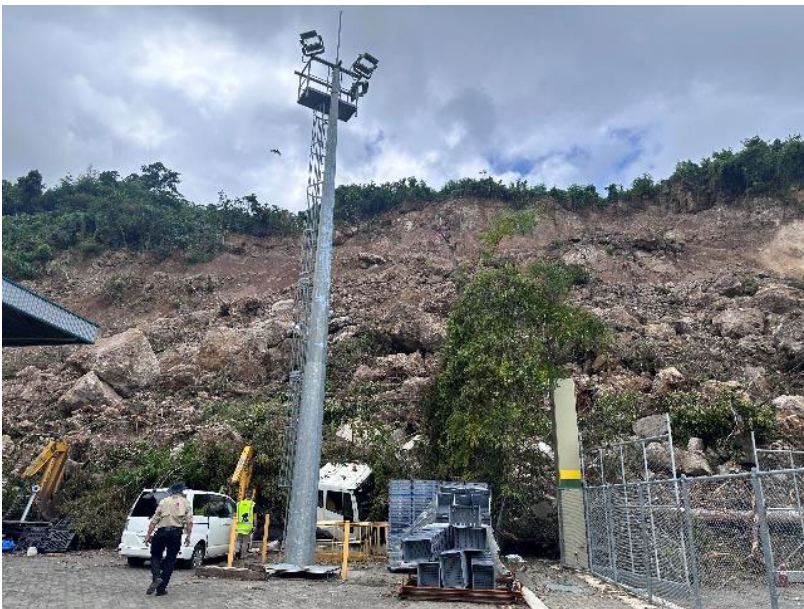
*Figure 5. Large rock avalanche at Lapetasi Port access road*

Thousands of cubic meters of material including boulders up to six metres in diameter (from the limestone layer capping the slope) failed and inundated the access road and port entrance. The slope is understood to have suffered failures in the past including large rock fall however an event of this scale had not been witnessed previously.

The slope is north facing, 50m in height and around 500m long, comprised of a combination of tuff and capped with coral limestone. The slope appears to have been in the order of 60-80 degrees prior to the earthquake and is covered to varying amounts by vegetation. Multiple joint set are visible throughout the face with many boulders and loose debris still hanging above the road. Material ranges in size from silt to boulders in the order of 6m, with a large number of boulders 5m+ present.

Removal of the debris slope will be a difficult and dangerous exercise and requires co-ordination with all parties operating beneath the areas being excavated to be as safe as possible. It is unlikely that all risk to the operators of the excavators can be removed due to the material at the crest of the slope being unstable.

There are multiple options for slope retention and or debris fall protection however these need to be specifically designed and is beyond the scope of USAR on these types of deployment. Typical options might include rock bolting, meshing, drapes or rock fall fences/bunds or ditches, or indeed a combination of the above.

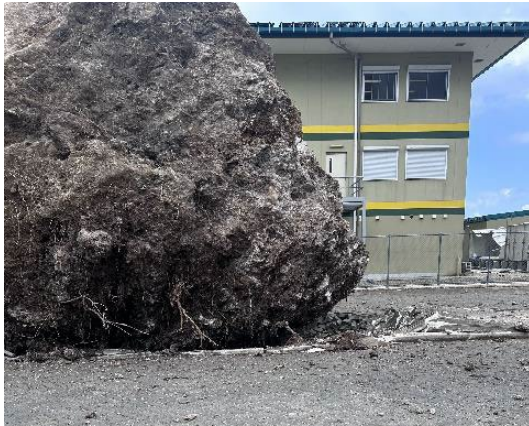
The rockfall debris formed a slope of around 45degrees at various sections along the road totalling around 300m. Boulders have travelled up to around 20-30m from the original base of the cliff with one particularly large boulder coming to rest between the two port buildings which are located either side of the former entrance gate as seen in Figure 6.

*Figure 6. 6m boulder travelled some 30m coming to rest between port buildings*

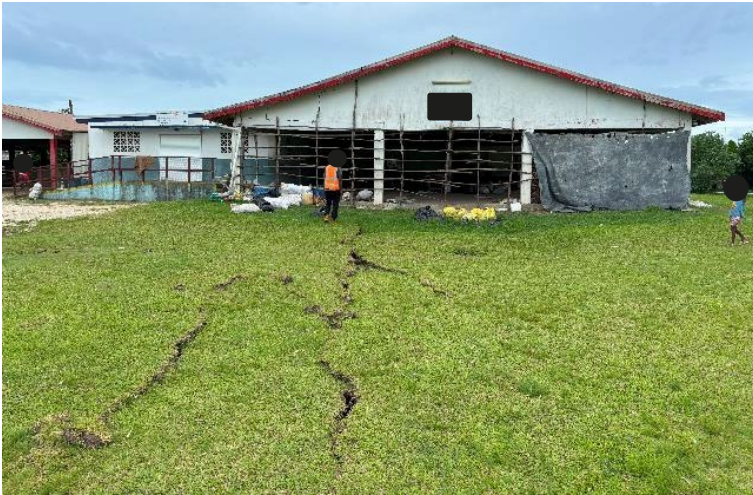
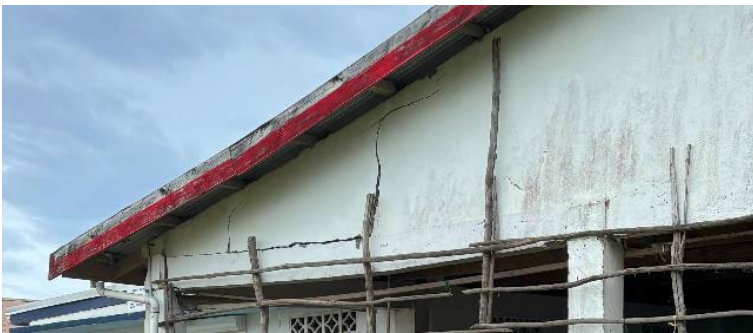
*Figure 7. Surface rupture through building. Uplift approximate 300mm.  
Figure 8. Concrete frame and masonry infill damage as a result of uplift*

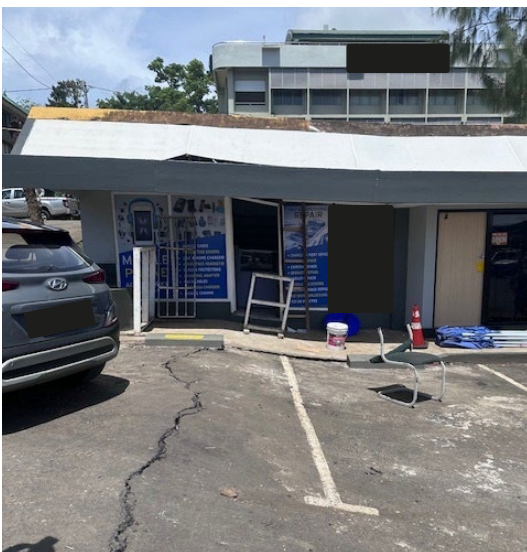
*Figure 9. Possible fault rupture through Port Vila CBD. This building was not inspected by the FENZ USAR team.*

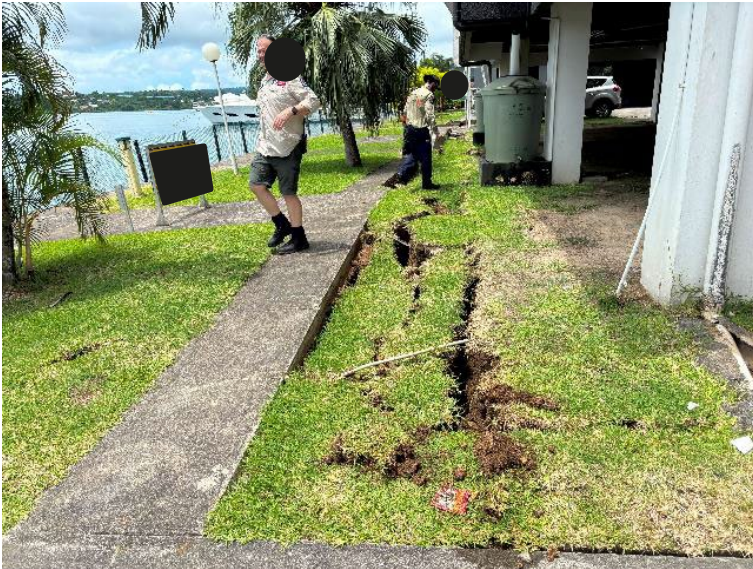
In places the sea wall had moved forward most likely due to a combination of lateral spreading and translation due to excessive loading during the M7.3 event.

As mentioned above, significant areas of the coastline have been reclaimed in the past to generate building platforms in the area and the variable control or nature of the engineered filling could have contributed to this lateral spreading.

*Figure 10. Seawall damage leading to cracking and subsidence next to concrete spread footings.*

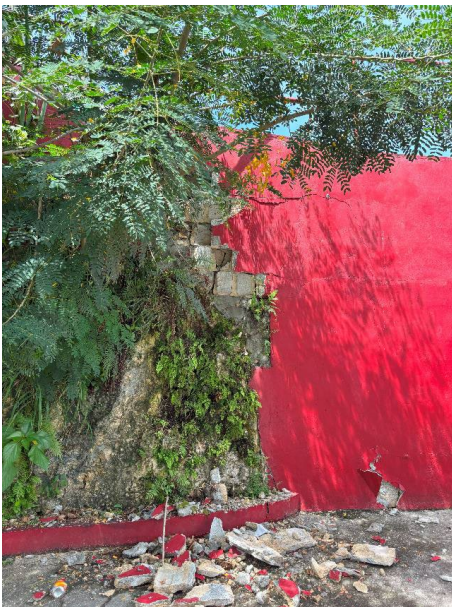
*Figure 11. Damage to masonry retaining wall. In addition to the hazard posed by falling blocks, this retaining wall supports a road beyond, which is at risk.*

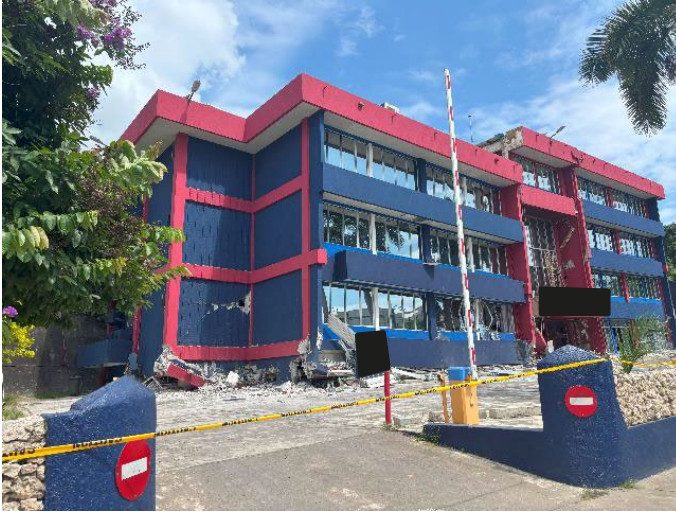
*Figure 12. Partial soft-storey collapse of concrete frame building. The building appears to be three seismically separated structures. The left most has suffered a soft-storey collapse at ground level. The other two are also heavily damaged at ground level and above but remain standing with a pronounced lean at ground level.*

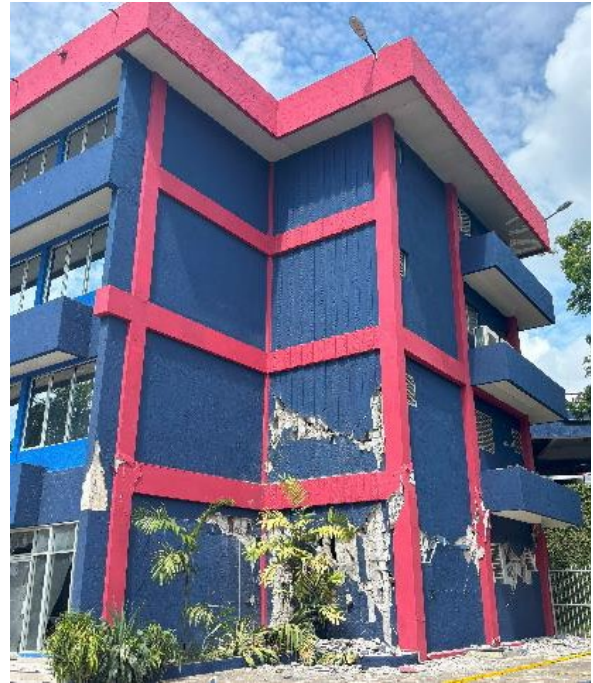
*Figure 13. Right side of same building, showing heavy damage to columns and infill masonry walls at ground and first levels.*

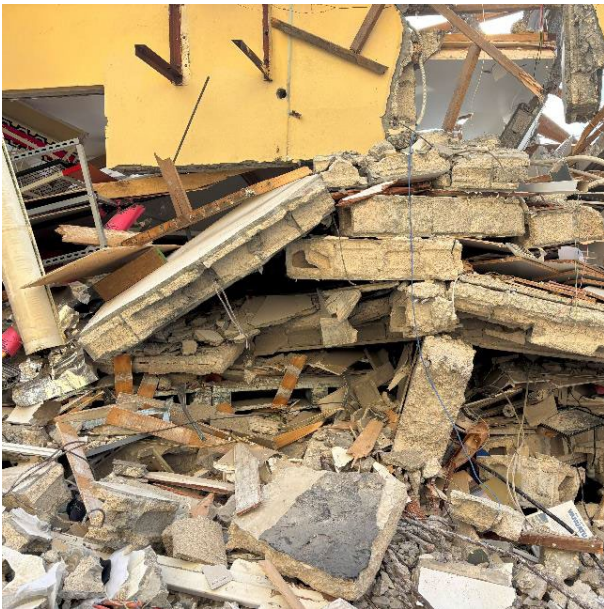
*Figure 14. Complete pancake collapse of concrete frame building. Non-ductile concrete frame with masonry infill walls and brittle flooring system with post-tensioned ribs.*

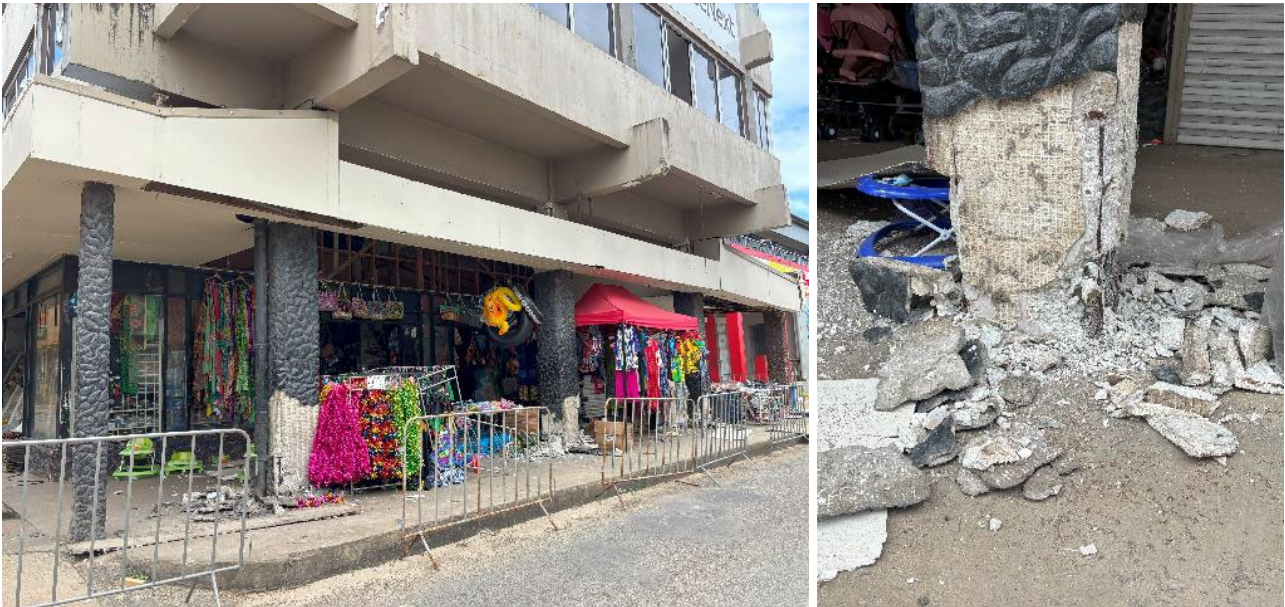
*Figure 15. Concrete frame building with major damage to ground floor columns. Likely soft-storey effect due to “tuck-under” parking in the rear and open shopfront in the front.*

*Figure 16. Buckled longitudinal reinforcing at ground floor column. Top joint and other columns sustained similar damage.*

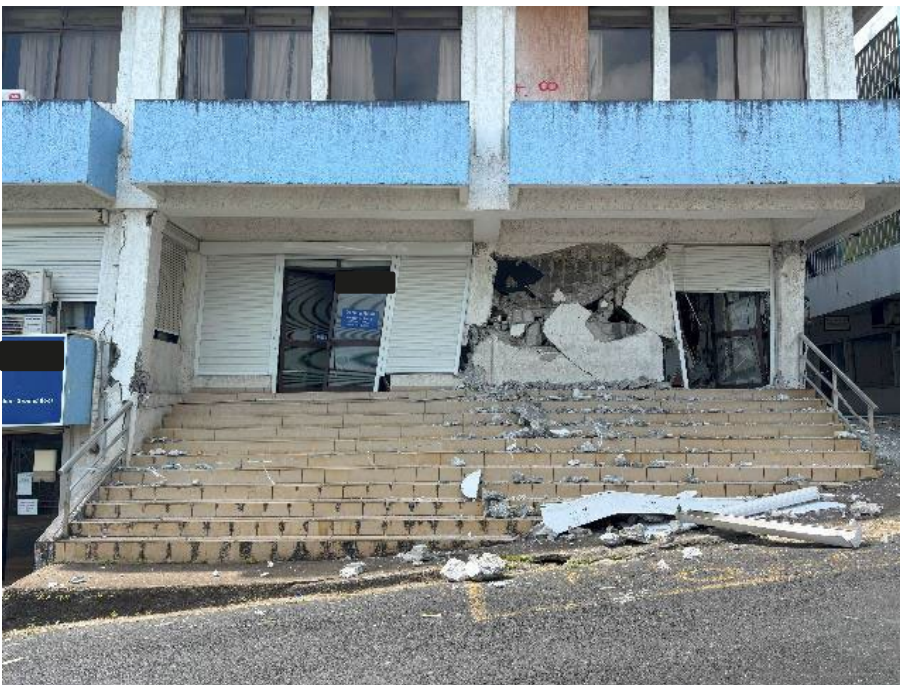
*Figure 17. Major damage to ground floor concrete frame and infill masonry wall. Large vertical irregularity with discontinuous frame above entry and potential soft-storey effect.*

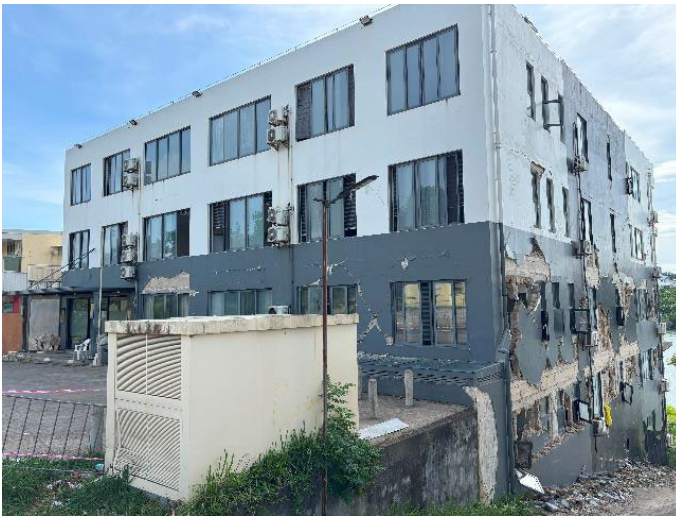
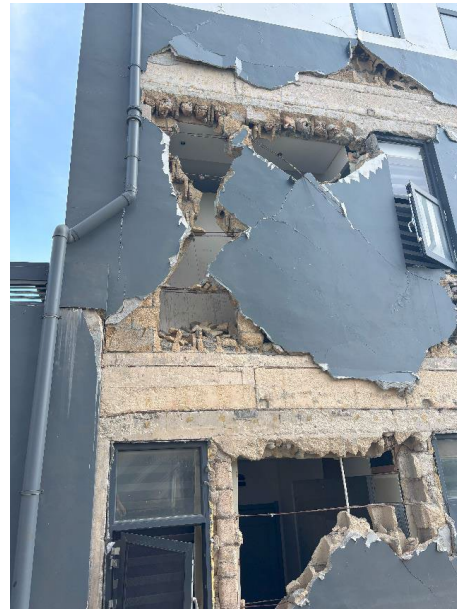
*Figure 18 and Figure 19. Major damage to masonry walls on side of building, minor-to-major damage at front. Concrete frame appeared to be generally intact. Close up of damage.*

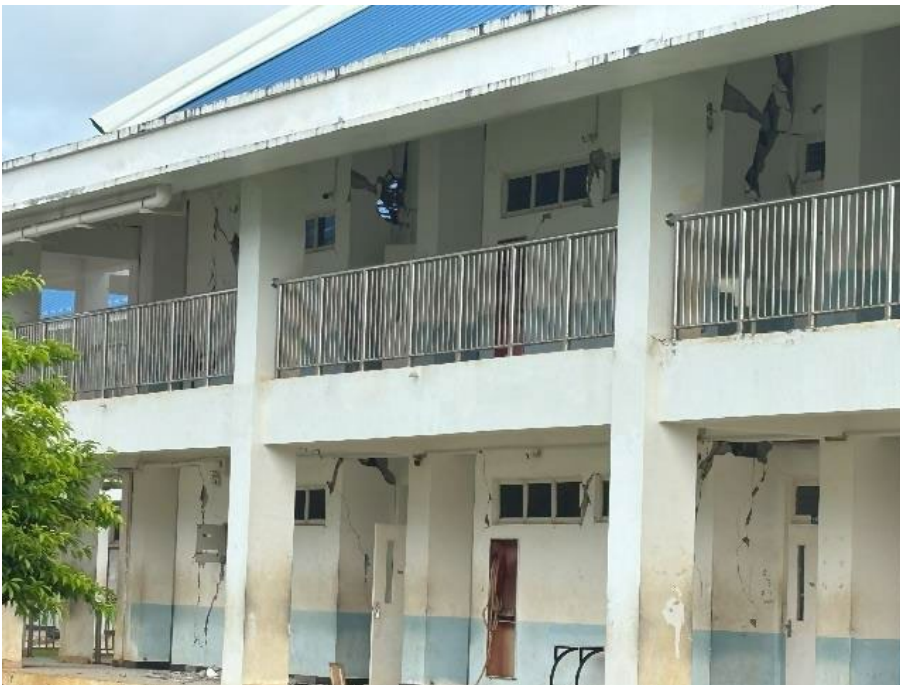
*Figure 20. Major damage to infill masonry walls in concrete frame building. No major damage to concrete frame noted, however serious fall hazard from heavily damaged walls and ceilings remains.*

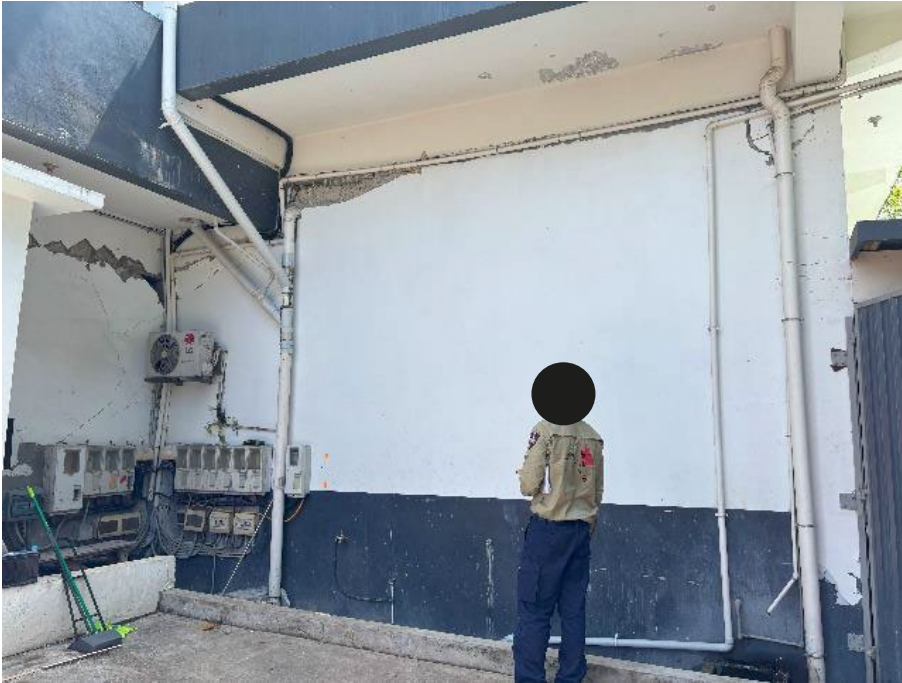
*Figure 21. Infill wall damaged at interface with concrete frame. Wall on left verging on major damage due to increasing disconnection from frame and supporting utilities.*

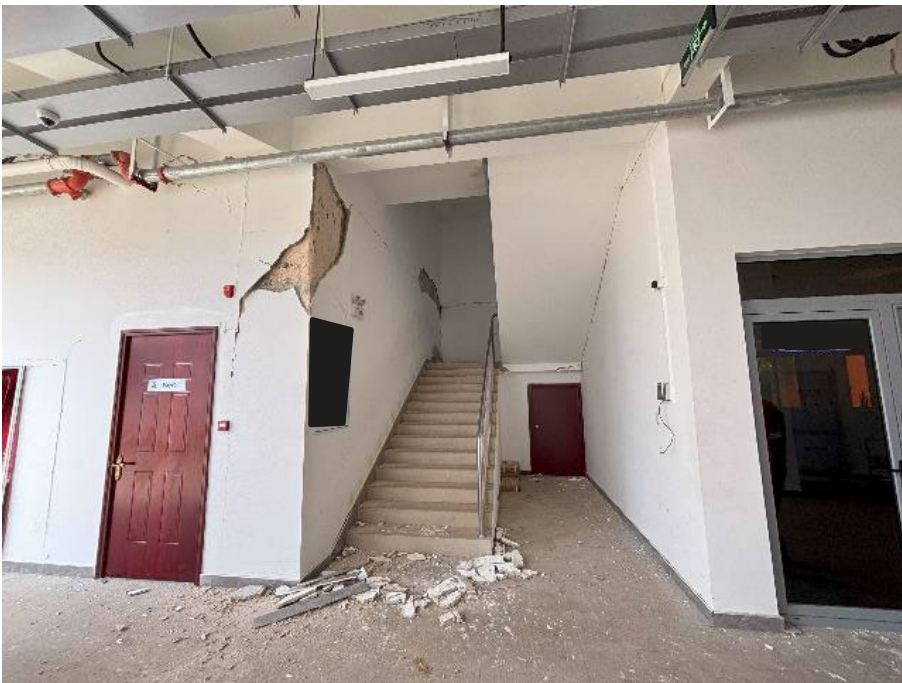
*Figure 22. Minor damage to masonry walls at interface with concrete frame. Like many other similar buildings in Port Vila, this building had a thick plaster render applied to the surface of the wall and frame, which failed in a brittle manner before any significant cracking developed in the structure behind.*

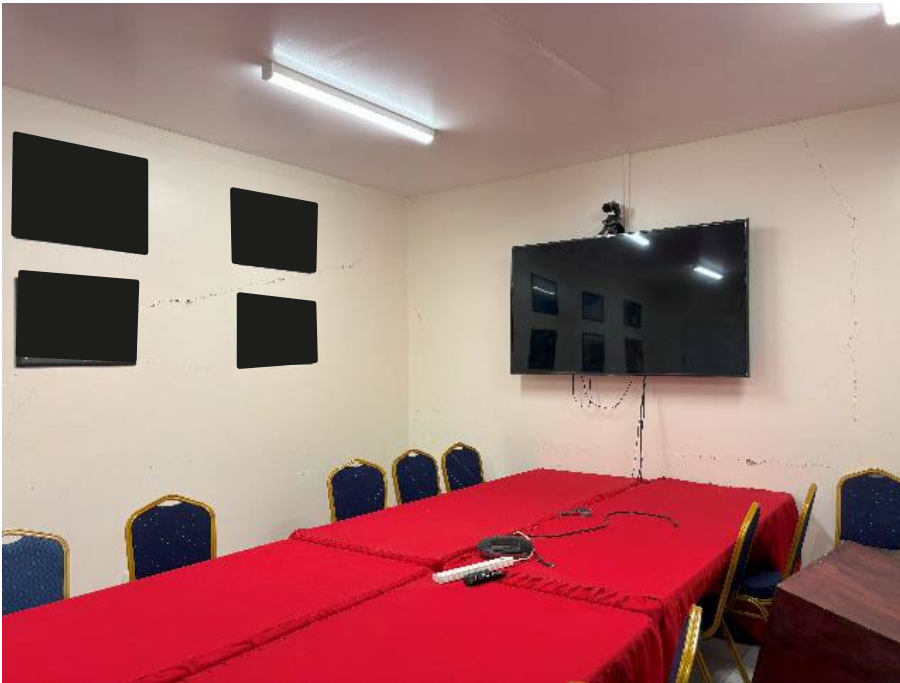
*Figure 23. Minor cracks to plaster finish on infill walls. Most common type of damage observed.*

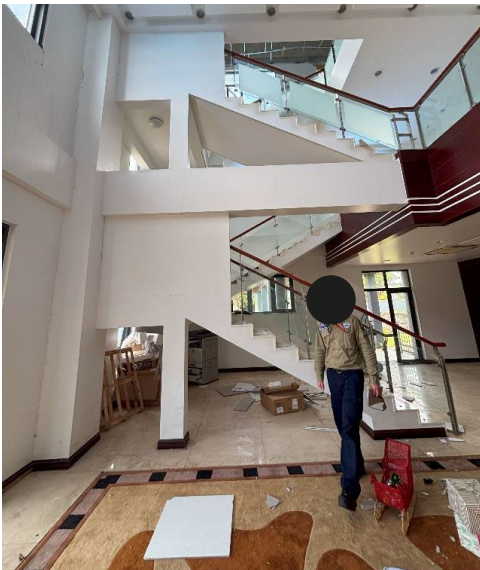
*Figure 24. Heavy cement plaster ceiling tile which has fallen from two storeys above (metal ceiling supports can be seen above stairs at top of photo). Many similar buildings featured these heavy ceiling tiles which pose a major falling hazard in an earthquake if not sufficiently restrained.*

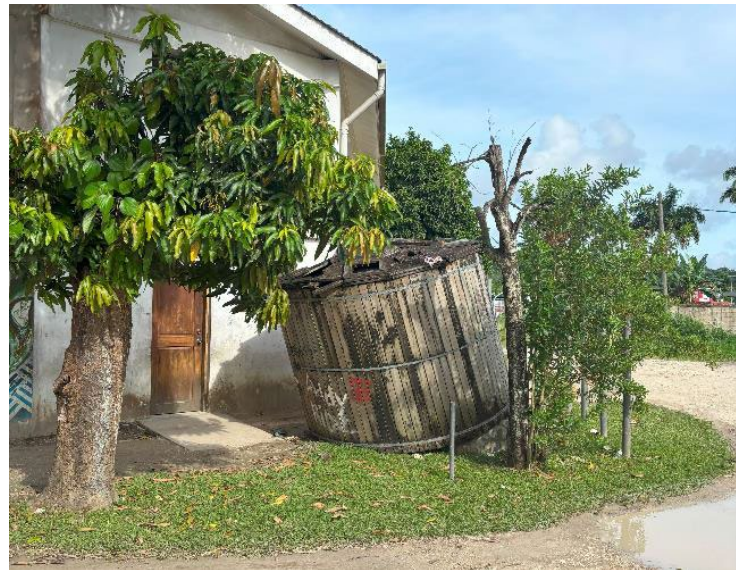
*Figure 25. Dislocated water tank. Many buildings were otherwise usable but lacked water supply due to water tank damage, including to pipe work, connection to foundation, or damage to the tank itself.*
