# A System-Level Evaluation of the Seismic Performance of Different Drywall Partitions in Shake-Table Experiments

*M. Hosseini, A. Shegay & C. Clifton*

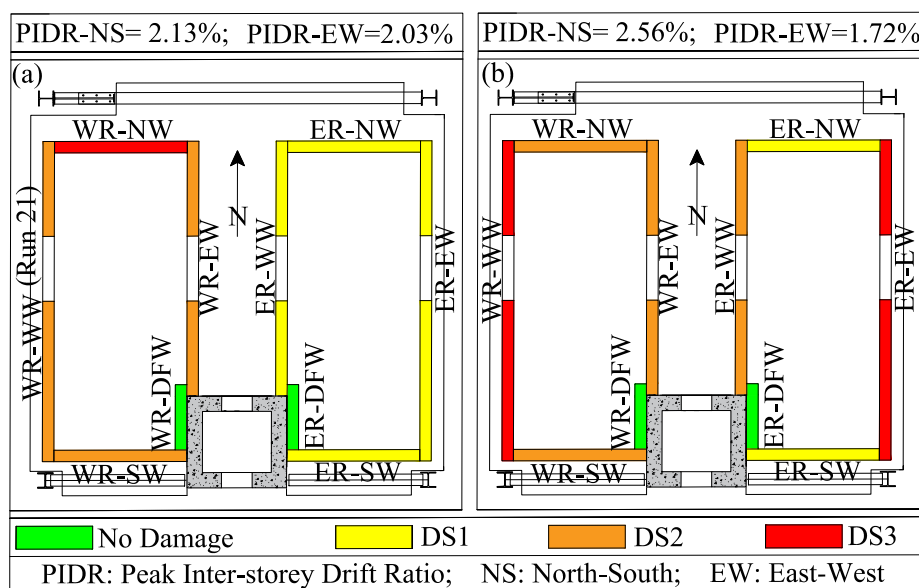
After Run 24, all partition walls and ceilings were assessed in terms of damage state, and the results are summarized in Figure 5. As can be seen, the partition walls of the second-floor eastern room performed very well and suffered much less damage in comparison to the other partition walls. This underscores the effectiveness of the low-damage Qubit 360 system in isolating partition walls from inter-story drift demands (as schematically shown in Figure 6), thereby mitigating damage to them. The limited observed damage to these partition walls was restricted to screw pull-out and paper tape warping. Although partial detachment of plasterboard linings was observed in these walls, there might be no need for plasterboard replacement due to the limited extent of damage.

Figure 5: Damage states of partition walls located on (a) Floor 2 and (b) Floor 3 after Run 24.

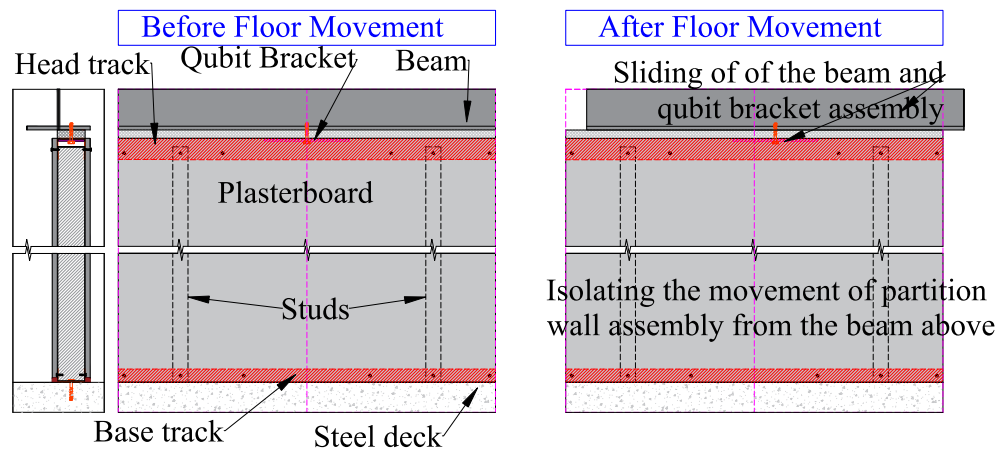
Figure 6: Mode of movement of the partition walls in the N-S direction in the Qubit 360 system in the eastern room on the second floor.

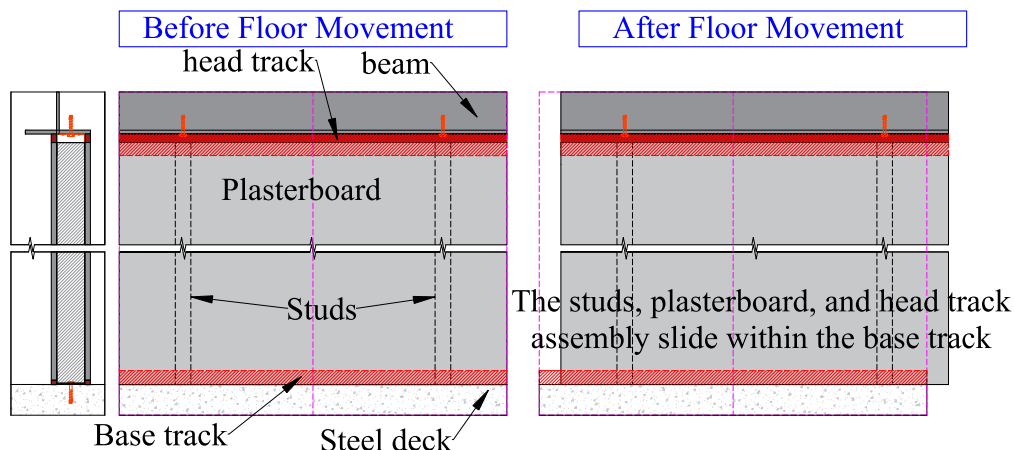
Partition walls oriented in the N-S direction in the third-floor eastern room performed poorly. Specifically, in the Eastern Room–Eastern Wall (ER-EW), corner studs popped out of the base tracks, as shown in Table 2 (g). In addition, this partition wall experienced residual displacement, as illustrated in Table 2 (h). These damage modes were specific to this partition wall and are the result of having no connection between the studs and the base track. Lack of this connection allows the partition wall assembly to slide within the base track (instead of the head track) during shaking, as schematically illustrated in Figure 7. It appears that the friction forces between the plasterboard and the sealant, as well as those between the studs and the head track at the top, were greater than the friction forces between the studs and the base track at the bottom. Furthermore, because this partition wall is single-lined, its studs are more susceptible to torsional buckling compared to the studs in similar double-lined partition walls. In addition, implementing low-damage corner joint detailing at both ends of this partition wall creates a condition in which the return walls at the ends of the partition wall cannot effectively restrict its in-plane sliding during shaking, contributing to the development of residual displacement. In contrast, the partition walls oriented in the E-W direction in the third-floor eastern room (ER-NW and ER-SW) experienced significantly less damage compared to the other walls in this room (ER-WW and ER-EW). This is primarily due to the implementation of the low-damage corner joint detailing at both ends of these walls. Such detailing isolates the in-plane drift of the partition wall from the out-of-plane drift of the intersecting partition wall, thereby preventing the transfer of inter-story drift demands between them. Additionally, the in-plane sliding of these walls was restrained at both ends by the return walls, preventing the development of residual displacements. Consequently, damage to these walls was limited to minor screw impressions in the plasterboard and slight separation of the corner joint sealant.

Figure 7: Mode of movement of the partition walls in the N-S direction in the eastern room on the third floor.

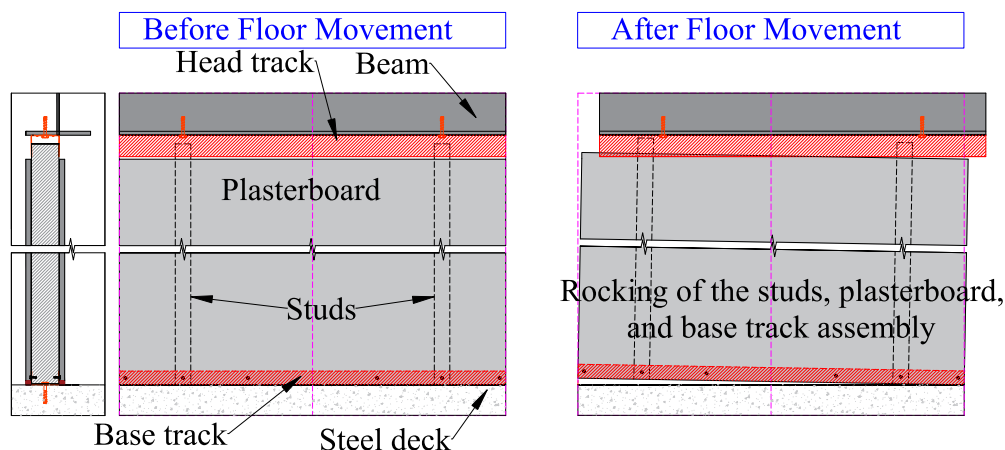
For the partition walls located in the western rooms on both floors, the predominant damage modes consisted of screw impressions, localized crushing of plasterboard around screw locations, and separation of the plasterboard from the sealant where sealant joints were used, as shown in the corresponding figures in Table 2 (e) and (f). In the WR–NW partition wall on the second floor, bending of the head track and local buckling of the noggings at both ends of the wall were observed, as shown in Table 2 (i). In contrast, no such damage was observed in the corresponding wall on the third floor. This difference can be attributed to the use of partial-height plasterboard lining in the second-floor partition wall, compared with the full-height lining combined with fire-rated sealant used on the third floor. During shaking, when inter-story drift in the N–S direction imposes out-of-plane drift on the WR–NW partition wall, this out-of-plane drift is transferred to both intersecting walls (WR–WW and WR–EW partition walls) through corner joints, dragging them along. This caused the two intersecting walls (WR–WW and WR–EW partition walls) to rock in order to accommodate the imposed in-plane drift, as schematically illustrated in Figure 8. Because partition walls on the second floor used partial-height plasterboard lining, there was no effective restraint at the top of the wall; consequently, the resulting uplift was sufficiently large to induce local bending in the flange of the head track at the corner joint intersections. Conversely, on the third floor, the use of full-height plasterboard combined with fire-rated sealant provided top restraint to the wall assembly, limiting uplift and thereby preventing significant bending of the head track at the end studs of the return walls in the WR–NW partition wall.

*Figure 8: The rocking mode of movement of the partition walls in the N–S direction in the western room on the second floor.*

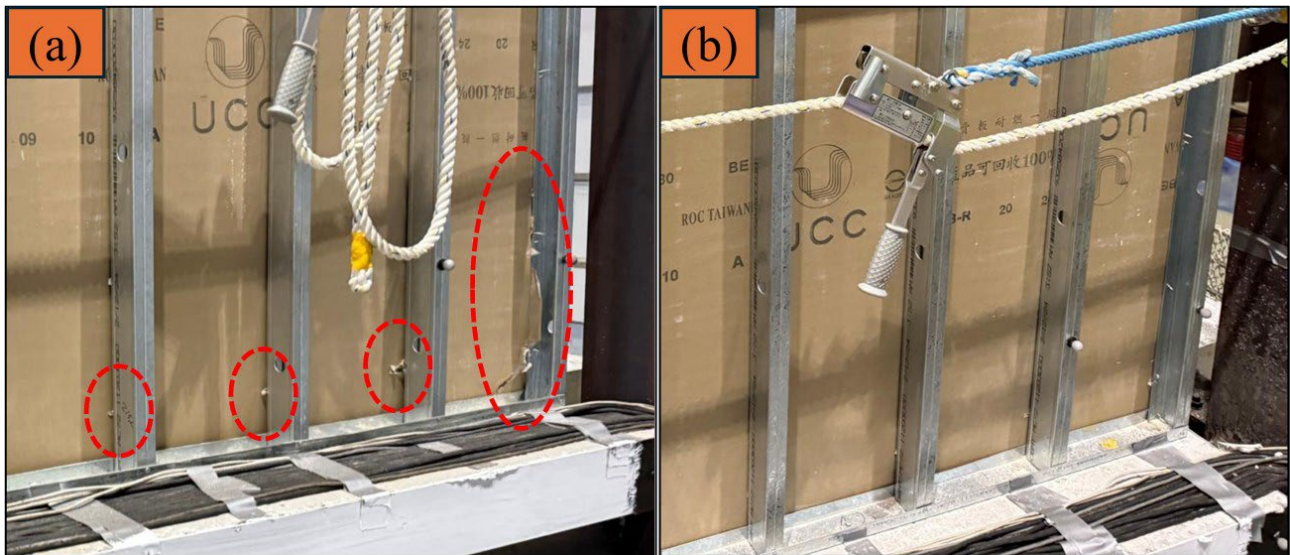
Another difference observed between the partition walls of the western rooms on the second and third floors was that crushing of the plasterboard at the screw locations was more severe on the third floor (as shown in Figure 9), despite there being no considerable difference in the inter-story drift demands. It appears that this difference is also related to the use of full-height plasterboard linings combined with fire-rated sealant in the partition walls of the third-floor western room, as opposed to those on the second floor. In fact, the presence of a full-height wall with fire-rated sealant not only transfers friction forces from the soffit to the wall due to inter-story drift but also restrains the wall from accommodating the drift transferred from the return walls through rocking and uplift mechanisms. Consequently, the studs are forced to bend to accommodate the imposed drift demand, as schematically illustrated in Figure 10. When the studs bend, they are not only more likely to sustain damage themselves but also slide relative to the plasterboard, resulting in the screws crushing the plasterboard. This mechanism intensifies damage to the plasterboard and studs in these walls compared to the partition walls in the western room on the second floor, where the walls can more readily accommodate the drifts imposed by the return walls through uplift and rocking mechanisms due to the use of partial-height plasterboard linings.

Figure 9: Damage observed in the plasterboard of the WR–WW walls after Run 23, located on (a) Floor 3 and (b) Floor 2.

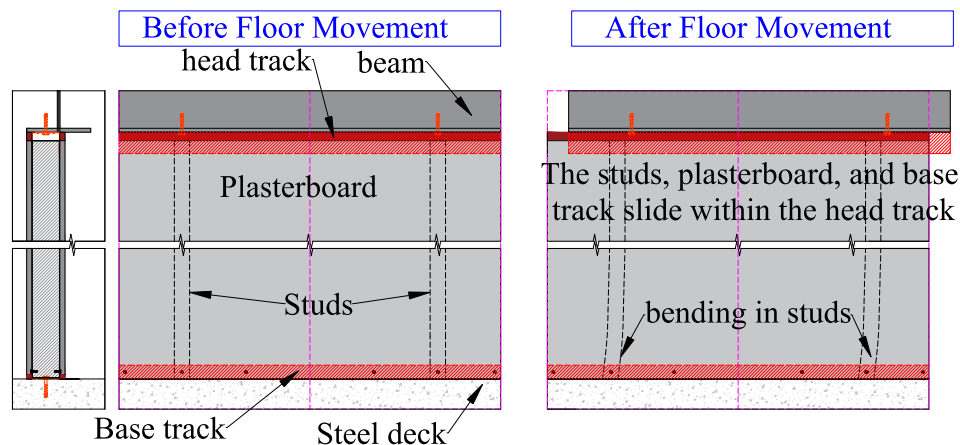
Figure 10: Mode of movement of the partition walls in the N–S direction in the western room on the third floor.
