# Seismic strengthening of the three-storey URM CApSc building

*S. Gardiner, C. Caponi & P. Cammock*

Egis NZ Ltd, Christchurch, New Zealand.

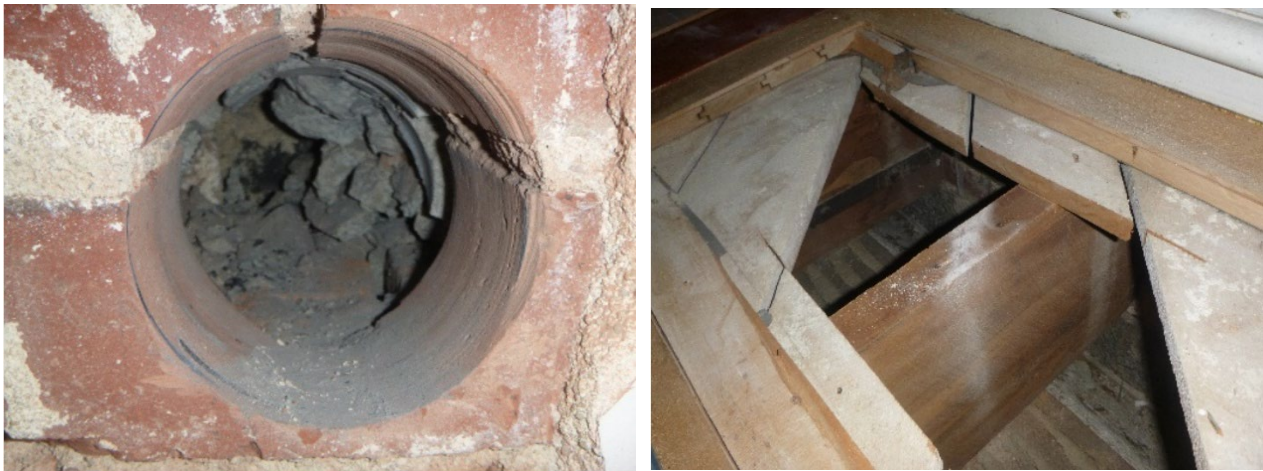
The new assessment provided a detailed picture of the building, confirming the structural deficiencies and painting a clear picture for strengthening. The assessment confirmed the building to be earthquake-prone, with a capacity <15%NBS. A key vulnerability was the makeup of the exterior walls, constructed as distinct layers with limited ability to act compositely.

*Figure 3: Sample photos of intrusive investigations*

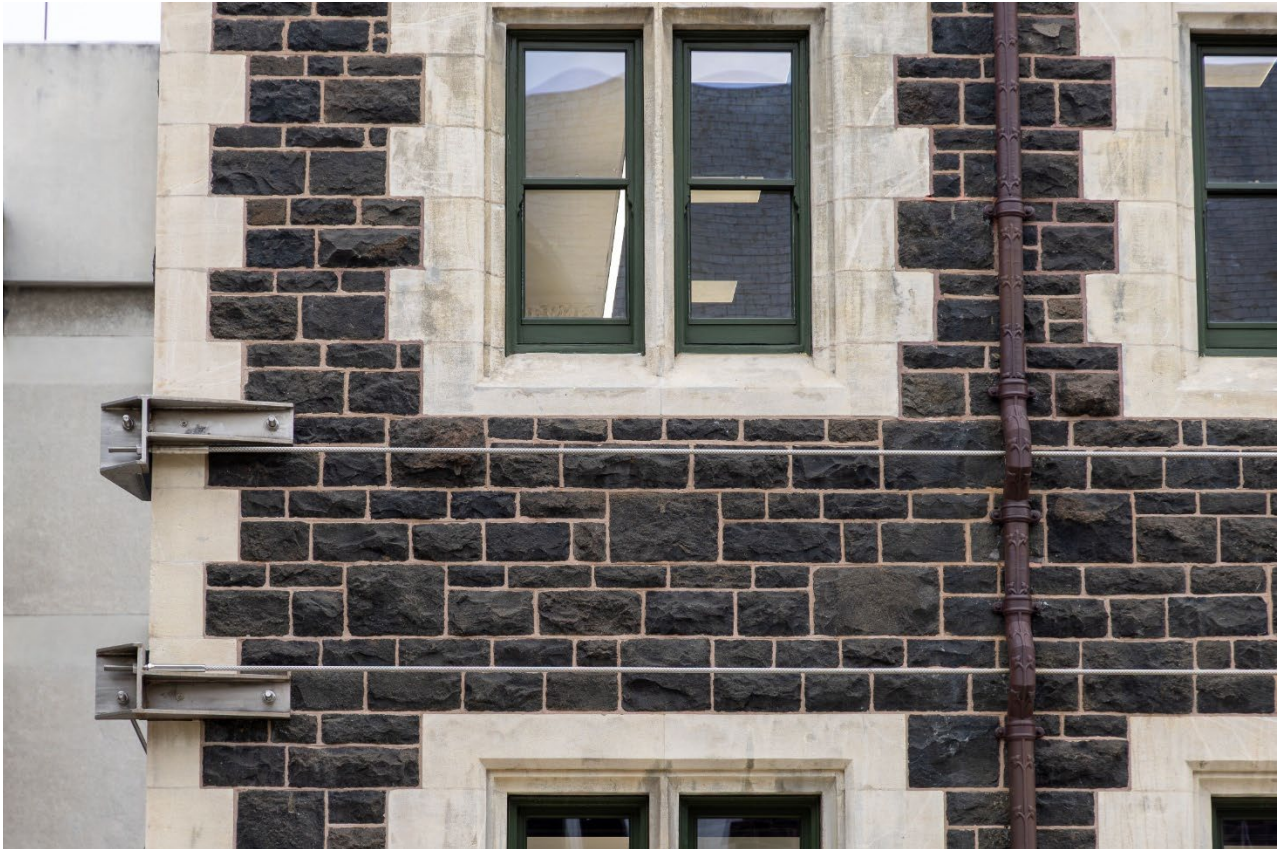
*Figure 5: External post-tensioning brackets and cables (Credit: Cook Brothers Construction, University of Otago)*

Core drilling of the Northern and Southern Wall elevation piers required meticulous efforts by the subcontractor (Contech) to ensure vertical alignment was maintained along the entire pier height and provide clearance to the vertical tendons. The installation of the post tensioned tendons (vertical) and cables (horizontal) involved initial site setup by the sub-contractor where permanent scaffold was already in place, followed by the installation of tendons/cables, stressing and capping/locking off.

For the vertical cables, the methodology involved a four-step process per pier being an initial slack pull up, full load up, with two final pickups to the prescribed post-tensioned load. For horizontal post-tensioning, it was important to stress the wall spandrels evenly to ensure a balance of load and not induce any significant bending/tension demand in the spandrel. This required each set of four cables on the spandrel to be stressed in sequence to balance the induced compression loads at the extreme fibres of the spandrel itself. Similar to the vertical post tensioning, this involved a sixteen-step process per set involving removing the initial slack, a 50% pull up, 100% pullup, and a final pickup. The physical site set up, installation and stressing were undertaken within one working week for each stressing system (vertical, horizontal), with no significant issues arising during installation. Theoretical elongations of cables/tendons were compared against actual elongations and pressure gauge readings to verify installation capacities, with minimal additional ‘pick ups’ required.
