# Post-earthquake assessment and remediation: findings from the December 2024 Port Vila earthquake

*S. Gardiner, P. Cammock & J. Thompson*

## ABSTRACT

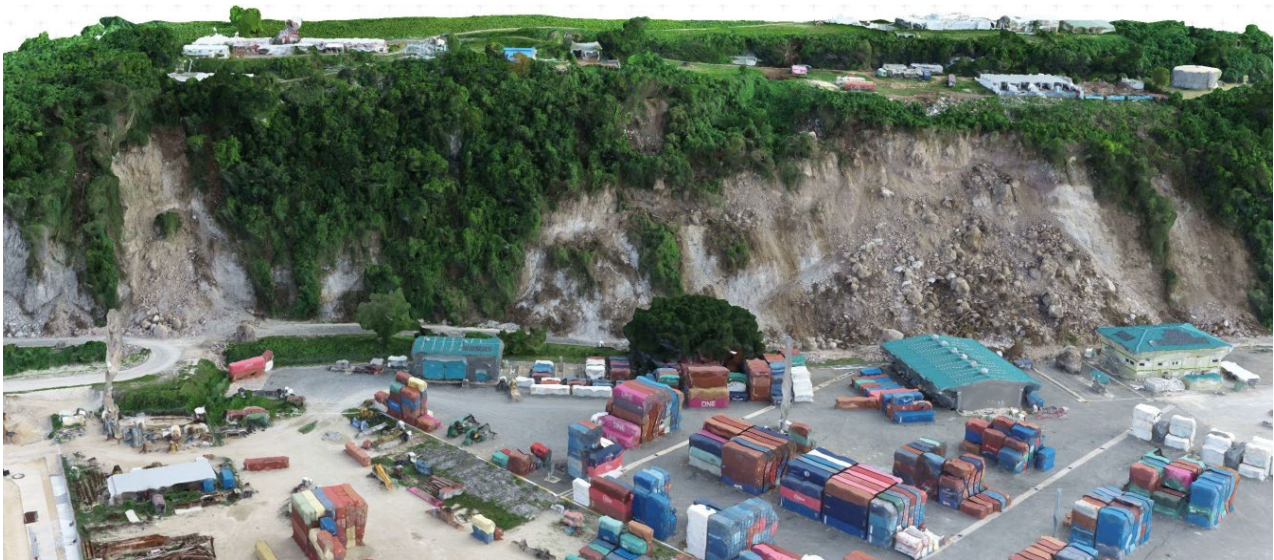
*Figure 1: Wharf Road Landslide*

However, the landslide at Wharf Road, displacing tens of thousands of cubic metres of material, involved a combination of complex failure mechanisms due to the local stratigraphy. The initial failure was primarily translational failure along the weathered horizon of weathered volcanic Tuff. However, this failure undermined large, jointed limestone blocks at the crest of the slope, which subsequently toppled downslope. Cracking and displacement were also observed behind the slope crest, revealing cavities associated with karstic features and uncontrolled fill.

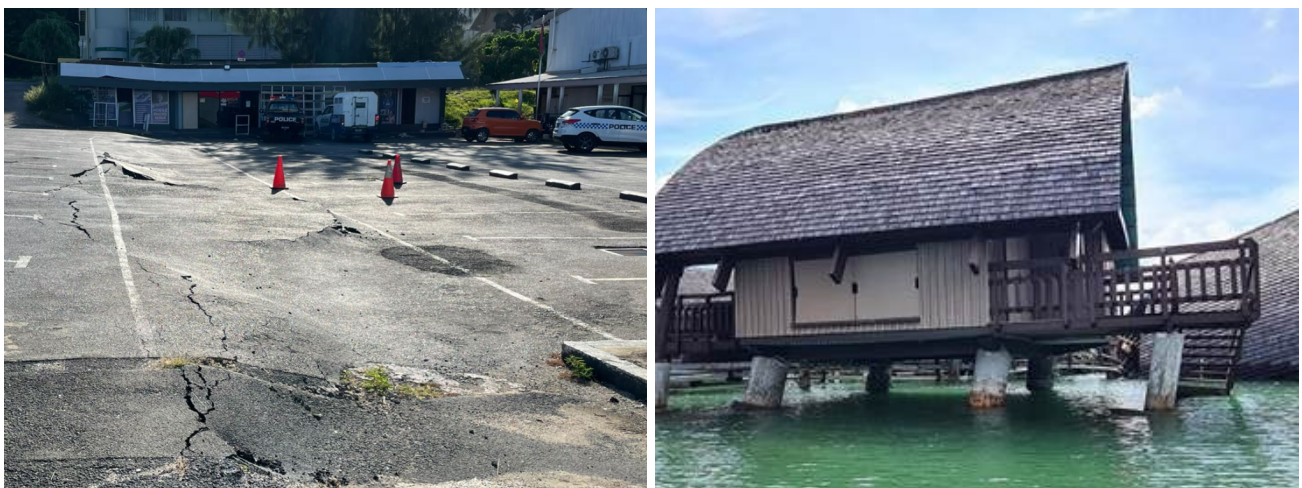
Within the Port Vila CBD, significant ground settlement, in the order of several hundred millimetres, was observed along a linear zone within the CBD. While initially attributed to surface fault rupture, preliminary investigations identified a buried sea cliff beneath the site. This feature marks a distinct boundary between competent limestone to the north and deep marine soils overlain by reclamation fill to the south. An area-

*Figure 3: Ground damage effects at Port Vila CBD (Left), Erakor Lagoon (right)*

For Erakor Lagoon, widespread liquefaction-induced settlement and lateral spreading were observed along the Erakor Lagoon coastline and across Erongo Island. A review of historic aerial imagery from 1971 indicates that the ground damage caused by the 17

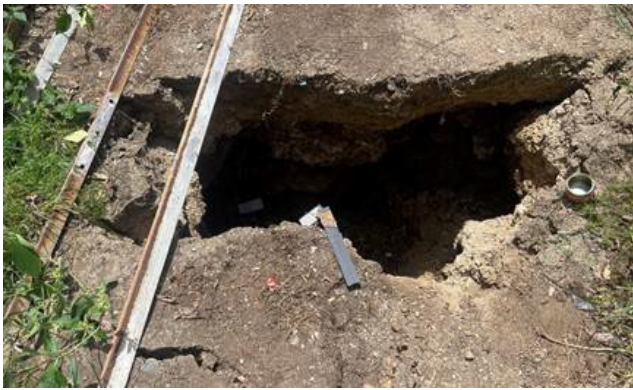
*Figure 4: Wharf road landslide behind crest slope failure*

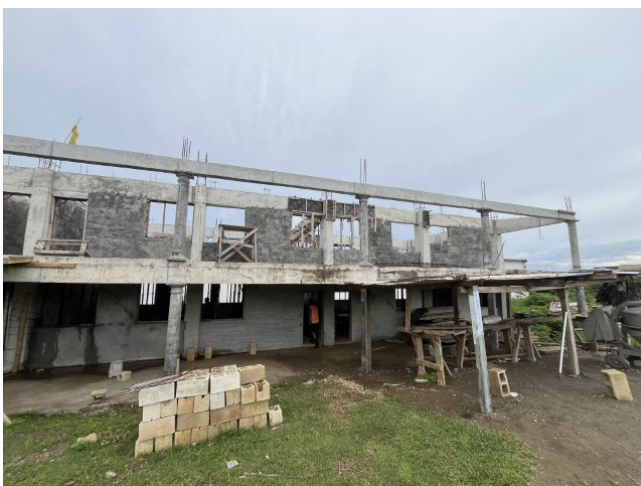
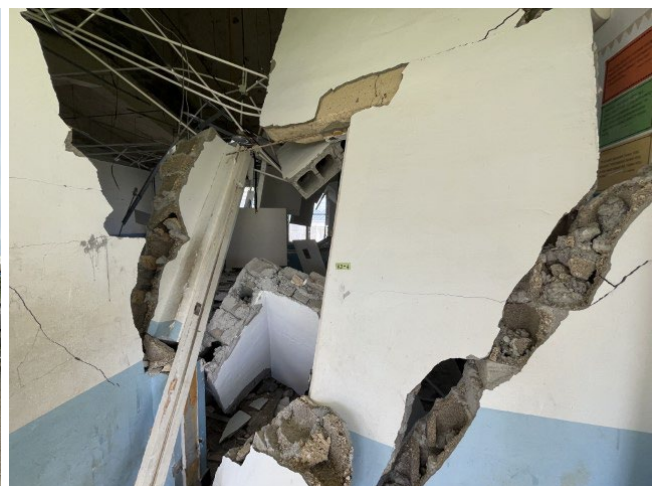
*Figure 5: Concrete frame with masonry infill typology (Left), Observed URM infill failures (Right)*

Common damage included cracking and crushing of unreinforced, or lightly reinforced, masonry infill panels (particularly at the interface with the surrounding concrete frame), flexural and shear cracking in reinforced concrete elements, pounding between adjacent buildings, and damage associated with differential settlement. In areas affected by liquefaction and ground settlement, otherwise well-performing structures experienced significant damage driven primarily by foundation movement rather than inertial seismic demand.

“Regular” structures, particularly those constructed with an in-situ concrete frame over the masonry infill, generally performed well. Less well-confined infills, such as those installed after the frame was constructed, generally suffered more damage, include complete failure out-of-plane, in some instances.

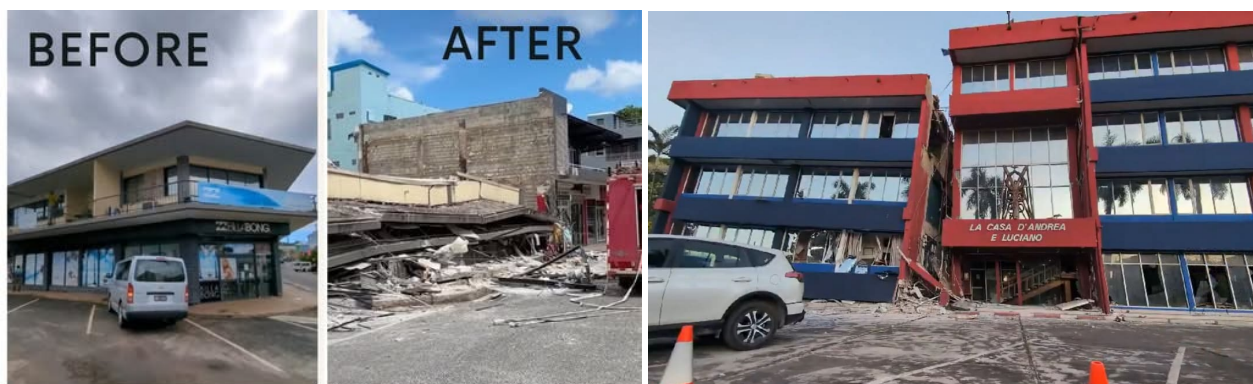
Whilst cleared before our arrival, the worst structural damage causing collapse and loss of life, occurred to a two-storey, corner, CBD commercial building (Billabong) with little bracing structure to the street faces, resulting in significant torsional response and pancaking.

The four-storey, concrete, La Casa D'Andrea E Luciano building in Port Vila, housing the New Zealand High Commission on the top floor, suffered catastrophic damage, separating vertically near the middle of the building and completely collapsing the ground floor level at one end.

Figure 6: Billabong building before and after (Left) (Witnol Benkor Tor, Ni Vanuatu News, <https://www.facebook.com/groups/649624838544277/posts/2805904292916310/>)

La Casa D'Andrea E Luciano (Right) (Maia Ingoe, Vanuatu quake: 'You could hear people absolutely screaming their heads off', <https://www.rnz.co.nz/news/world/536977/vanuatu-quake-you-could-hear-people-absolutely-screaming-their-heads-off>)

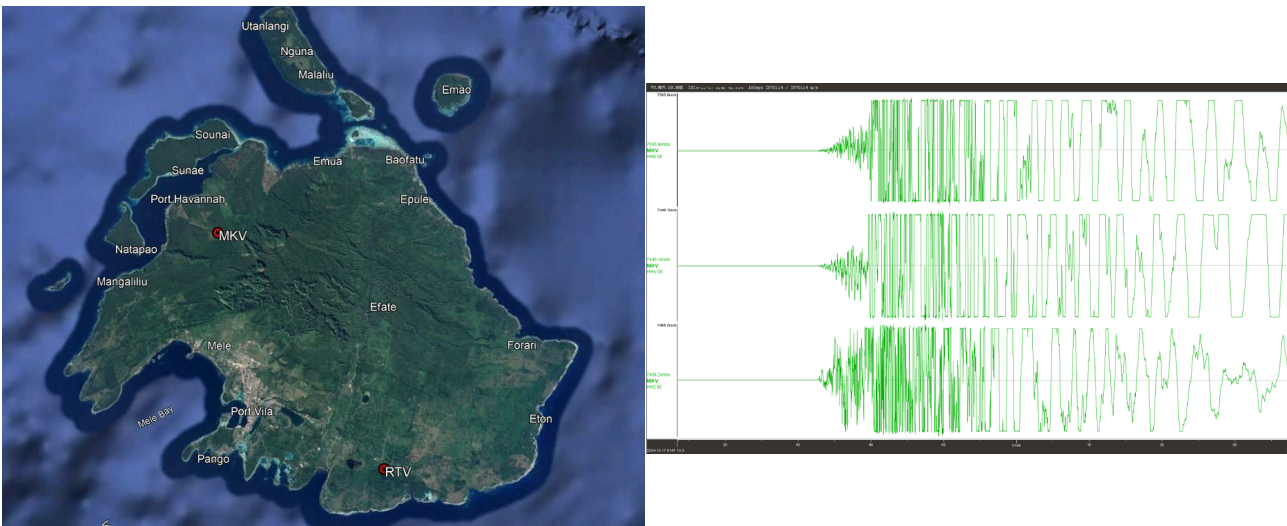
To understand the level of shaking experienced, and to help inform the subsequent development of remediation and rebuild strategies, it was desirable to review local accelerometer data from the December earthquake. Unfortunately, local recorded data from PWD was not easily recovered and, when reviewed, was found to be truncated and unusable. USGS estimates have the PGA around Port Vila around 0.5g, (USGS. *M* 7.3 - 24 km WNW of Port-Vila, Vanuatu. <https://earthquake.usgs.gov/earthquakes/eventpage/us7000nzf3>).

Figure 8: Recording stations and truncated ground shaking records

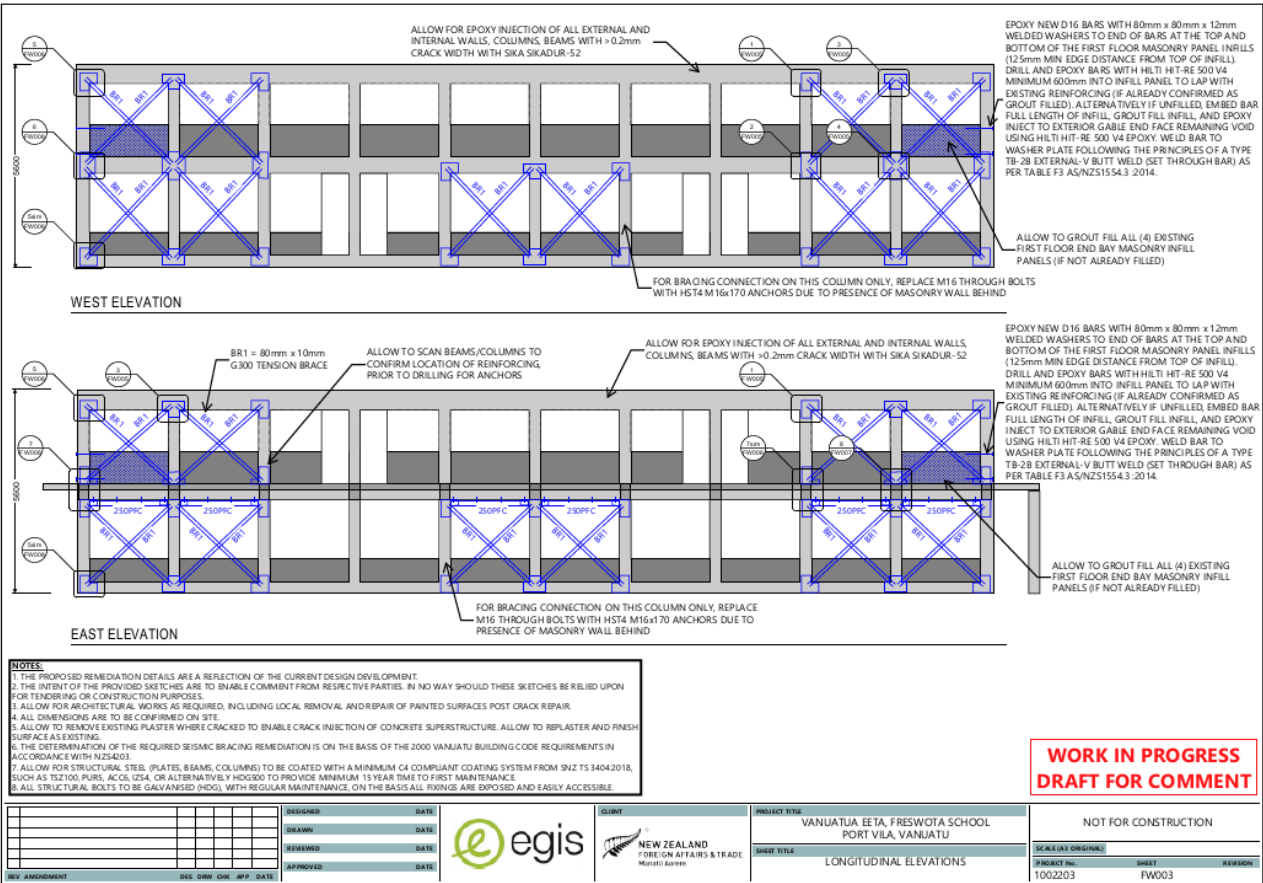
Figure 9: Typical Concrete Frame Conceptual Strengthening Solution

Structural retrofit or repair solutions were designed for reinstatement to at least the pre-earthquake building/system capacity or to a minimum level of seismic demand corresponding to the 2000 Vanuatu National Building Code, which for Port Vila, when converted from NZS4203, was approximately equivalent to a seismic hazard factor of  $Z = 0.2$  from NZS1170.5. Primarily, this was implemented as a result of the

With consideration to the evolving regulatory context, observed damage, and local capability, structural intervention involving repair or reinstatement considered general good practice principles, such as ensuring a ductile building response where possible and adopting overstrength design principles such as those for connections, with introduced lateral load resisting systems detailed to be capable of withstanding higher seismic demands, if imposed.
