Seismic review of a typical low rise commercial building – a case study

M.L Grant

LGE Consulting Ltd, Masterton.

The Case study building was designed and built in 2003. The building is a single storey rectangular shaped 25m x 21m steel portal frame structure with precast concrete panels. The building is typical of a modern commercial building in New Zealand.

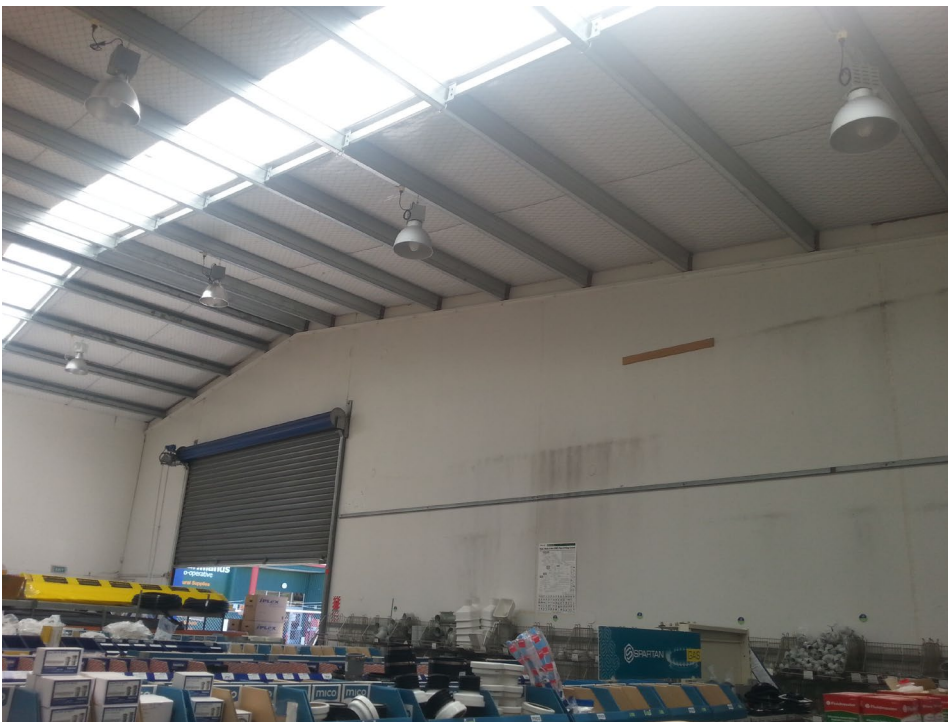
Figure 3: View from inside of Grid 1 wall

The load path for a precast panel on Grid 1 acting out-of-plane is to be reviewed. The panel chosen is reasonably tall and slender, with a height of approximately 7m and a thickness of 170mm.

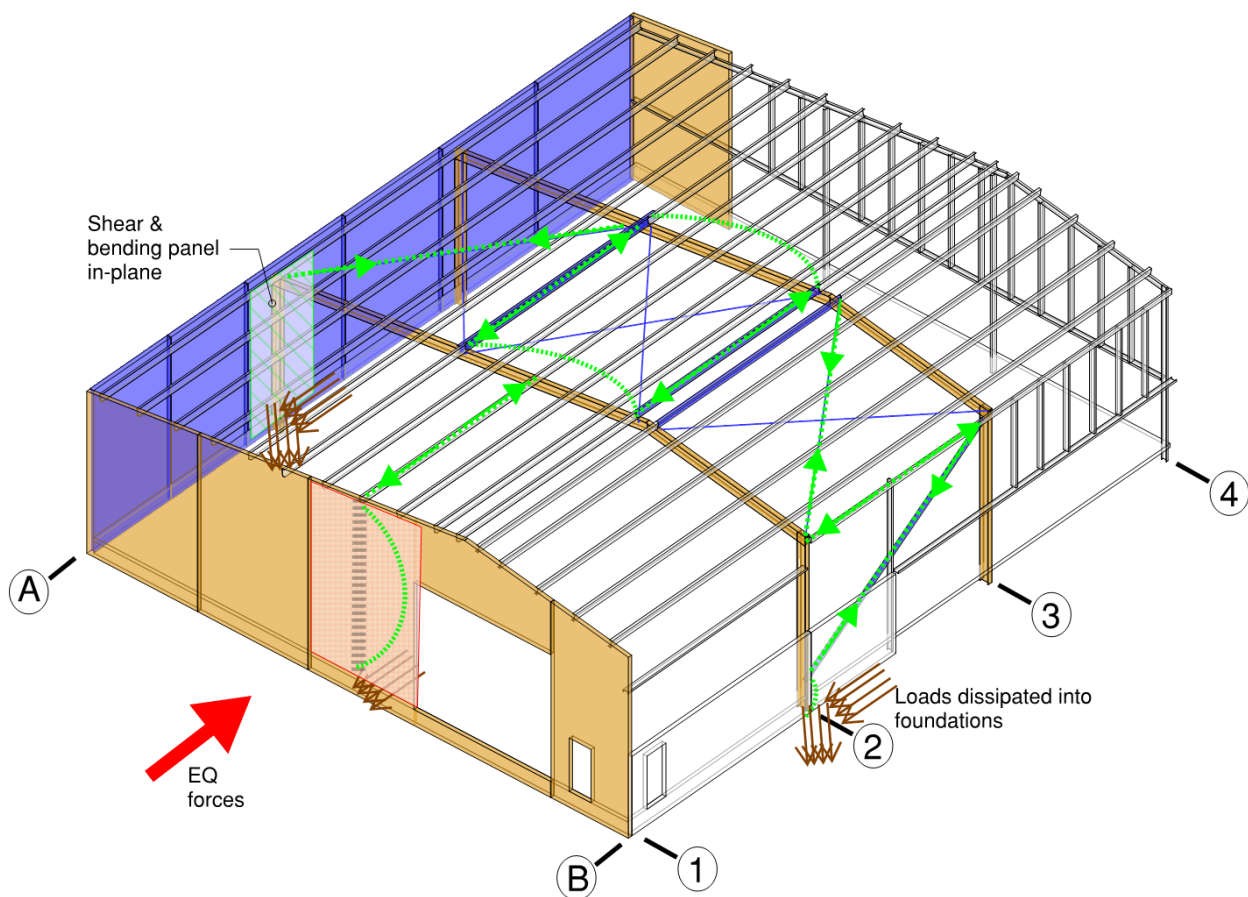
Figure 5: Load path for out-of-plane support of a precast panel on Grid 1

The panels on Grid 1 span out-of-plane, from the ground to roof level. At roof level, the panel loads are transferred to the purlins which act as struts. The purlins transfer forces along their length to the portal frame rafters. The portal frame rafters must bend in the weak direction to transfer loads out to the cross-bracing struts. The roof plane tension-only bracing then transfers loads out to the side walls.

On Grid A, the load is then transferred into the precast concrete panel. The panel transfers forces in-plane to its base, where the proprietary inserts transfer forces into the slab and foundations which are then dissipated into the surrounding soils.

On Grid B, the load is then transferred into the angled tension and compression brace. The brace transfers forces to the portal frame column footing, where the footing base plate and connection transfer forces into the foundations which are then dissipated into the surrounding soils.

- The ability of the purlins to act as compression struts and in bending to support the high gable end (Grid 1) concrete panels
- Reliance on the purlins to act as strut members in the roof plane bracing system
- Reliance on weak direction bending of the portal frame rafter to transfer heavy concrete panel loads
- The tension roof bracing loads are resisted by a single panel on Grid A as there is no joint between the panels. It is unlikely that this is acceptable considering the demand on the inserts as well as the reasonably small foundations.
- The resistance available for the uplift component on the foundations when the wall brace is in tension.

- Secure the out-of-plane panels by
 - Installing new structural steel collector beams and columns and improve the connection to the roof purlins. These columns are supported at the top by new struts which connect to the new roof plane struts.
 - Install new roof plane Donobrace bracing and SHS compression struts with concentric connections
- Grid B wall bracing
 - Replace the existing eaves strut and angles brace. Members must have joints with concentric load paths, and Donobrace cross bracing
 - Provide reliable load path for the uplift demand for the new bracing
- Grid A wall bracing
 - Provide a shear connection between the in-plane panels

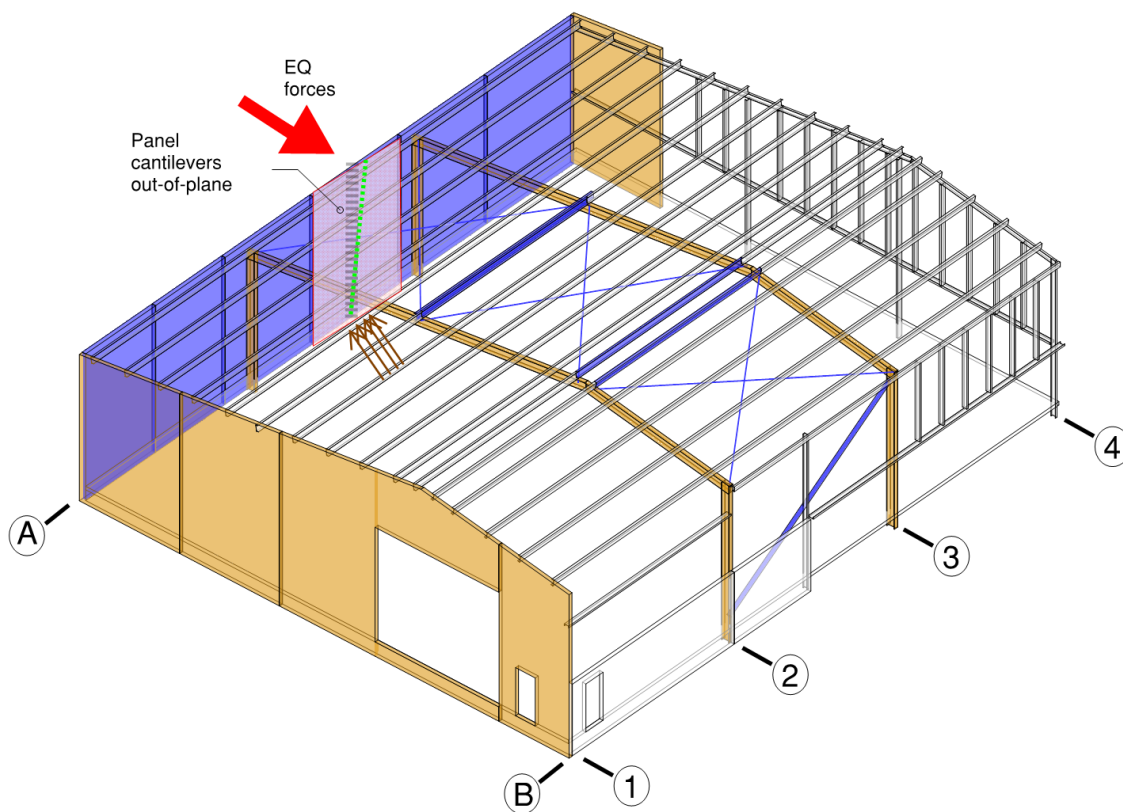
Figure 7: Load path for out-of-plane support of a precast panel on Grid A

In our global review, it was assumed that the primary load resisting system is the portal frames, and in-plane end walls on Grid 1 and 4. However, on inspection of the structural plans it is noted that there is no collector to support the panels at the top. While there are some smaller weld plates, these are nominal in size only.

This means the only available load path to resist seismic loads is via the panels cantilevering from their base.

- A 150mm thick precast panel is unlikely to be able to cantilever 6m in a high seismic zone.

- Secure the out-of-plane panels by
 - Installing a new collector at the top of the precast panels, spanning between in-plane end walls and portal frames.
 - Installing a new epoxied dowel connection to secure the panel base to the footings.

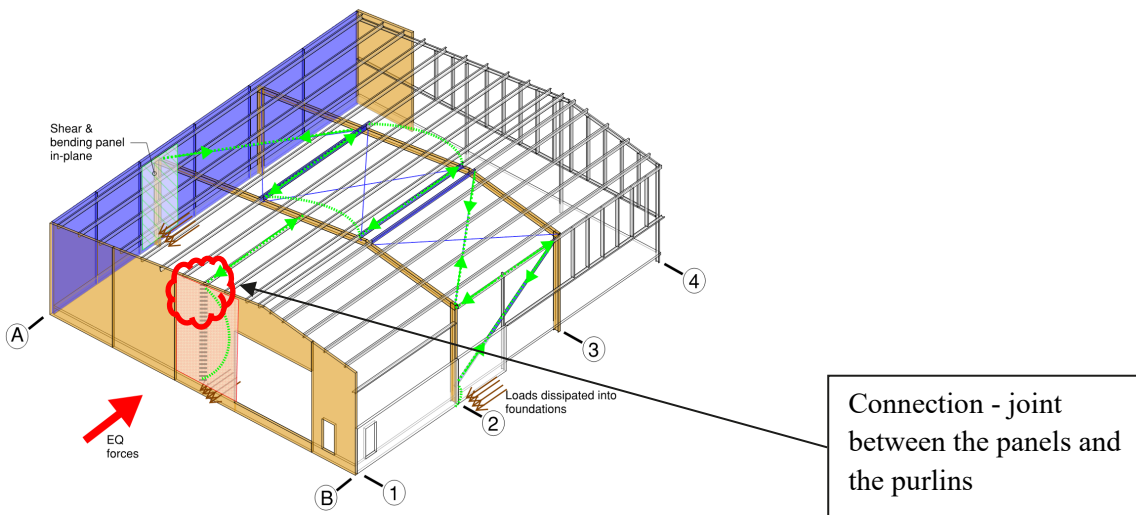
Figure 8: First connection for support of top portion of precast panels on Grid 1 out-of-plane

The first connection in this load path is the connection between the precast concrete panels and the roof purlins. The detail on the plans is shown in figure 9.

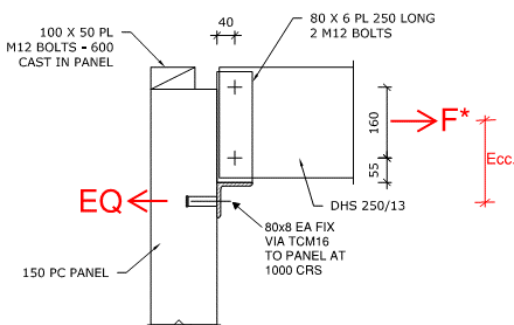
Figure 9: Connection of precast panels to strut

As can be seen, the connection has the following issues identified from a visual review. No calculations are needed to identify these deficiencies; however, calculations would be necessary to confirm the capacity of the connection.

- Highly eccentric connection
- The capacity of the bolts in the thin-walled purlin steel section will likely limit how much load can be transferred to the purlin (tear out)
- The TCM16 inserts are at 1m centres, so the EA must act in bending to transfer loads to the strut cleats
- The cleat bending and weld to the EA
- The pull-out capacity of the TCM insert, which are non-seismic rated
- Prying action at the insert

It should also be noted that this connection is relied on to transfer loads in the other direction, ie roof loads need to be transferred to the concrete panels in-plane on Grid 1. This connection is also deficient for loads in this direction.

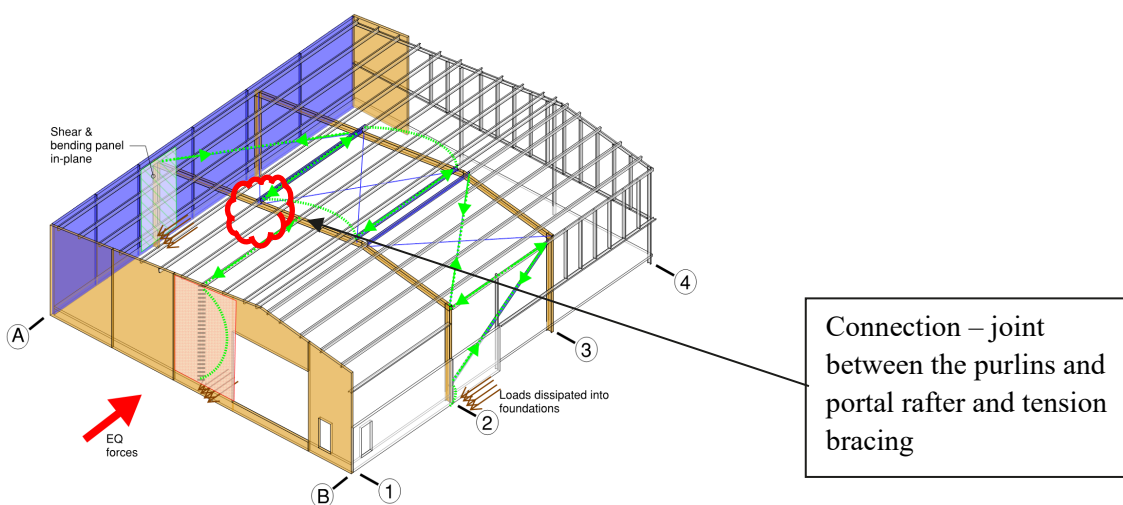
Figure 10: Location of connection under review

Another connection in this load path is the connection between the roof purlins/struts and the portal frame rafter. The detail on the plans is shown in figure 10.

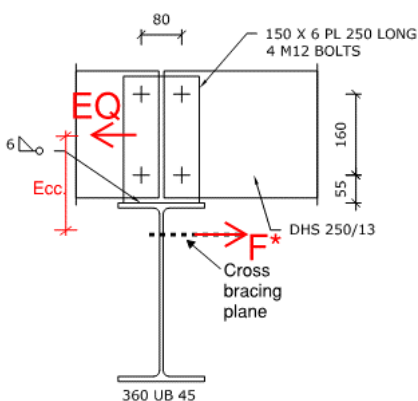
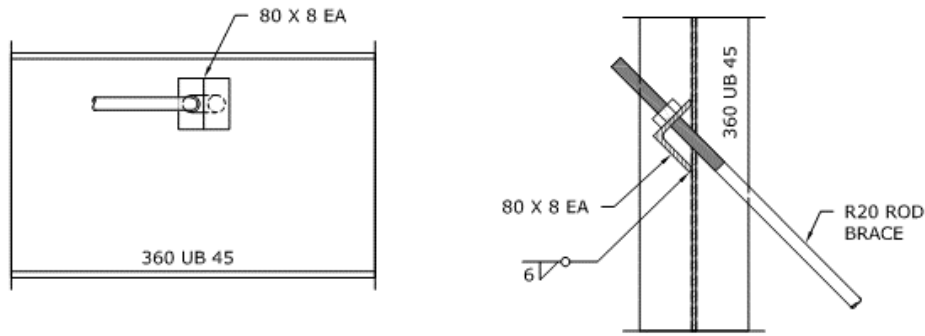
Figure 11: Section of connection of purlin struts to tension-only bracing

Figure 12: Extract from structural plans of connection of purlin struts to tension-only bracing

- Eccentric connection with both vertical and horizontal offsets between the point of applied loads and the point of resistance.
- A reliance on indirect load path (web bending) to transfer loads
- The capacity of the bolts in the thin-walled purlin steel section will likely limit how much load can be transferred to the purlin (tear out)
- The cleat bending and connection to the UB

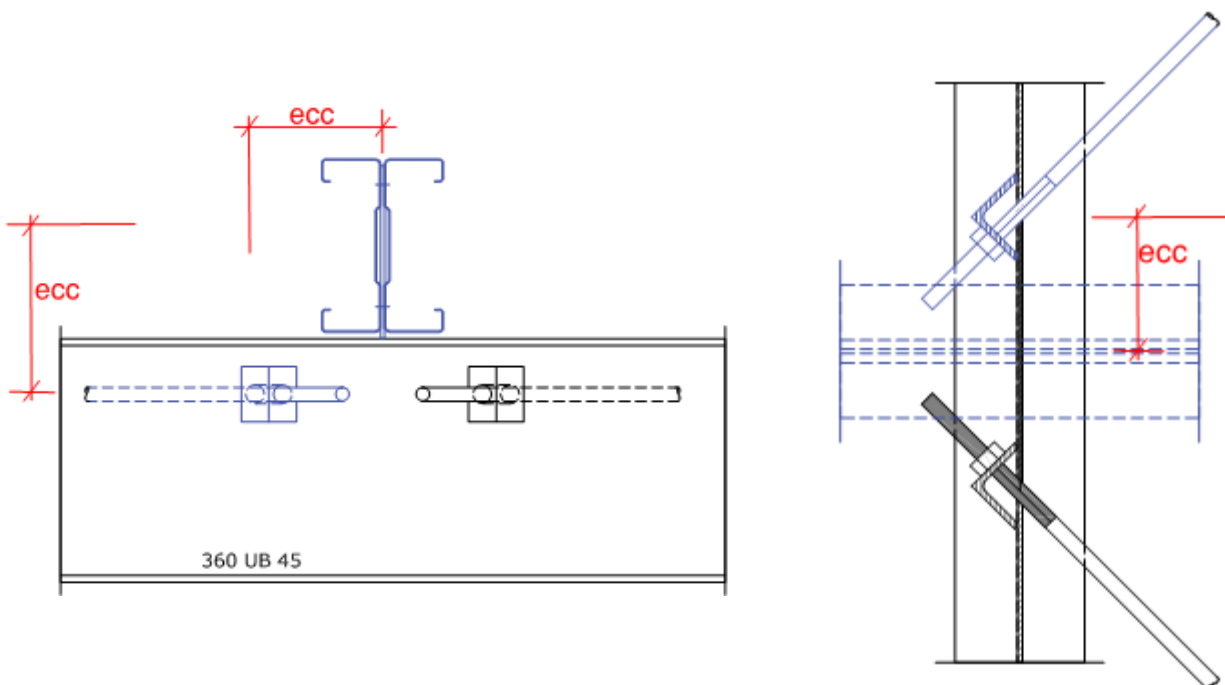
Figure 13: Completed elevated and plan view of connection of purlin struts to tension-only bracing noting eccentricities

Structural details are for individual components (see figure 11 and 12), however when the collated load path detail is drawn the eccentricities become clearer (see figure 13).

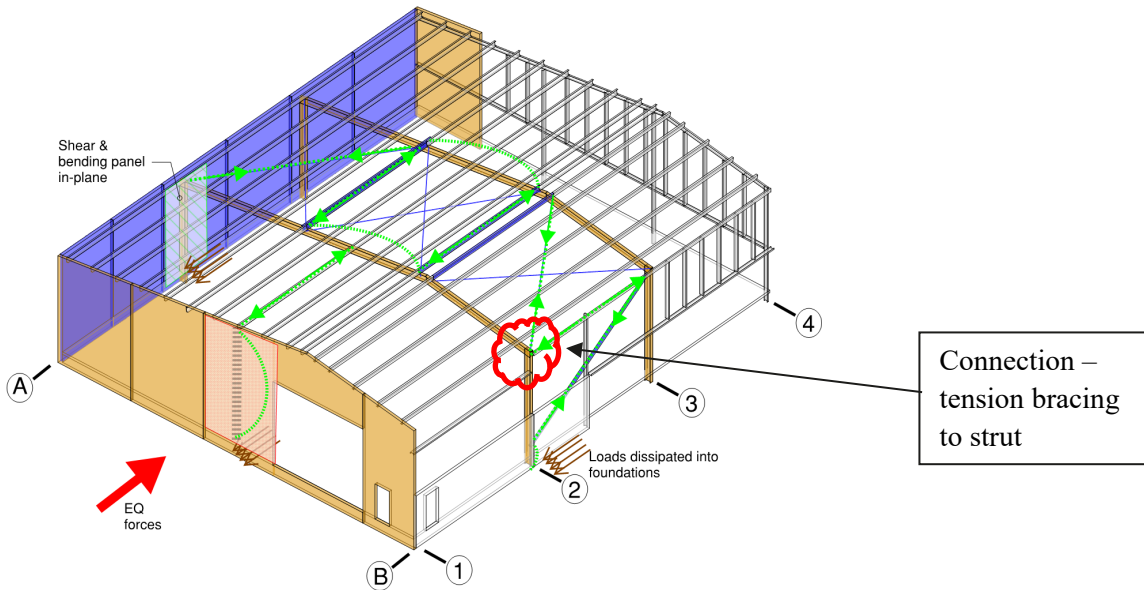
Figure 14: Location of connection under review

The angle tension/compression brace on Grid B is the only load path for longitudinal loads on this side. It is required to transfer reasonably substantial loads from the heavy gable end wall precast panels out-of-plane. The details provided on the plans are shown in figure 15.

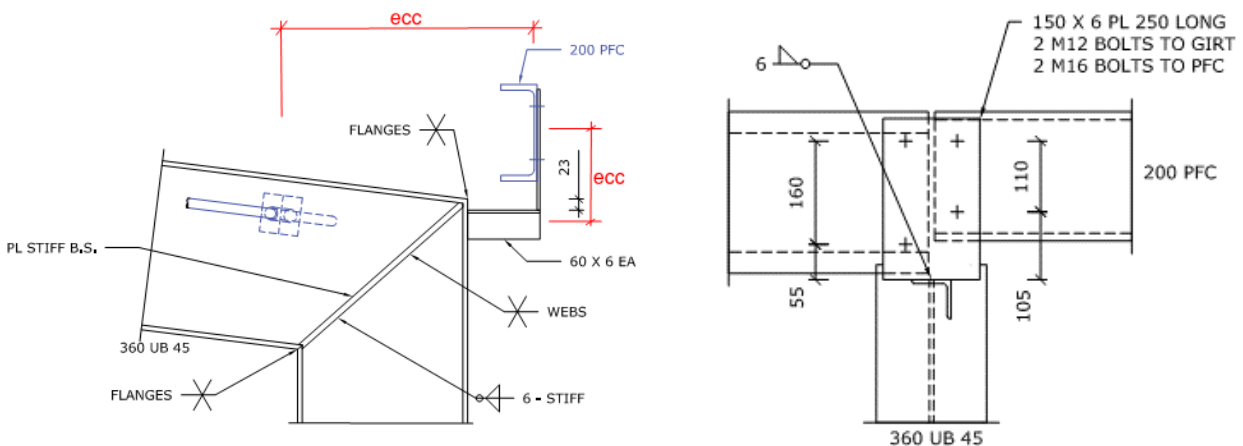
Figure 15: Connection of tension brace to strut in section (left) and elevation (right)

As can be seen, the connection is extremely eccentric and relies on multiple indirect load paths to transfer loads.

- Eccentric connection with both vertical and horizontal offsets between the point of applied loads and the point of resistance.
- A reliance on cantilever bending and torsion of a 60x6 EA stub
- Loads to be transferred through the knee joint arrangement
- M16 bolts specified, with no grade.

The poor detailing of this joint would make quantifying the joint capacity difficult.

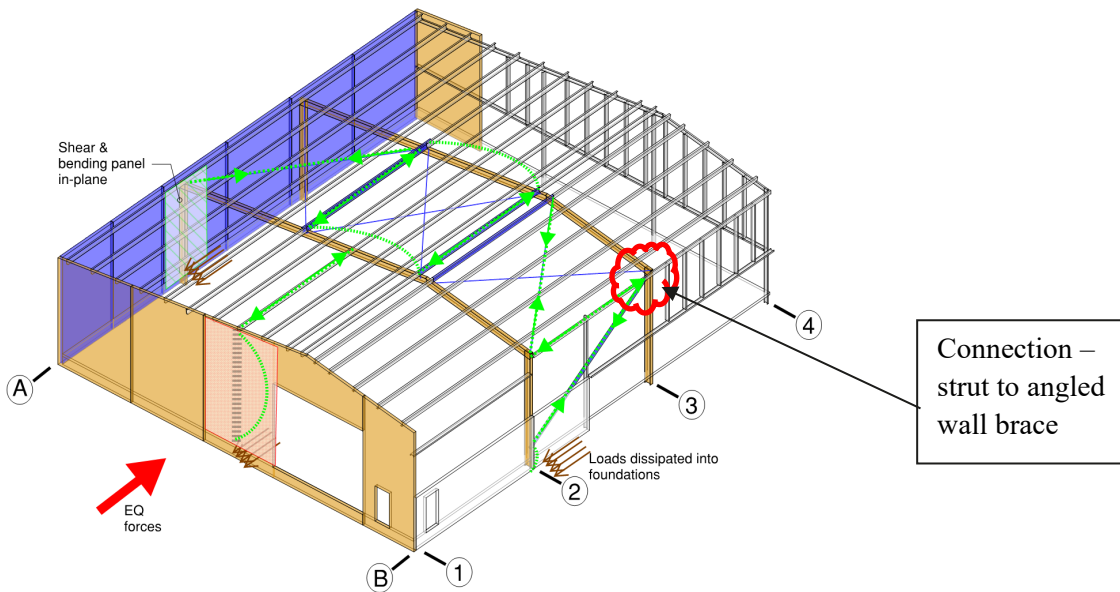
Figure 16: Location of connection under review

Assuming transfer of loads through the above connection is possible, the strut loads then need to be transferred to the angled tension/compression brace. These loads are reasonably substantial, as they include the heavy gable end wall precast panels out-of-plane. The location of this joint and the details provided on the plans are shown in figure 16 and 17.

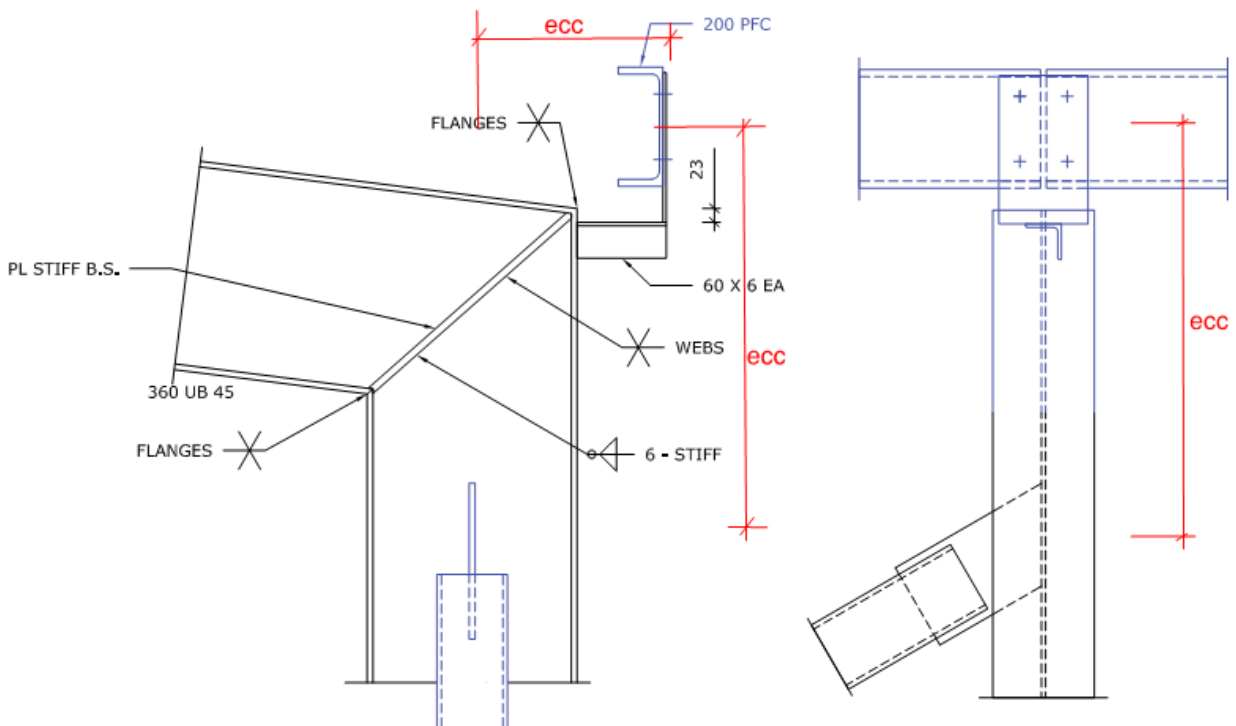
Figure 17: Connection of tension brace to strut (details from plans, blue elements added for clarity)

As can be seen, the connection is extremely eccentric and relies on multiple indirect load paths to transfer loads.

- Eccentric connection with both vertical and horizontal offsets between the point of applied loads and the point of resistance.
- A reliance on cantilever bending and torsion of a 60x6 EA stub
- Weak direction bending of the portal column
- Cleat bending and connections
- M16 bolts specified, with no grade.

The poor joint detailing makes quantifying the joint capacity difficult.

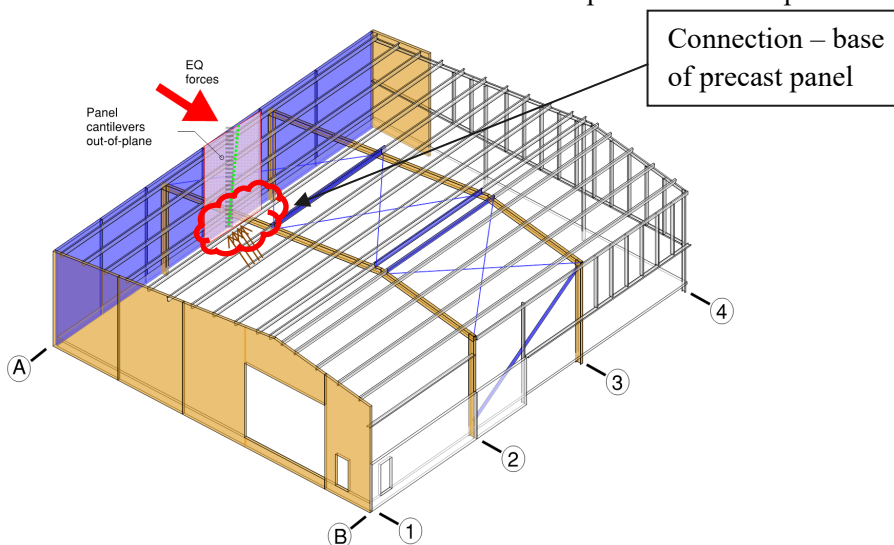
Figure 18: Location of connection under review

As discussed above, there is no collector present to support the top of the precast concrete panels. Therefore, the first connection is the connection between the precast concrete panel and the footings.

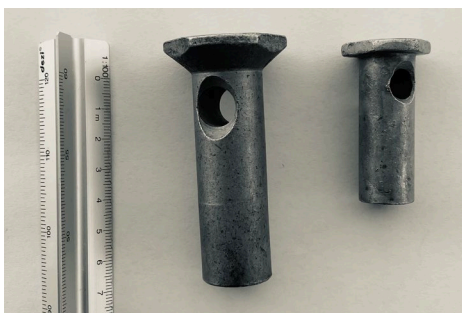
Figure 19: RB12 insert (left) and TCM12 inserts (right)

A review of the drawings shows that there is a proprietary insert present. An engineer would usually assume a typical proprietary panel type connection, however on closer inspection of the plans it is seen that a TCM12 insert is specified, not a RB12. These inserts are a significantly smaller threaded rod insert, as seen in the image below.

Recent research has highlighted the poor performance of this configuration of the proprietary panel insert connection, with a reliance on concrete to act in tension (Hogan 2018). This configuration of a threaded rod insert detail will fail when the panels reach reasonably low levels of drift (Hogan 2018).

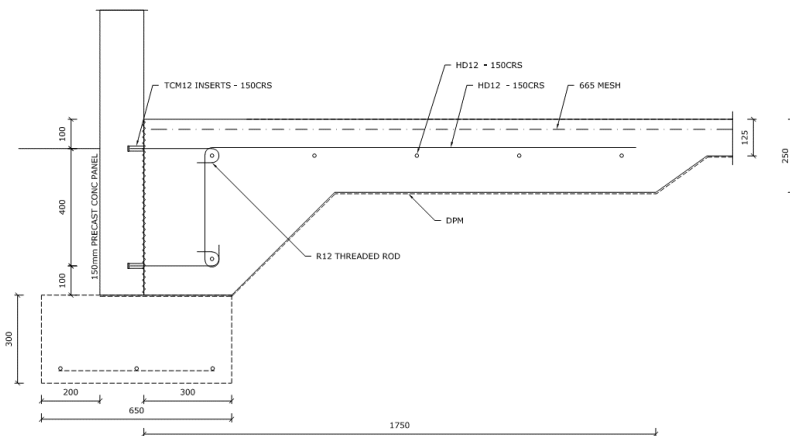
Figure 20: Connection detail at base of panels on Grid A

The detailing around the footing highlights the following concerns.

- TCM12 inserts with very shallow embedment into the precast panel
- Poor detailing with limited ability to develop the footing reinforcing
- The threaded rod is of uncertain material.
- The footing size is relatively small compared to the panel size and may not be adequate for overall stability. If the slab is required for additional capacity, the fixing between the two, particularly to transfer tension forces from the bottom footing reinforcing bar, is poor.

It should be noted that this detail is likely to be unacceptable for a post-fire stability load even once remediation of the seismic structure is completed.

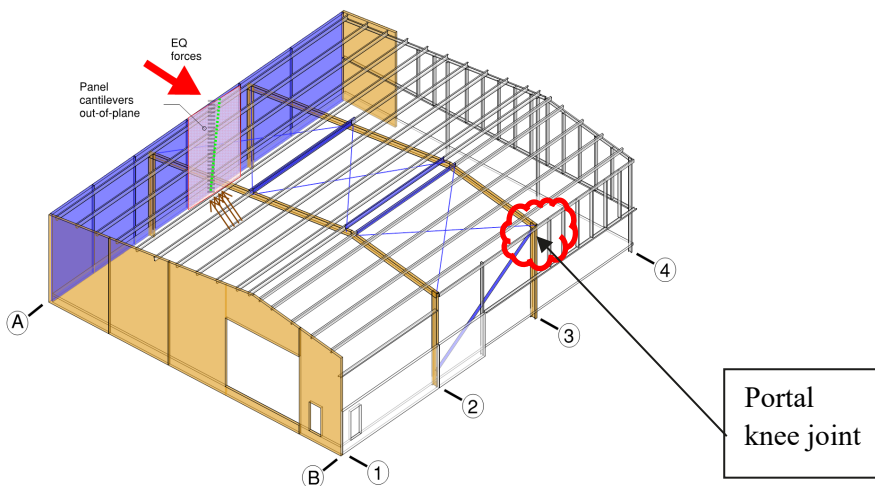
Figure 21: Location of connection under review

The critical portal frame connections are the knee joint and footing base plate, and to a lesser extent the apex joint. For this example, we will review the knee joint.

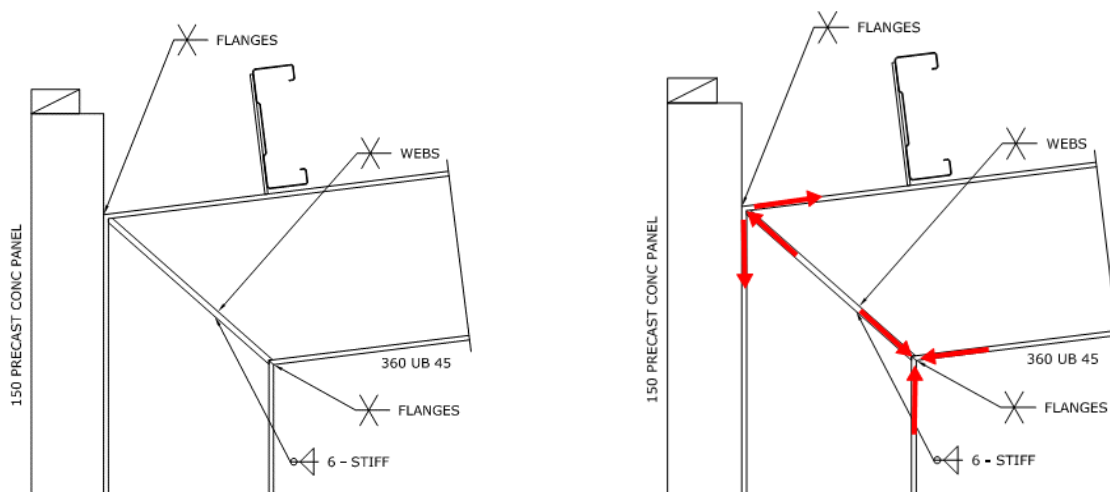
Figure 22: Connection detail at base of panels on Grid A

The detailing around the knee joint highlights the following flags.

- A 10mm Grade 250MPa plate is unlikely to resist the forces from two 9.8mm Grade 320MPa flanges
- No lateral restraint to the inside flanges of the column
- The quality of the butt weld to the flanges at an acute is difficult to achieve and may not be covered under AS/NZS5131

Basic calculations show that the knee joint capacity is significantly lower than the section capacity.

- Improve the portal frames as follows.
 - Providing some base fixity with rigid connections to a new ground beam
 - Install new knee brace to reduce demand on knee joint
 - Install fly bracing to provide lateral restraint
