Seismic strengthening of the Seatoun Tunnel

B. Radosavljevic & D.A. Latham

ABSTRACT

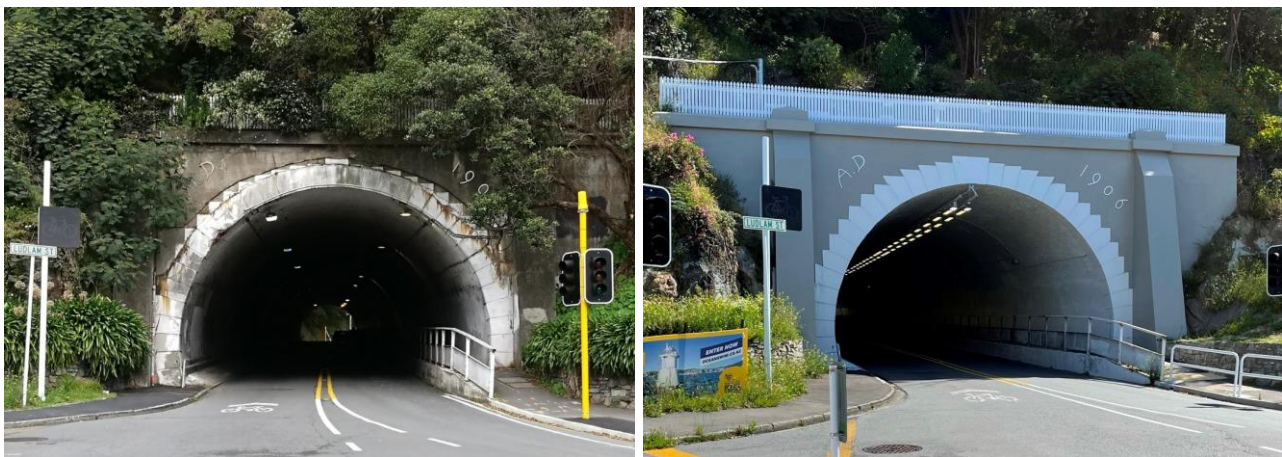
The final repair and restoration of the concrete structure preserved the original appearance with little evidence of the new concrete beams and ground anchors. Figure 2 shows images of the Seatoun portal end before and after strengthening work.

Figure 2: View of the Seatoun portal end, before and after the strengthening works.

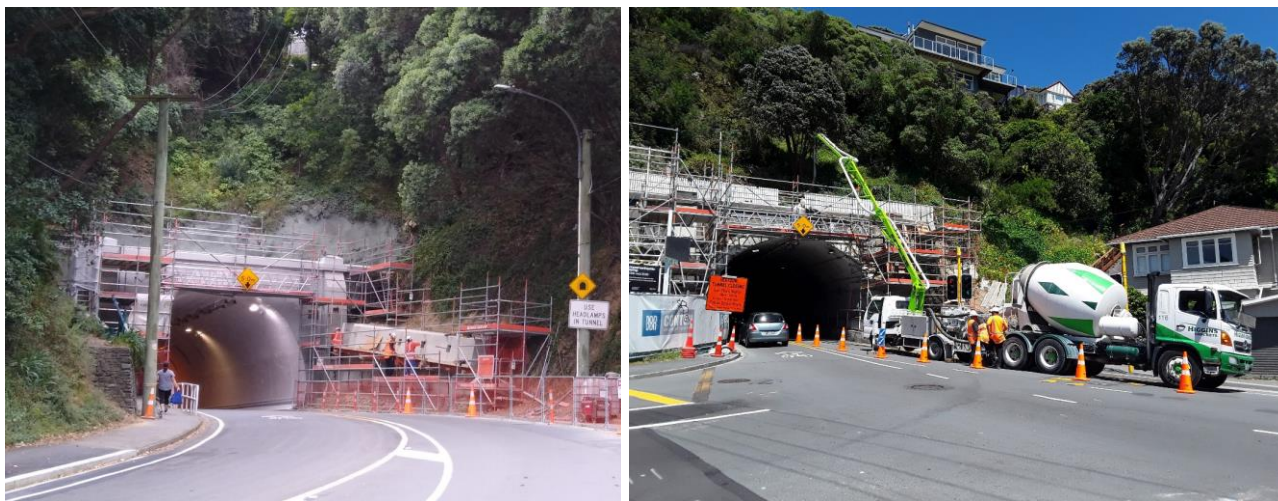
The construction of the ground beam along the top of the portal required caution when excavating to ensure no damage was caused to the top of the existing tunnel. Temporary measures comprising rock bolting, shotcrete and rockfall netting were implemented to ensure stability of the excavation and to provide a safe work environment for personnel. Figure 6 shows photographs of the construction of beams and concreting activities with traffic management in place.

Figure 6: Photographs of the beam construction activities at each end of the tunnel.

These structural elements were relatively conventional and only required standard construction methodologies. The main challenge experienced was planning and sequencing the work with very limited working room and the need to maintain safe traffic passage through the tunnel at all times. A full scaffold system was designed and constructed to provide full access up the buttresses and across the top of the tunnel. This allowed access to both sides of the portal regardless of lane closures. It also provided the base platform for setting up formwork and placing reinforcement and concrete.
