Challenges associated with the geotechnical design of Te Kaha – Canterbury’s new Multi-Use Arena

A.K. Murashev, S. C. Baker & J. Fearnley

WSP, Christchurch, New Zealand.

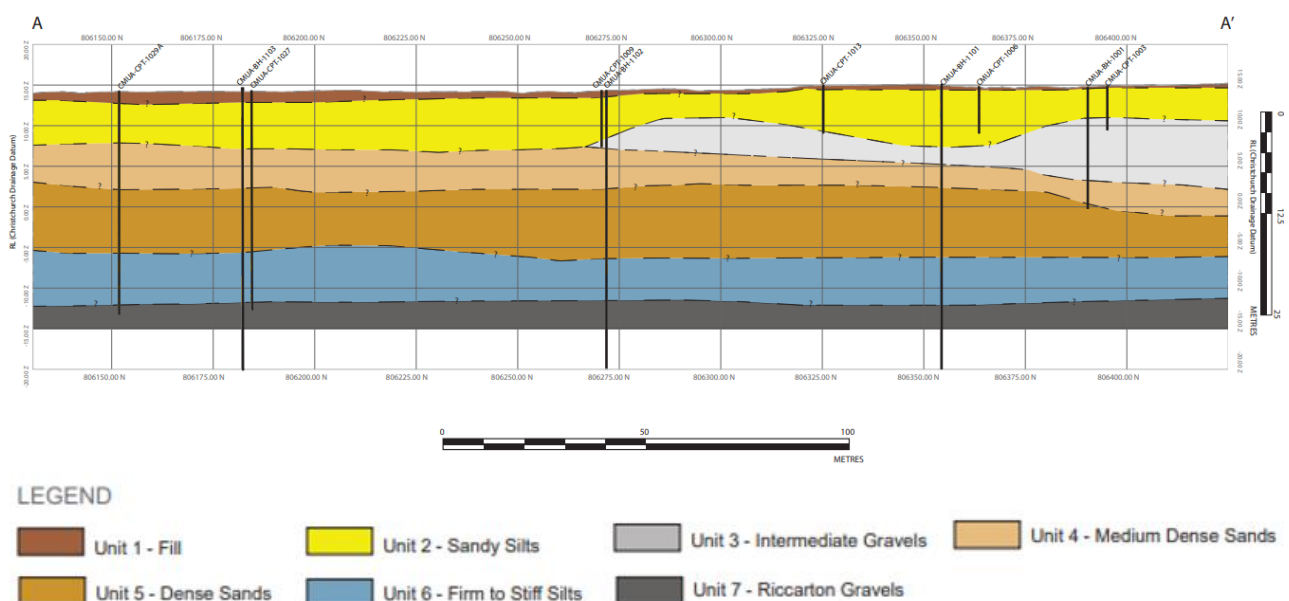
Figure 3: Geological long section through the Te Kaha site (north on right hand side of section).

Geotechnical investigations at the site encountered interbedded sands, silts, and gravels, as shown in Figure 3. Soil units and layering were generally consistent across the site, with the exception of an intermediate dense gravel layer from approximately 5.5 to 8.5 m below ground level (bgl), which was present in the northwest part of the site but absent in the southeast (refer Figure 2). Geotechnical boreholes were extended to over 60 m bgl and encountered both silt and gravel layers approximately 15 m beneath the top of the Riccarton Gravel Unit, which is often considered a proxy for bedrock in central Christchurch. These deeper units are not shown in Figure 3.

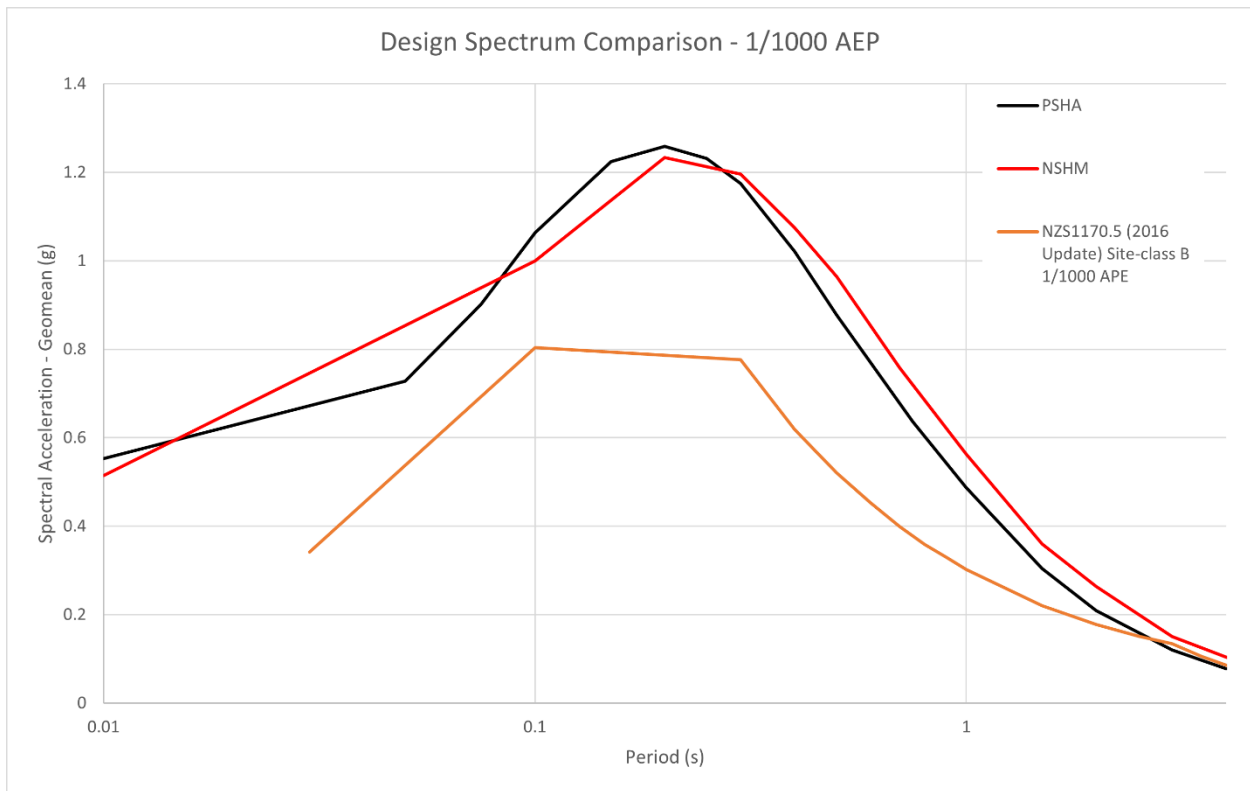
Figure 5: Comparison of 1/1,000 Annual Exceedance Probability (AEP) uniform hazard spectra from NZS 1170.5, CMUA site-specific PSHA, and the 2022 revised NSHM (sourced from nshm.gns.cri.nz).

New Zealand Standard 1170.5 allows for “special studies” to depart from the prescribed method of developing earthquake design actions. A site-specific PSHA and SGRA were completed for Te Kaha as a special study in lieu of using the codified method. This allowed consideration of pertinent changes in the scientific understanding of seismic hazard that have occurred since the last substantial update of New Zealand Standard 1170.5. Figure 5 presents a comparison of the 1000-year return period uniform hazard spectra from NZS 1170.5, the 2022 revised NSHM, and the Te Kaha site-specific PSHA. This demonstrates relative agreement between the PSHA and revised NSHM, providing an element of validation that the site-specific seismic hazard assessment, and consequently the Te Kaha project, has captured the best-available understanding of seismic hazard at the site at this time.

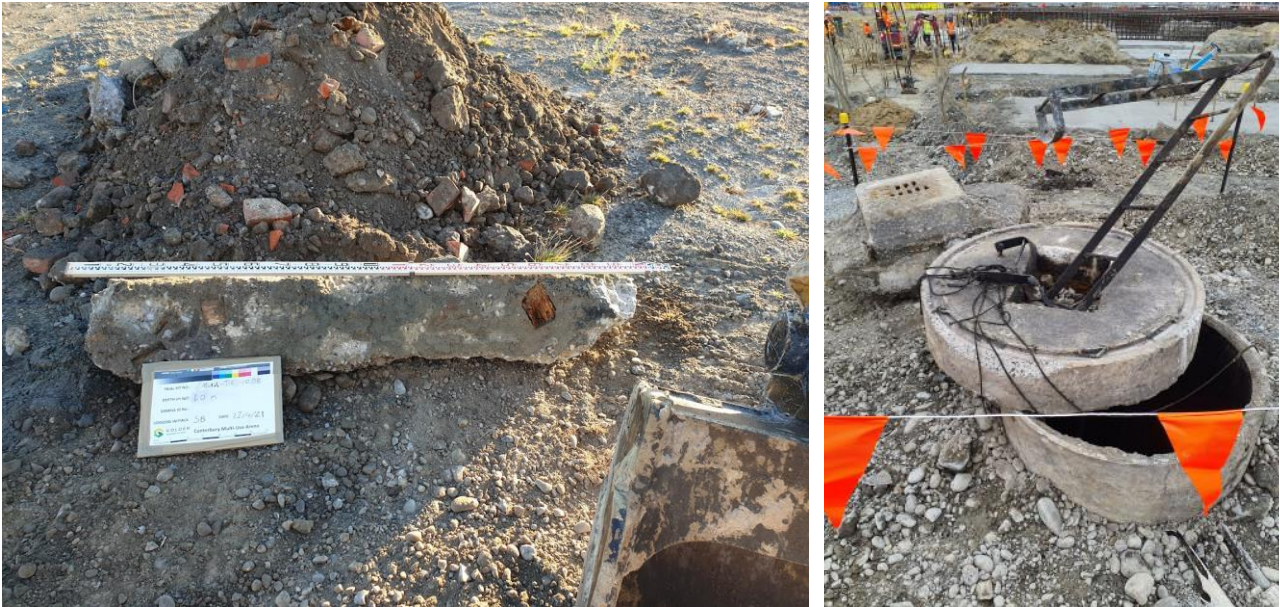
Figure 8. Left - historical foundation beam encountered during enabling works; right - historical oil sump within the foundation footprint encountered during foundation excavation.

Historical demolition debris was encountered over much of the site and significant obstructions were uncovered in the uncontrolled fill layer. These presented challenges during construction of the RAPs and foundation system. Figure 8 shows two examples of significant obstructions encountered on the site.
