Performance-based assessment and seismic strengthening of the Christ Church Cathedral

J.W. Smith, S.J. Oliver & P.E. Carney

Holmes, Christchurch, New Zealand.

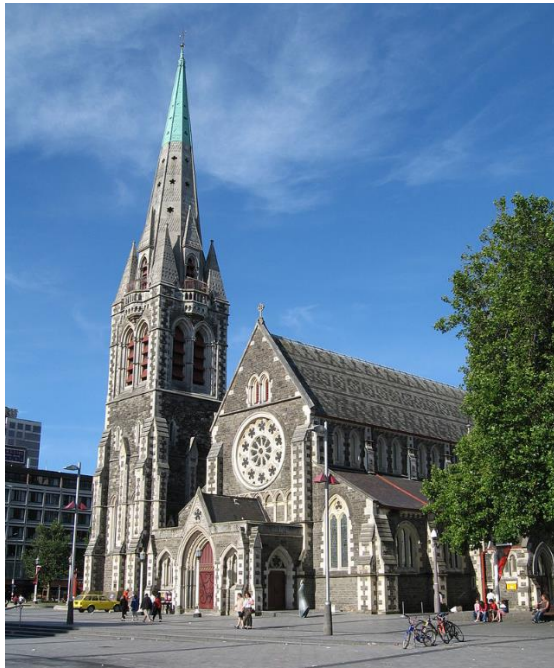
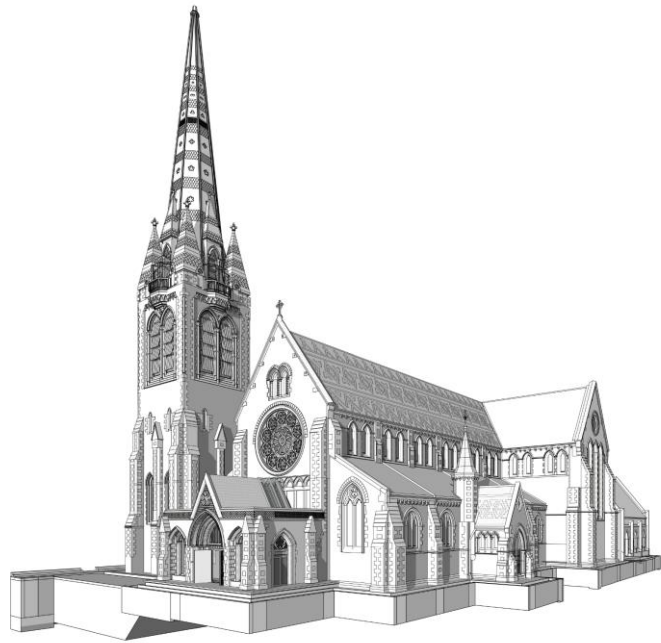
Figure 1 Photograph illustrating the Christ Church Cathedral from the southwest perspective (left) and 3D Revit model of the same view (right)

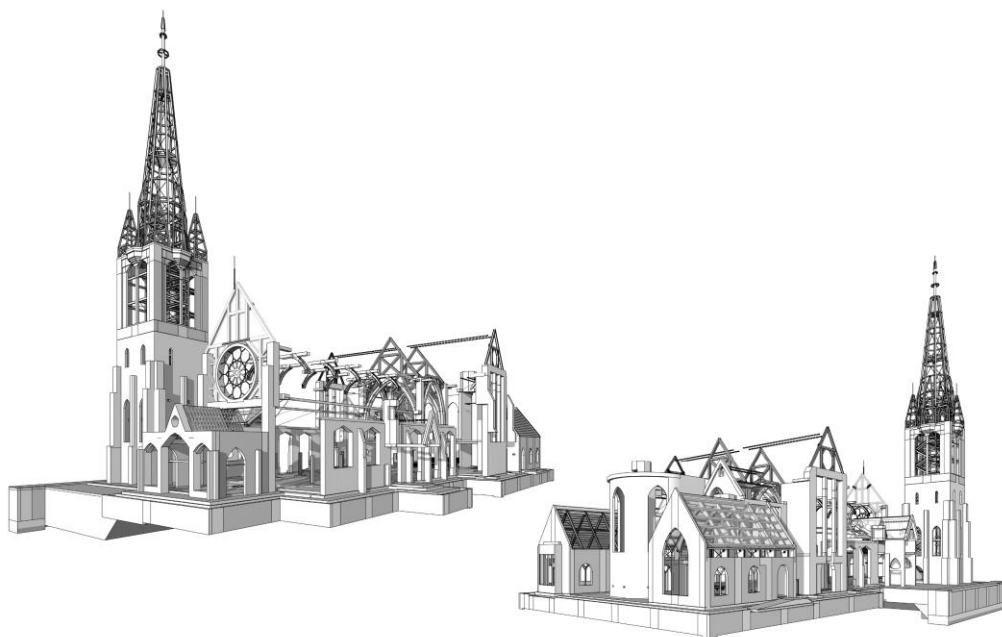
These new structural elements are all shown below in Figure 4, which contains two 3D perspectives of the retrofit and new/re-build elements.

Figure 5 Strengthening (structure only) southwest (top-left) and northeast perspectives (bottom-right)

Above the isolation plane, new structural elements associated with the seismic strengthening includes:

- pinning and grouting of URM walls,
- a new ground floor reinforced concrete transfer grillage to resist the overturning actions generated by the isolators,
- selected reinforced concrete overlays to mitigate brittle failure of unreinforced masonry elements,
- new ply roof diaphragms,
- various steel bracing/collector elements and
- post-tensioning of the west porch wall.

The Tower, West Porch and Vestries are to be re-built entirely.

Below the isolation plane, a new foundation raft is required to support the strengthened building.

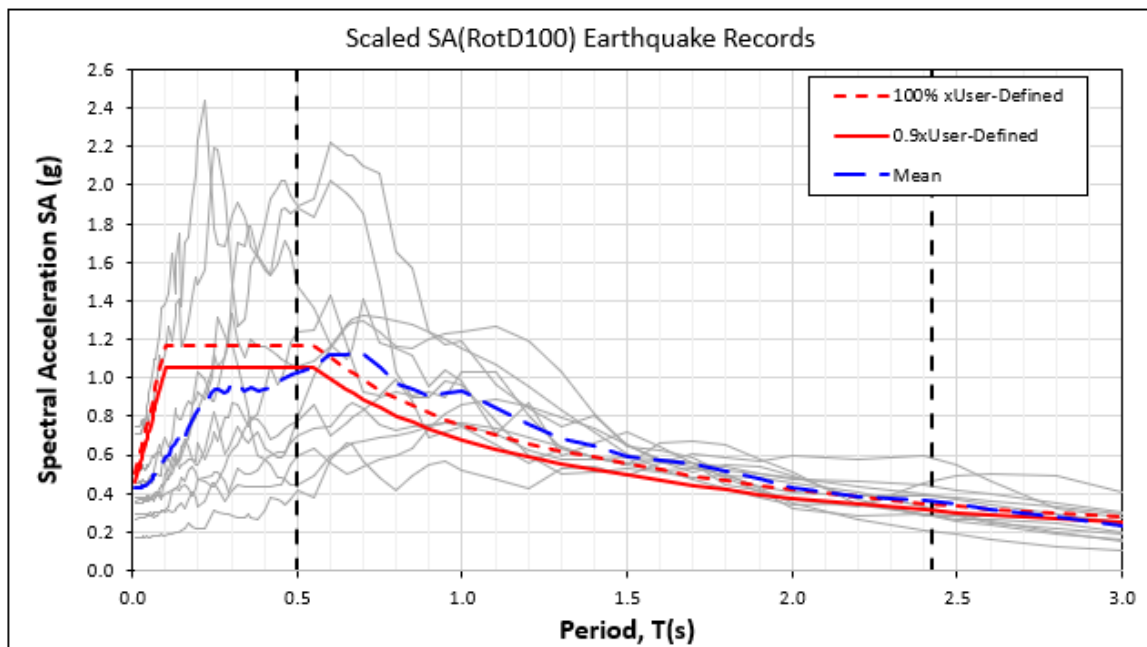
Figure 6 NZS1170.5 Hazard spectrum for the Christ Church Cathedral site (1/1000 year return period) and scaled earthquake records (shown in grey); the upper and lower bounds of the scaling range are indicated by the vertical dashed lines

Referring to the elastic design spectrum illustrated in Figure 6, it is clear that the isolation system effectively reduces the seismic demands in the superstructure by a factor of 5 or more.

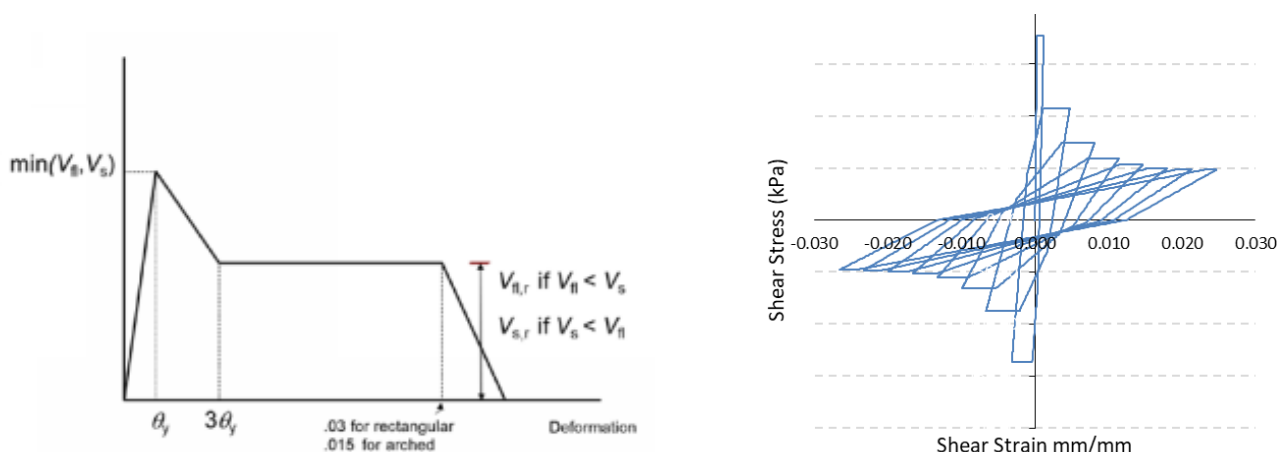
Figure 8 Standardised backbone curve and shear hysteresis for unreinforced masonry spandrels

Experimental testing has demonstrated that unreinforced masonry spandrels have substantial deformation capacity past initial cracking (Beyer & Dazio, 2012). The standardised NZSEE backbone curve and typical

shear hysteresis implemented in the ANSR II model for unreinforced masonry spandrels are illustrated in Figure 8 below. Acceptance criteria for the ULS limit state were derived from the NZSEE Guidelines and are summarised in Table 4.
