# Seismic Performance of Rib and Infill Floors

*A. Moshref*

*M. Khanmohammadi*

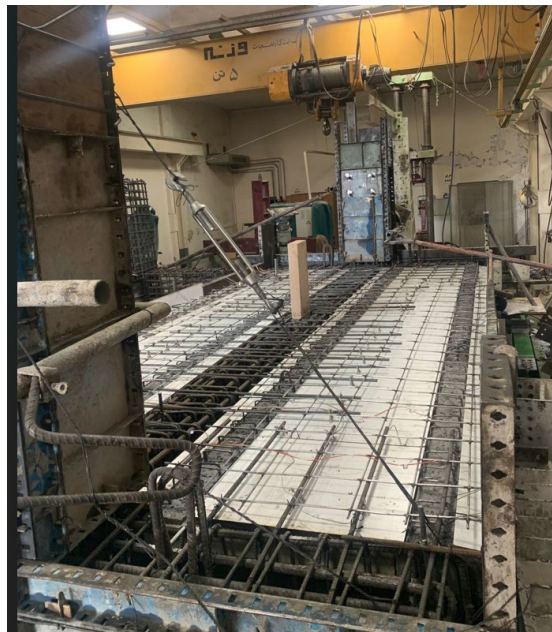
Figure 3 shows the specimen before concrete pouring.

Figure 3: Specimen before concrete pouring

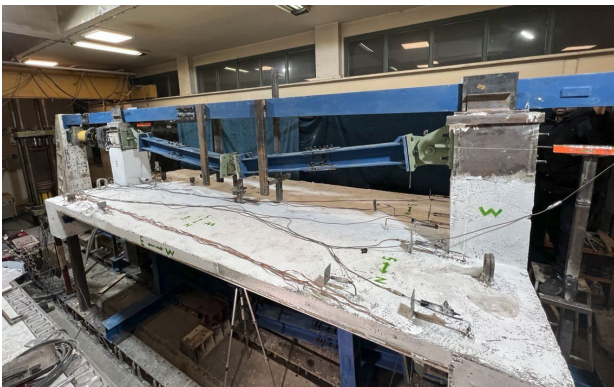
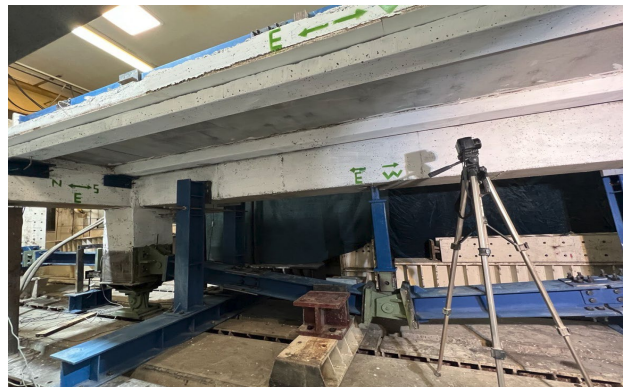
*Figure 4: Test setup*

The test setup consisted of a central concrete frame with cantilevered concrete beams supporting two precast concrete ribs either side of the central parallel beam, referred to as the east bay and west bays. This configuration was used for to capture elongation of the frame transferred to the rib support and rotation of the support beam. Figure 4 illustrates the general test setup along with a photograph of the test setup.

e) General test setup

b) Top view of the test setup

c) Underside view of the test setup

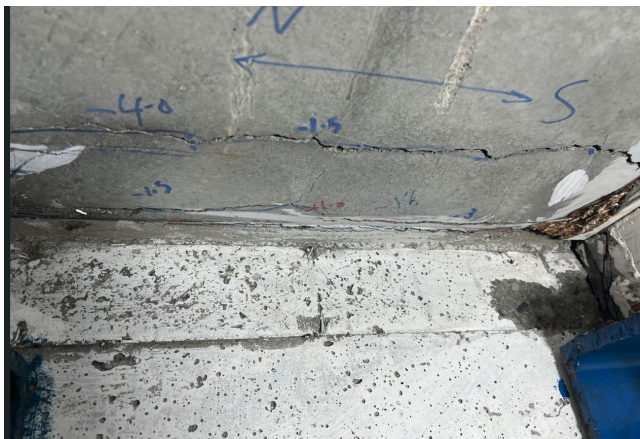
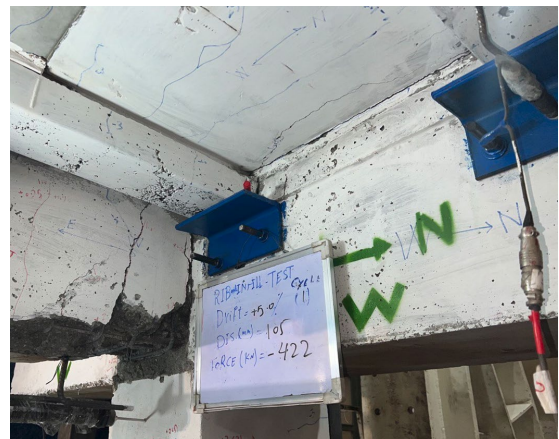
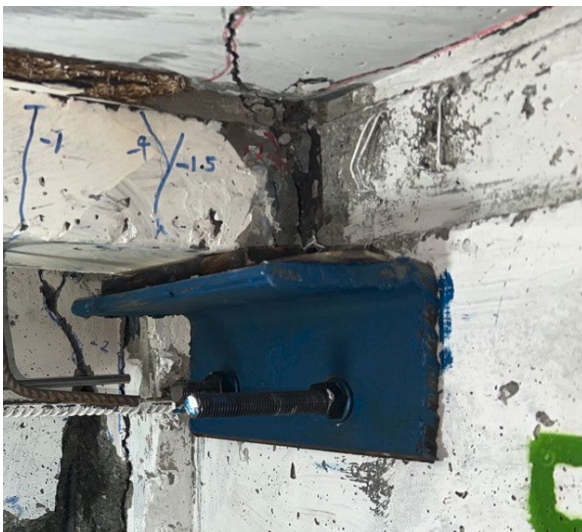
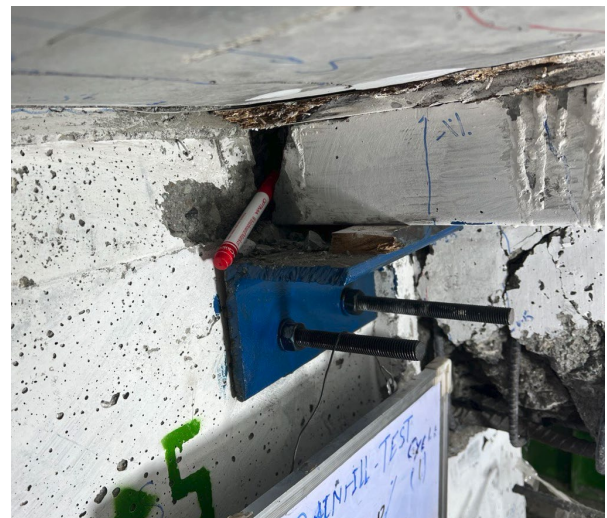
During testing, horizontal cracks formed at the intersection of the beam and topping on both ends of the specimen at a drift ratio of 0.25%. These cracks continued to widen throughout the test, reaching final widths of 17 mm at the east end and 12 mm at the west end during the last cycle, corresponding to 5% drift.

A second horizontal crack appeared at a drift ratio of 0.5%, approximately 100 mm from the interface crack at the east end, and continued to widen up to 8mm at 2% drift.

Cracks at the end of the starter bars emerged at a drift ratio of 1% and propagated, though they did not open significantly during the test.

Cracks formed on the ribs at 1% drift and continued to propagate up to 2% drift, but they did not widen during testing.

At 2% drift, crushing began at the ends of the ribs. By 4% drift, the ends of the ribs adjacent to the beam had completely lost seating. However, in spite of the complete loss of seating for precast units, collapse of the floor did not occur.

*Figure 6: Cracks and damage pattern*

- Localized deformation concentrated at a crack at the interface of the beam and topping, which could lead to a loss of diaphragm integrity at the damaged support.
- Rib end damage began at approximately 2% drift, and by 5% drift, the ribs were fully unsupported. However, they did not collapse onto the supplementary seating angle.
- Dowel action of the starter bars effectively transferred shear forces from the ribs to the supporting beam.
- Cracks at the ends of the starter bars were observed but did not widen significantly during the test.
