# Findings of the subsurface compacted rubble rafts (SCRR) pilot project for severe liquefaction mitigation in Christchurch

*Zhaodong Du, Si Xu & Robin Brightwell*

Geotech Engineering and Consulting NZ Limited (GECNZ), Christchurch, New Zealand.

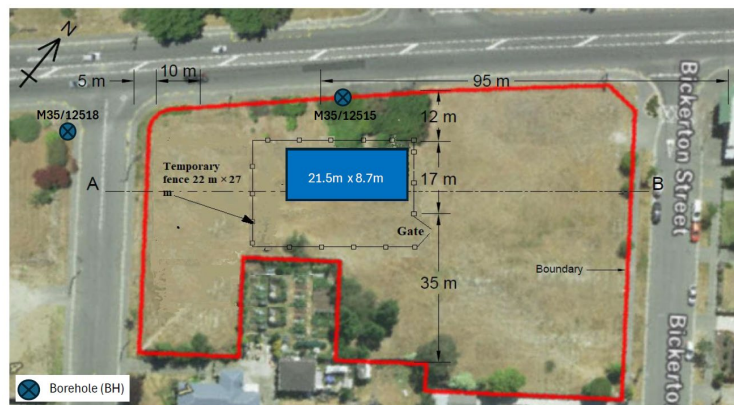
*Figure 2: Plan of the SCRR pilot project site at 74 Wainoni Road, Wainoni, Christchurch. The red line encloses the site, and the blue rectangle depicts the specific treatment area for ground-improvement testing using the SCRR method (from Canterbury Maps Property Search).*

Site inspections and analysis of cone penetration test (CPT) data from the New Zealand Geotechnical Database (NZGD) identified Wainoni Rd as the most suitable location (Fig. 2). The chosen site, 74 Wainoni Rd, was adjacent to two former EQC trial areas (Traylen, 2017). The selected SCRR treatment area at 74 Wainoni Rd measured  $21.5 \text{ m} \times 8.7 \text{ m}$  on the surface, with the subsurface treatment zone extending to  $23.5 \text{ m} \times 10.7 \text{ m}$ , incorporating a 1 m perimeter buffer.

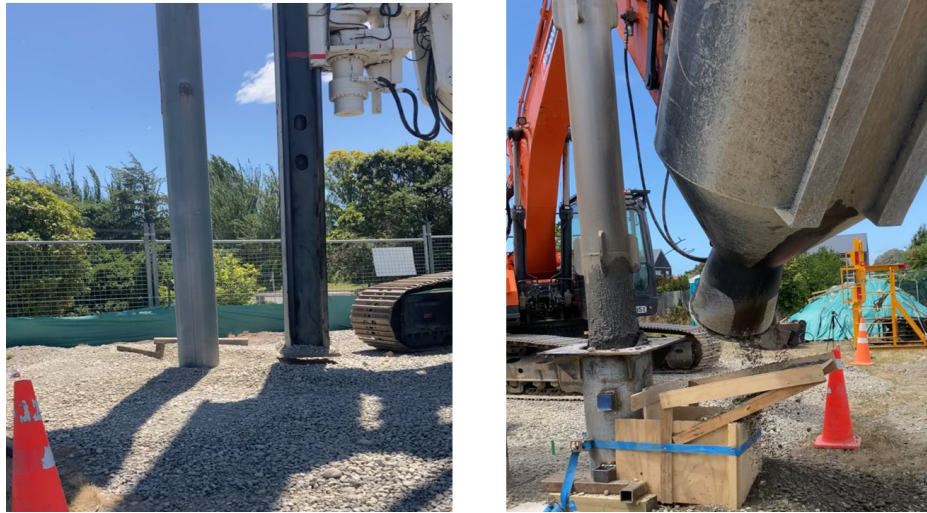
Figure 3: Rig working on a 300 mm gravel pad, showing (left) the casing and mandrel set being lowered and (right) a hopper feeding aggregate (right) at the Wainoni SCRR pilot project site.

In the SCRR method, an installation casing and a mandrel tool are inserted into the ground at regular intervals, typically following a triangular pattern, to a specified depth. Concurrently, a feed mandrel is affixed to the casing (Fig. 3, left photograph). Multi-component materials are introduced into the casing and compacted at the base of the hole. Here, they infiltrate the soil matrix during an applied vibration compaction process (Fig. 3, right photograph and Fig. 1c). The casing remains at the determined depth until the designated volume of aggregate has been introduced and SCRR bulb installation/formation is completed.
