# Seismic Strengthening of the Carillon Tower – a National Historic Landmark in Wellington, New Zealand

*R.A. Brook, M.R. Whiteside & L. John*

Holmes NZ, Christchurch, New Zealand.

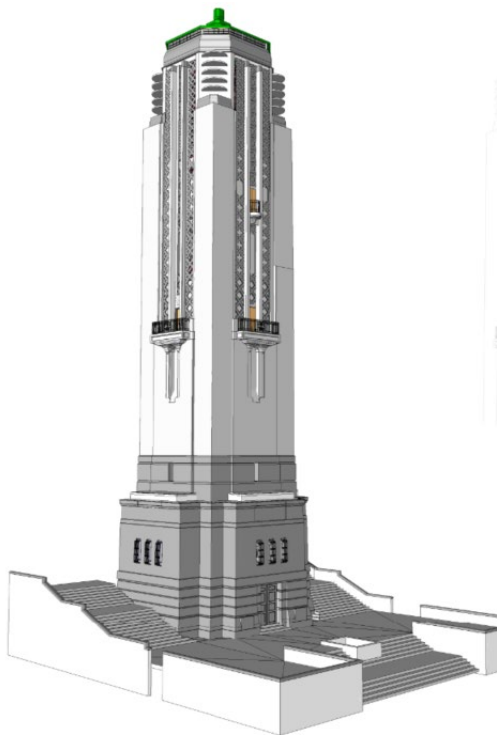
Figure 2: Structural 3D model of the Carillon Tower

The Carillon Tower is a 52 m tall reinforced concrete structure. At lower levels it comprises solid reinforced concrete walls about 380 mm thick, forming a tubular core. At higher levels these walls transition to cantilever corner piers and discrete concrete columns (Figure 2 and Figure 3), providing the openness required for sound transmission across central Wellington. The plan footprint at the base is approximately 10.3 m by 12.7 m (about 131 m<sup>2</sup>).

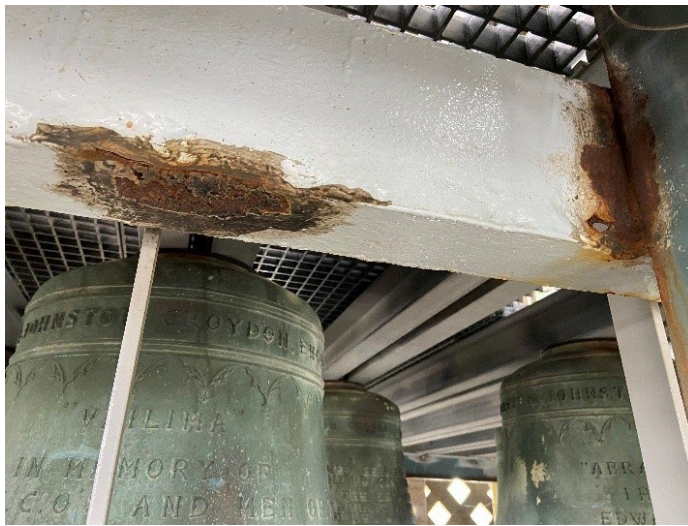
*Figure 8: Upper bell frame - Locations of typical corrosion*

The tower is located approximately 1 km from the coast, and sea-salt laden winds enter the open upper levels. Internal concrete and steel surfaces are not regularly washed by rain, resulting in a highly aggressive chloride environment. Consequently, the steel elements of the upper bell frame and adjacent steel bracing have experienced widespread corrosion (Figure 8), with previous recoating and member replacement providing only short-term improvement.

Reinforced concrete elements have also been affected, with cracking and spalling observed at various elevations. A past impressed-current cathodic protection system was unsuccessful, largely due to failure of titanium anode wires under wind-induced movement. A specialist corrosion consultant was therefore engaged to develop a durable mitigation strategy. The adopted approach includes full abrasive blasting and recoating of bell frame steel in a controlled environment, using a high-performance coating system appropriate for internal marine exposure. New steelwork is detailed and coated for the same exposure. Concrete deterioration is being addressed through repair and a maintenance regime including regular washdown to remove deposited salts and reduce chloride ingress.

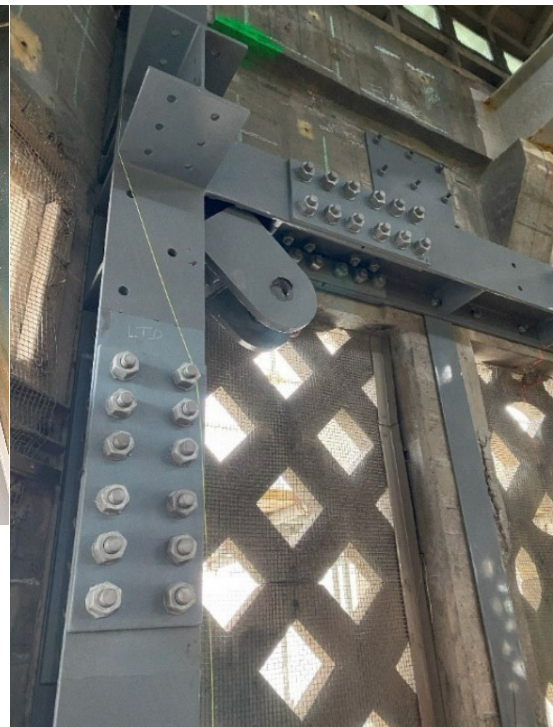
*Figure 9: Steel portal frame at Level 8 and double cleat for the viscous damper install.*

The contractor undertook 3D laser scanning of the internal spaces prior to fabrication. The resulting point cloud informed the construction methodology and the steel shop drawings. This allowed clashes and tolerance issues between new and existing work to be identified and resolved digitally. As a result, steel erection has proceeded with minimal fit-up problems or rework (Figure 9).
