# Full-scale experimental validation of a new crack stitching system for URM

*G. Zammattio & I. Giongo*

## ABSTRACT

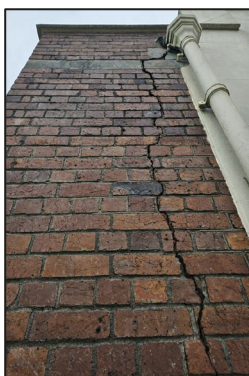
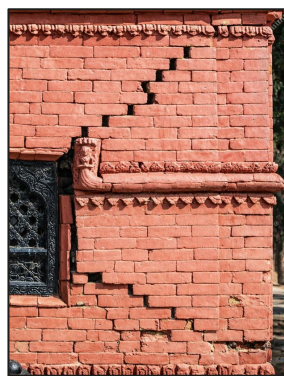
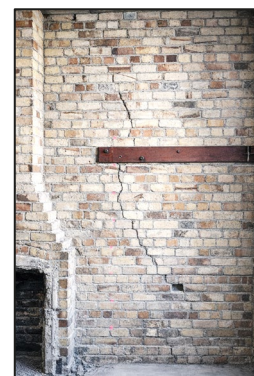
Figure 1: Examples of cracked masonry

(a) Thermal expansion cracking

(b) Earthquake cracking

(b) Differential settlement cracking

Cracks are the most common defect observed in masonry construction (Drobiec et al., 2008), often requiring repair for structural or aesthetic reasons (see Figure 1). Cracks can reduce the structural capacity of load bearing unreinforced masonry (URM) piers or spandrels and disrupt load paths in seismic resisting elements. Several common repair techniques are used for repairing or retrofitting URM, including reinforced concrete or plaster overlays, addition of external framing, core grouting or near surface mounted insertions (Binda et al., 2005; Earthquake Engineering Sectional Committee, 2009; Kouris & Triantafillou, 2018). Among these solutions, crack stitching solutions are widely adopted due to its minimal visual impact and ease of application. Crack stitching consists of inserting tension-resisting linear elements into mortar bed joints bonded with adhesives, aiming to restore continuity by stitching cracked URM portions together, limit slippage along mortar joints, and enhance in-plane shear behaviour by absorbing tensile stresses (Valluzzi et al., 2005). Experimental studies indicate that crack stitching is capable of restoring the original capacity of the URM and improving the ductility, while limited increments of strength from the as-built capacity have been observed (Valluzzi et al., 2005; Drobiec et al., 2008; Ismail et al., 2011; Demaj et al., 2022). Commonly used crack stitching techniques can be classified as: 1) reinforcing steel bars, 2) rigid high strength plain bars (Corradi et al., 2020; Corradi et al., 2022), 3) helical bars (Ismail et al., 2011; Licciardello et al., 2020), and 4) steel wire rope (Misnon et al., 2021). Despite its widespread use, only limited information and recommendations on the effectiveness of crack stitching is available, and interventions are often based on local practice, product availability, and engineering judgement (Drobiec et al., 2008). In this study, a crack stitching system is proposed, consisting of flexible steel stitch element (provided by PYTHON Fixings®) designed to enhance mechanical interlock with the adhesive, avoiding slipping of the wire, and installed within masonry bed joints using epoxy resin. This paper presents an experimental campaign designed to evaluate the effectiveness of the proposed solution, with three URM wallettes tested to assess the system at a component level and a full-scale wall tested to evaluate the effectiveness of the complete system in realistic service conditions.

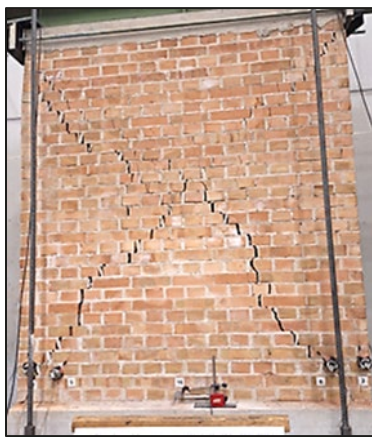
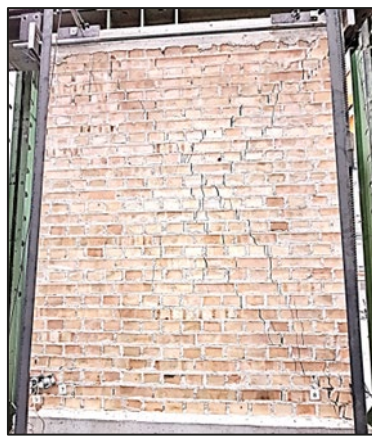
Figure 7: Failure modes and force vs displacement capacity curves (+ values equal specimen being pushed)

(a) 1\_URM

(b) 1\_URMt

(c) 2\_RpSB&S

The results obtained from the full-scale tests, including maximum force, maximum displacement and failure modes are presented in Table 2 and Figure 7. At the end of the cyclic testing of the 1\_URM and 1\_URMt specimens, a clear x-shaped crack pattern was observed as visible in Figure 7a,b. The 1\_URM test was interrupted when a capacity loss of 20% was reached, whereas specimen 1\_URMt was tested beyond a “Severe Damage” limit state (see Figure 7d). After specimen 1\_URMt was tested, the extensive cracking at the toe was repaired with epoxy mortar to prevent premature crushing failure during the 2\_RpSB&S test. Specimen 2\_RpSB&S was then tested up to failure, defined by a reduction in capacity of a cycle with respect to the previous cycle. Extensive diagonal cracking and significant damage were observed, particularly at the base of the wall (see Figure 7c). To evaluate the engagement and the force absorbed by the strongbacks during the 2\_RpSB&S test, each strongback was instrumented with strain gauges that allowed to calculate the axial force based on the measured axial strains, the cross-sectional area of the strongbacks, and assuming an elastic modulus for timber equal to 11,500 MPa. The forces registered in the strongbacks show an active engagement throughout the test with the maximum force being 60 kN near the actuator at mid-height of the strongback, suggesting a strut and tie behaviour that resulted in the crushing of the repaired corners of the wall.
