# Updates to Section C8 (Unreinforced Masonry Buildings) of the Engineering Assessment Guidelines

*H. Tocher*

Holmes NZ LP, Auckland

## ABSTRACT

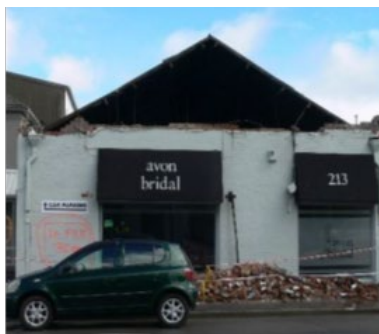
**(a) Concrete lintel discontinuity**

Gables failing as triangular vertical cantilevers are triggered by a discontinuity at the base of the gable. This failure mode may result from a change of wall thickness between the gable and the wall below the gable or by the presence of detailing such as a well-connected ceiling diaphragm, a reinforced concrete lintel, or a concrete bond beam. Additionally, this failure mode requires that there be no evidence that the gable is adequately fixed to the roof structure. This scenario may also arise when the wall below the gable has thickenings or buttresses that terminate at the base of the gable. These conditions cause a rotational weakness to occur at the base of the gable, which becomes the hinge point for the cantilevered failure. This failure mode was frequently observed in the Canterbury earthquakes, with examples shown in Figure 2.

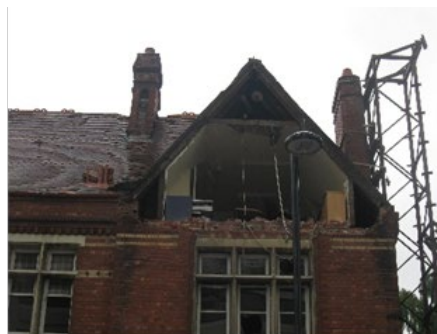
**(b) Diaphragm discontinuity**

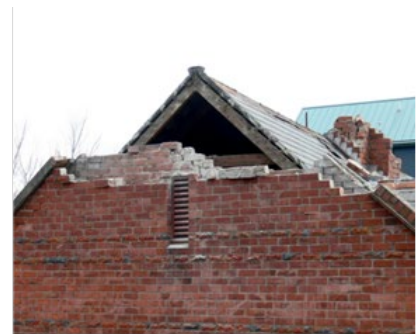
**(c) Top triangle failure**

*Figure 2: Gables failing as vertical cantilevers*

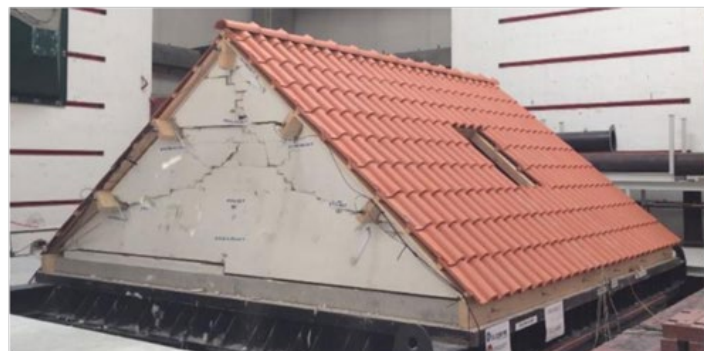
**(d) Experimental results from Correia et al (2018)**

*Figure 3: Vertically spanning gable failure*
