# Damage Observed in Chilean Hospitals during the 2010 $M_w$ 8.8 El Maule Earthquake

*R. Calcagno*

*R. Retamales*

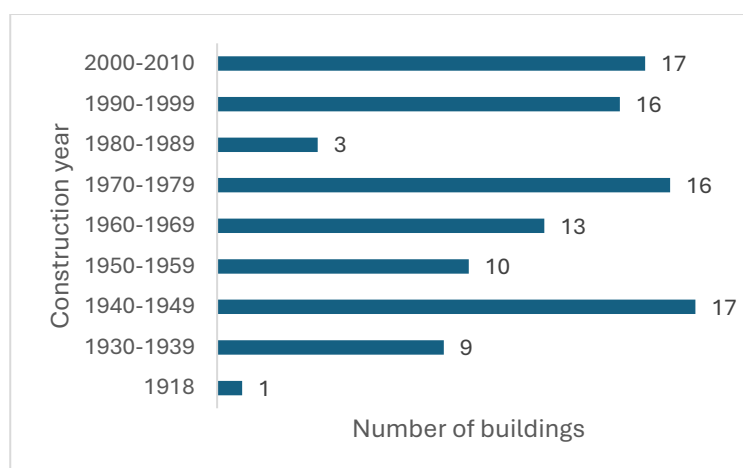
*Figure 2: Construction year*

This group of buildings includes the most complex hospitals, that contain most beds lost after the earthquake. These Hospitals were built at different times, as shown in Table 3. Table 3 shows the type of material used in the structures. It is observed that the most used material is reinforced concrete.
