# Damage to demolition – challenges and findings from inspection of damaged hollowcore floors

*H.S. McKenzie*

## ABSTRACT

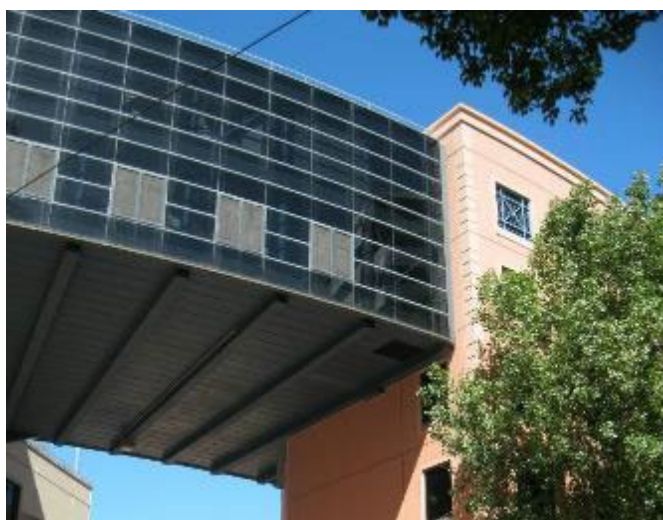
The building was curved in plan with non-orthogonal end frames contributing to the ill conditioned and flexible nature of the building, particularly in the transverse direction, parallel to the hollowcore span. This situation was further exacerbated by the addition of the Portico, at levels 4 to 6, to the northern end of CAB. The Portico was suspended above the Wakefield Street entrance to Civic Square, supported by the Central Library building to the north and CAB to the south. At the CAB end, the Portico was supported vertically on sliding bearings at Levels 4, 5 and 6 and was restrained against lateral/seismic actions at Level 5 only. At the Central Library end of the Portico sliding bearing supports, providing vertical support only, were provided under the Level 4 slab. A Detailed Seismic Assessment (DSA), undertaken by Holmes in early 2013 (Holmes 2013 a), showed that this eccentric distribution of seismic mass to the north end of the building meant that the building was prone to twisting under transverse loading, with maximum seismic displacement experienced along the northern frame on grid 28 (corresponding to 2.5% drift at 55%NBS load levels).

*Figure 2: Portico connection to north end of CAB*
