# Seismic strengthening of the three-storey URM CApSc building

*S. Gardiner, C. Caponi & P. Cammock*

Egis NZ Ltd, Christchurch, New Zealand.

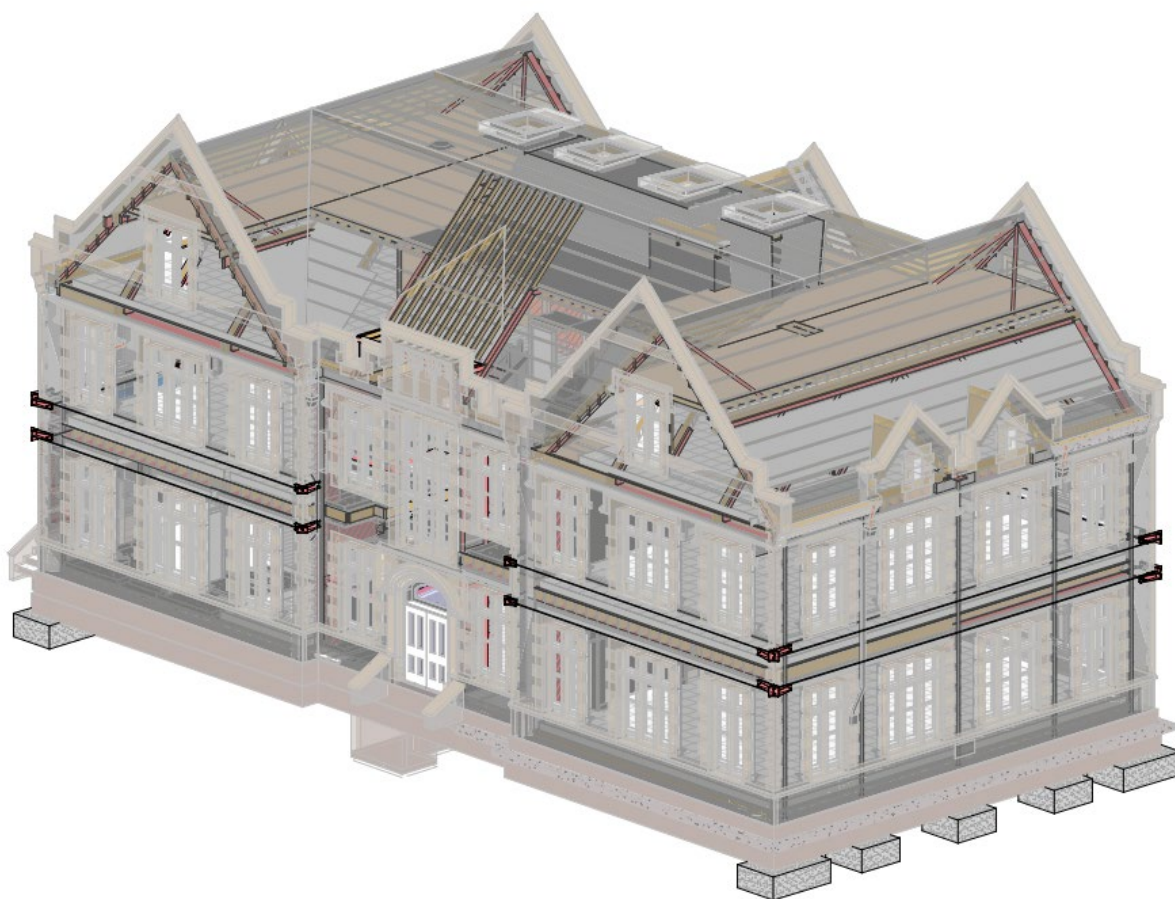
*Figure 5: CapSc building northeast view*

- Exterior walls consolidated with injection of Mapei Antique with M12 SS threaded rod wall ties at 600 crs each way.
- Two storey vertical internal (cored) post-tensioned cables (25mm dia. Macalloy bar) to the northern and southern external wall piers, with horizontal, external post-tensioned cables (4-22mm dia. Macalloy spiral strand wire ropes), at level 1 to the perimeter of the building, anchored with SS brackets. The existing eastern and western walls inherently had >67%NBS in-plane and out-of-plane

strength once consolidated and tied into diaphragms at each level with the additional horizontal post tensioning undertaken.
