# Post-earthquake assessment and remediation: findings from the December 2024 Port Vila earthquake

*S. Gardiner, P. Cammock & J. Thompson*

## ABSTRACT

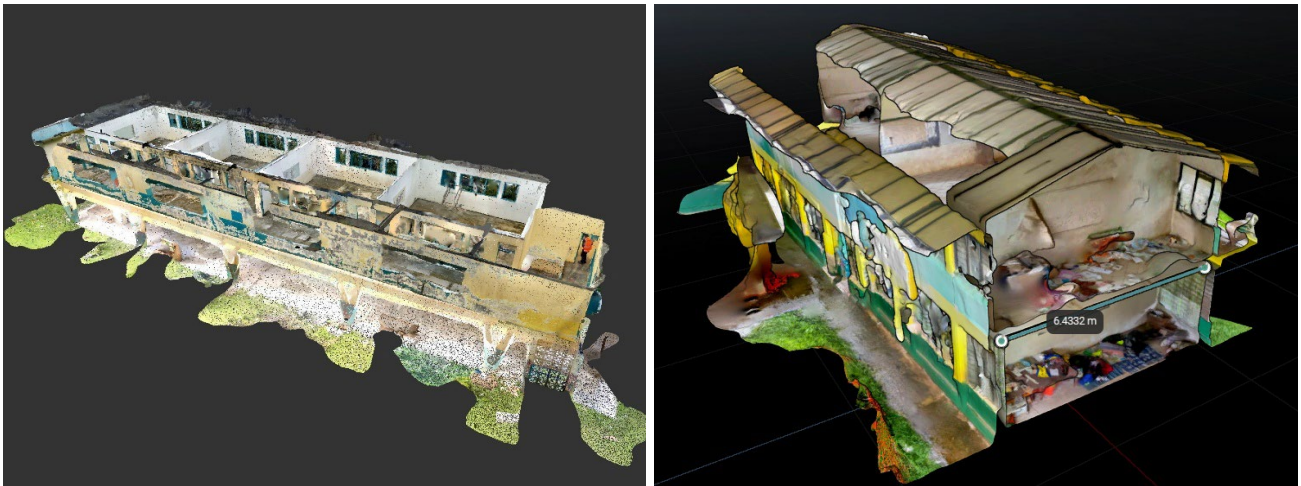
LiDAR scanning was undertaken for many buildings to support efficient assessment and remote collaboration. Point cloud scans were used by the New Zealand-based team to visualise damage, extract approximate dimensions, and develop drawings and remediation concepts. A drone was taken with the intention to assist with aerial surveys and photogrammetry to supplement ground-based observations, however, did not end up being used as no buildings were identified where the use would add value; the buildings inspected were all low-rise and easily accessible.

*Figure 2: LIDAR Point Cloud Scans*
