Seismic Damage States and Damage Quantification of Light Timber Framed Walls in Residential Houses

A. Liu & D. Carradine

BRANZ, Porirua, New Zealand

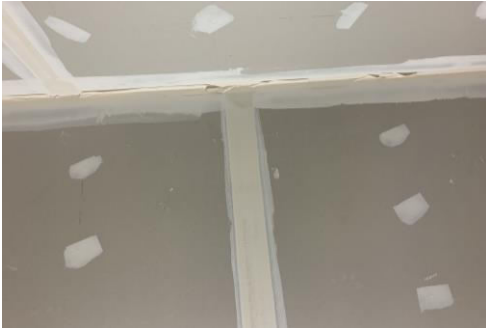
Figure 4. Significant tape breakage

In the early test cycles, only cosmetic tape wrinkling and screw distressing were visible. When the top plates of walls deflected 8.7 mm (0.36% drift), tape breakages (Figure 4) initiated along the joint lines between ceiling and walls, screw distressing and slotting were also visible. As the test progressed, the damage progressed but the bracing capacity maintained. Damage was limited within the tape joints up to the drift levels of 14.0 mm.

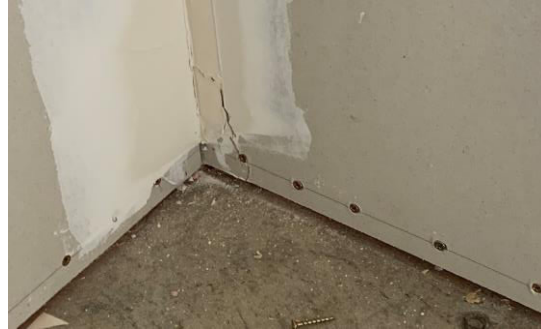
Figure 5. Local plasterboard damage

When the top plate deflections reached 17.3 mm (0.72% drift), the damage extended beyond the tape joints and local plasterboard damage occurred at the bottom corner of the east and west walls (Figure 5). Plasterboard cracks were as wide as 3.5 mm at the completion of the third cycle of the deflection of 17.3 mm.

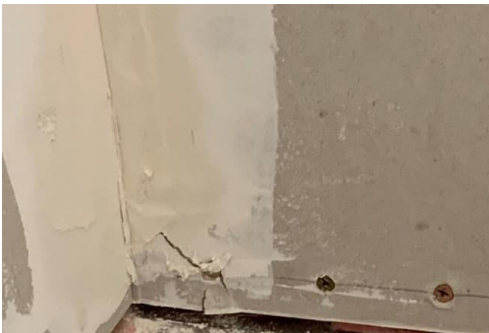
Figure 6. Significant local plasterboard damage in east and west walls

As the test continued, damage progressed too. At the loading cycles where the top of the walls deflected 24 mm (1% drift), local plasterboard damage spread to the bottom corners of the west wall adjacent to the north

Damage state	Description	Potential repair action	Storey drift % (top plate deflection)
1	Tape wrinkling, screw distress, tape tearing in isolated area	Retape, repair stressed screws and paint	<= 0.6% (14 mm)
2a	Plasterboard damage - local crushing or cracking within sheets (Figure 6)	Replace damaged plasterboard, retape the joints and paint	0.7% (17mm)
2b	Plasterboard sheet joints opening (Figure 7). Loading capacity dropped	Replace the damaged plasterboard, reinstall the screws, retape and paint	1% (24mm)
2c	Plasterboards detached from the framing, Out-of-plane buckling of plasterboards, Apparent loading capacity drops	Replace the board, refix the boards to frames, retape and paint.	1.5% (35mm)
3	Plasterboard significantly damaged and uneconomical to repair	Repair is uneconomical. Demolition is required.	1.8% (43 mm)

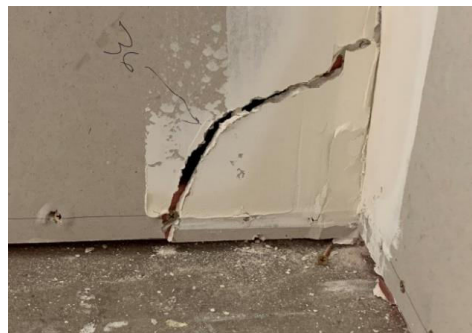
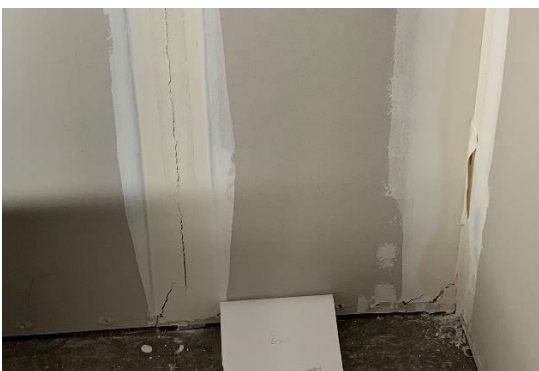
Figure 7. Opening of vertical plasterboard sheet joints

and south walls (Figure 6). Also observed was the failure initiating of vertical sheet joints of plasterboard sheets in east and west walls (Figure 7). This phenomenon was accompanied by noticeable load degradation. As the loading continued, the screw slotting in the plasterboard and thus detachment of plasterboard sheets progressed significantly. When the top of the walls deflected 35 mm (1.45% drift), out-of-plane buckling of plasterboard sheets occurred in a brittle manner in both east and west walls (Figure 8). The test was subsequently terminated. Following the testing, the linings over the areas of interest were taken off and no visible damage was observed to either the timber frames or the hold-down brackets.
