# Seismic performance of non-ductile reinforced concrete frame detailing – a Taiwanese example

## ABSTRACT

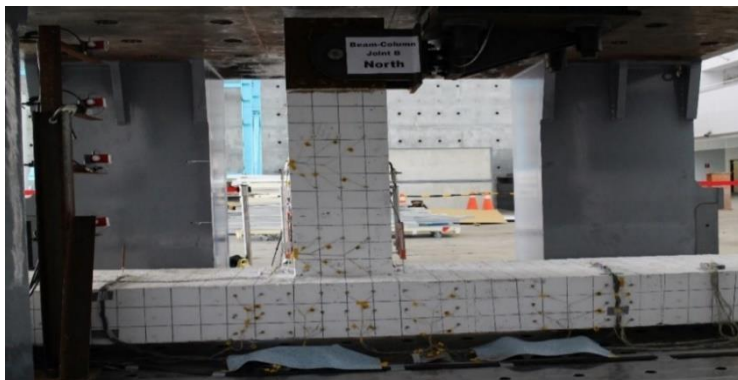
*Figure 2: BCJ specimen test configuration utilizing MATS*

This study investigates the effect of transversal reinforcement on the seismic performance of BCJs, specifically where the joint core lacks transversal rebars. The specimens were evaluated in the MATS with the beam positioned vertically and the column horizontally, as shown in Figure 2. The pinned hinge at the beam end was built as a swivel connector placed 1.3 m from the column face and connected to a load cell to simulate beam and column support conditions. Both joints were constructed with pinned hinge mechanisms to account for the rotation effect, and the supporting structure was built to let the column to exhibit vertical deformation. The bottom portion of the specimen bears the machine's lateral load. The specimens were equipped with motion tracker devices to record joint distortion, strain gauge devices to measure strain, strain part devices to assess beam deflection, and the Linear Variable Displacement Transducer (LVDT) to observe column slide and beam rotation. According to ACI 374.2R-13 (2013), the lateral loading methodology used displacement-controlled stages at 0.25, 0.375, 0.5, 0.75, 1, 1.5, 2, 3, 4, 5, 6, and 7%.

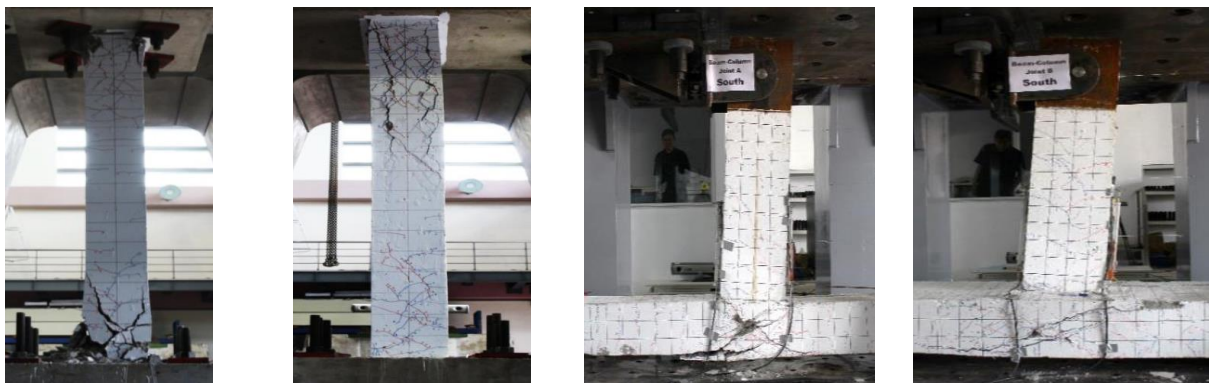
(a) C-A at 8% drift ratio (b) C-B at 4% drift ratio (c) BCJ-A at 5% drift ratio (d) BCJ-B at 7% drift ratio  
Figure 3: The final crack pattern at of the column and BCJ specimens, corresponding to different drift ratio

The C-A and C-B specimens developed minor flexural cracks at the lower end, indicating crack propagation. This process occurred gradually at drift ratios of 0.5% and 0.25%, respectively, and subsequently progressed to diagonal cracks at drift ratios of 1% and 0.5%, respectively. As drift ratio increased, crack width

increased. The maximum lateral loads for the two specimens were recorded at 96.86 kN for C-A and 225.24 kN for C-B, both occurring at a 3% drift ratio. The experiment was carried on at drift ratios of 8% for C-A and 4% for C-B. It was determined that C-B was unable to manage cracks because of rapid propagation and increases in crack width, which caused the test to end more soon than it would have otherwise. Upon conclusion the test of the C-A specimen, the most significant crack was observed at the junction of the column and the bottom base, suggesting that there was a slip of the longitudinal bars. Furthermore, in the case of the C-B specimens, the most significant crack was observed near the top, manifesting as splitting cracks. The C-A specimen exhibited failure in flexural mode, while the C-B specimen was characterized by shear failure. The C-A specimen exhibited a ductile response in contrast to the C-B specimen.

In both BCJ specimens, the initial cracks appeared in the joint area of the BCJ-A specimen, while in the BCJ-B specimen, they formed on the column face 700 mm away from the joint zone, at a drift ratio of 0.25%. This manifested as flexural cracks measuring 0.25 mm in width. Diagonal cracks in both specimens then emerged as a result of concrete crushing, deterioration of the bond in the beam's bottom reinforcement, and degradation of the lateral ultimate load. The fissures emerging around the joint area of the column resulted in the anchorage length of the beam adjacent to the column face being insufficient. The broader diagonal fractures observed at the base of the joint region suggest a decline in the joint's stiffness and its ability to resist moments. The BCJ-A achieved a peak load of 100.40 kN, which aligned with a drift ratio of 2% in the positive direction, persisting until the test concluded at a 5% drift ratio. Furthermore, the peak lateral load recorded for the BCJ-B was 157.57 kN, corresponding to a drift ratio of 3% in the positive direction, with the test concluding at a drift ratio of 7%. The main failure mechanism observed in both specimens was attributed to diagonal shear cracking within the joint zone, resulting from an inadequate quantity of joint shear transverse reinforcement. These results are identical to the study conducted by (Tonidis et al., 2024). Figure 3 illustrates the final crack development for all specimens.
