# Seismic Performance of Fired Clay Rib and Hollow Block Infill Floors

## ABSTRACT

This experimental program investigates structural performance of fire clay rib-and-infill systems under seismic drift. A specimen, including partial frames, representative of historic standard detailing were tested under cyclic loading to investigate drift capacity, gravity load paths, and positive and negative moment failure. Test setups were designed to replicate support conditions inside and outside beam elongations zones with varied imposed loading.

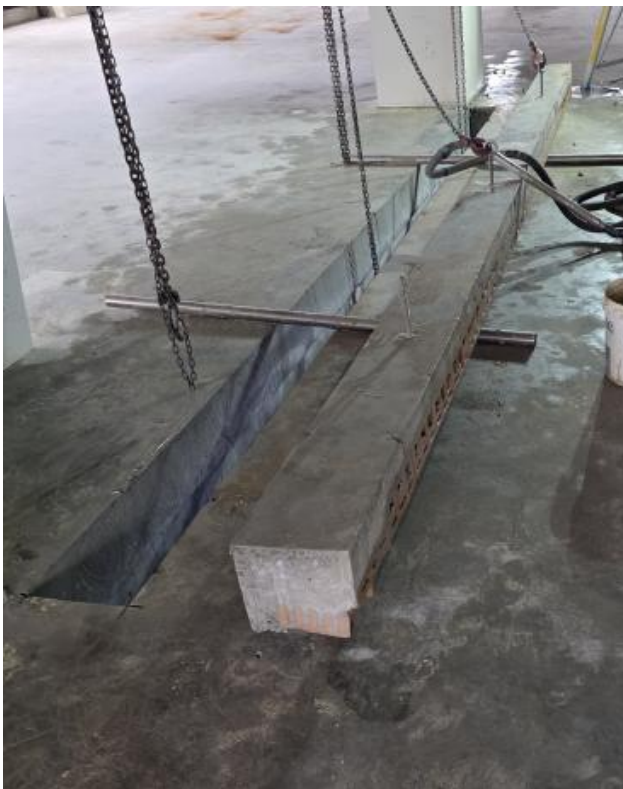
a) Extracted prestressed rib

*Figure 1: Extracted rib from an existing building in Wellington*

The specimen configuration for this study was based on an existing building in Wellington constructed in 1969. In the absence of shop drawings, and to develop a clear understanding of the detailing of the Stahlton floor system used in this building, a destructive investigation was undertaken. This involved cutting and removing one of the ribs, followed by hydro demolition to expose the reinforcement details, as shown in Figure 1. As shown in Figure 1b, the hollow block infill is oriented perpendicular to the ribs and is therefore partially filled with concrete during construction. This may increase the seismic mass of the structure but can also provide a degree of mechanical interlock between the hollow blocks and the concrete topping.

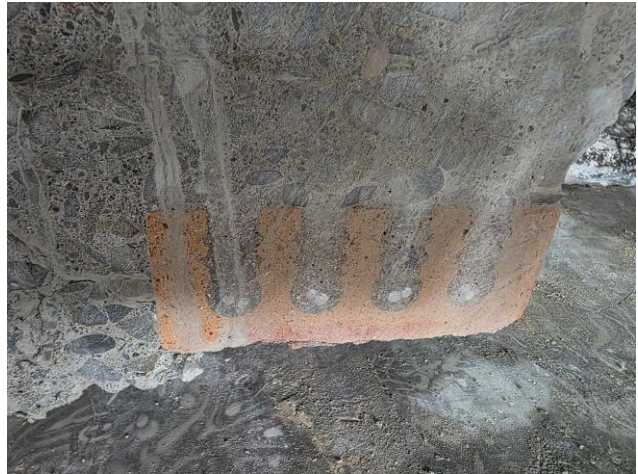
b) Close-up view of the rib section

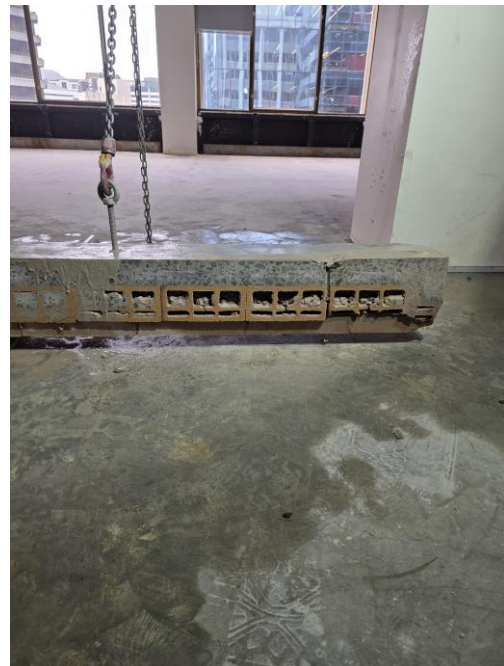
c) Close-up view of the hollow-block infill section

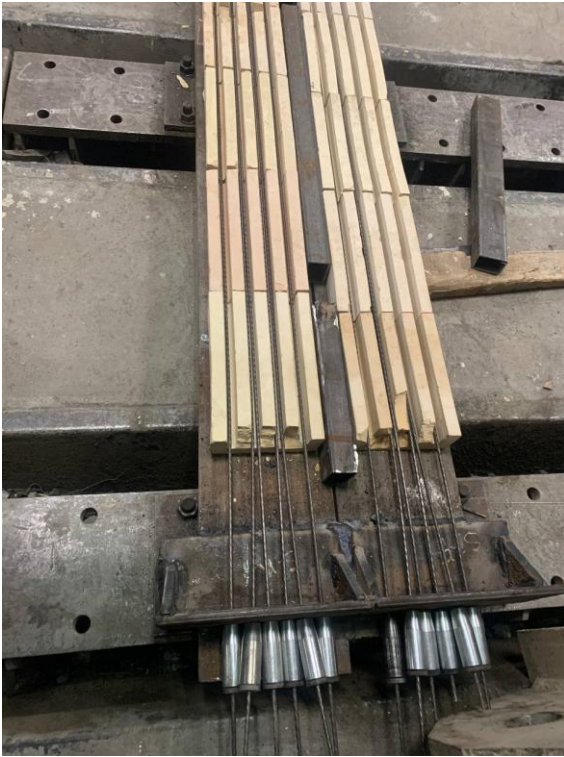
a) Ribs Following Prestressing of Wires

*Figure 6: Specimen construction*

Figure 6 shows the construction of the ribs and the specimens before carrying out the test.

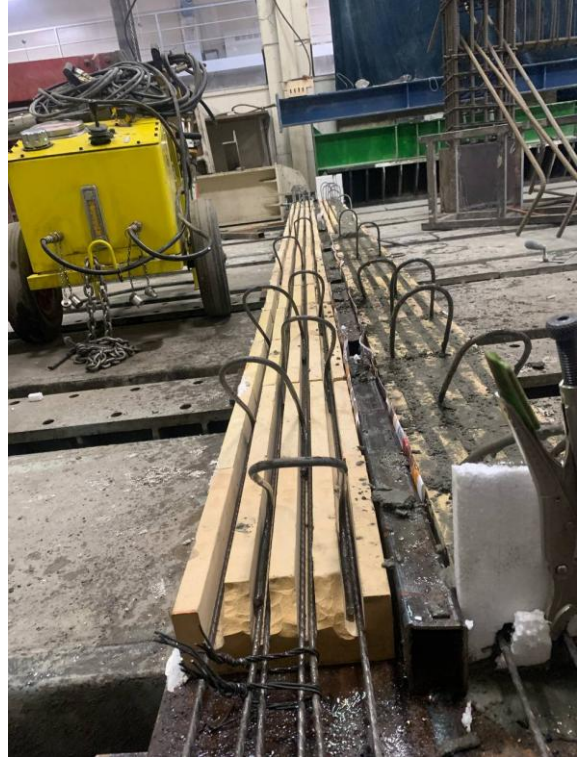
b) Ribs During Groove Grouting

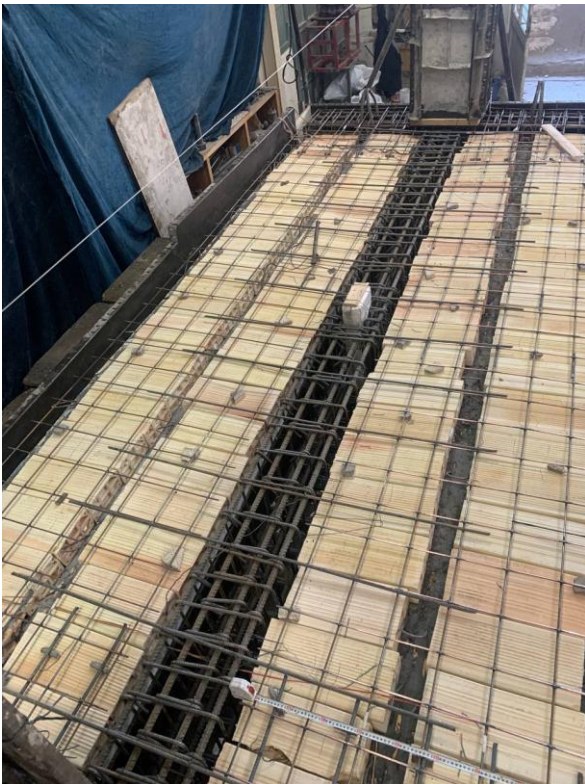
c) Specimen Prior to Concrete Pouring

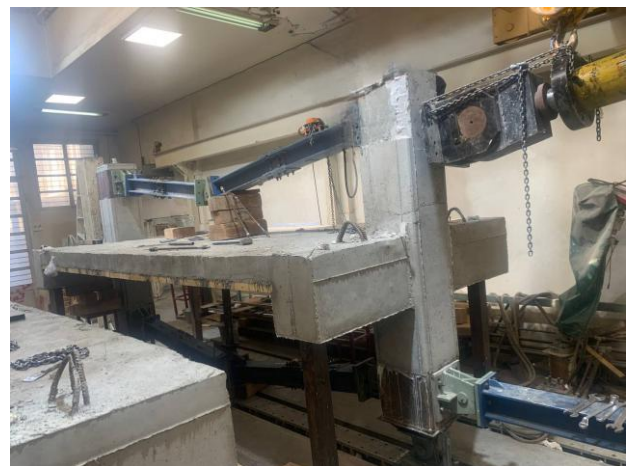
d) Specimen During Test Setup Installation

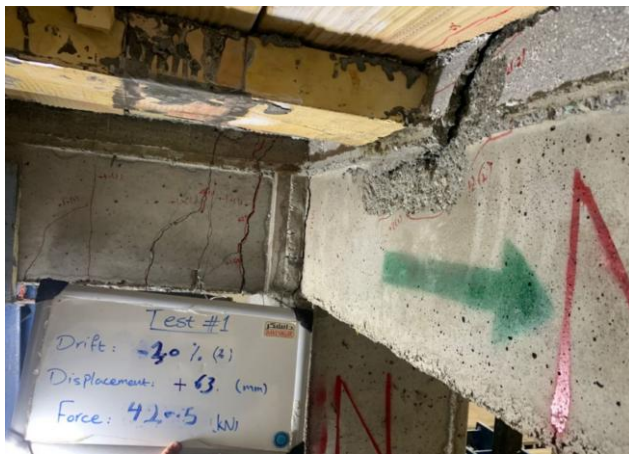
a) Rib Pull-Out Observed at 3% Drift

*Figure 9: Crack Pattern Observed at 3% to 4% Drift*

At a  $3\%$  drift ratio (both positive and negative), the damage progression observed at  $2\%$  drift continued. The main cracks on the topping surface widened to approximately  $3\text{--}5\text{ mm}$ , and rib pull-out of approximately  $2\text{--}4\text{ mm}$  was recorded on both the east and west sides.

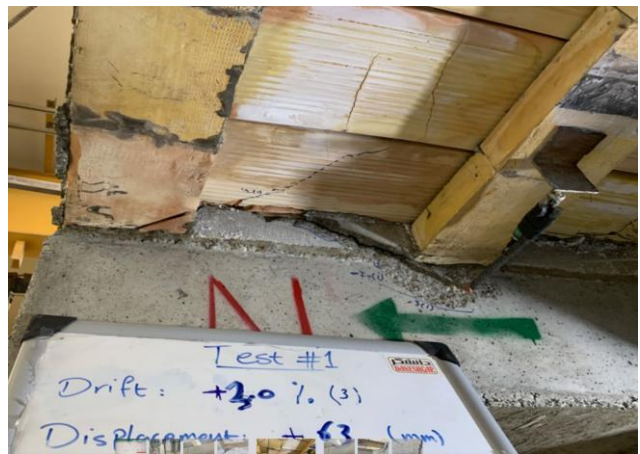
b) Cracking at the Bottom of the Infill Block and the Corner of the Rib Plank

At a  $2\%$  drift ratio (both positive and negative), the cracks formed at the previous drift level ( $1\%$ ) widened. The crack width at the end of the starter bars on the east side reached approximately  $2\text{ mm}$ , while the crack at the beam–slab interface on the west side widened to approximately  $3.0\text{ mm}$ . Other cracks exhibited widths of less than  $1\text{ mm}$ . At this stage, spalling of concrete at the rib supports initiated, and cracks also formed at the soffit of the hollow block infill tiles.

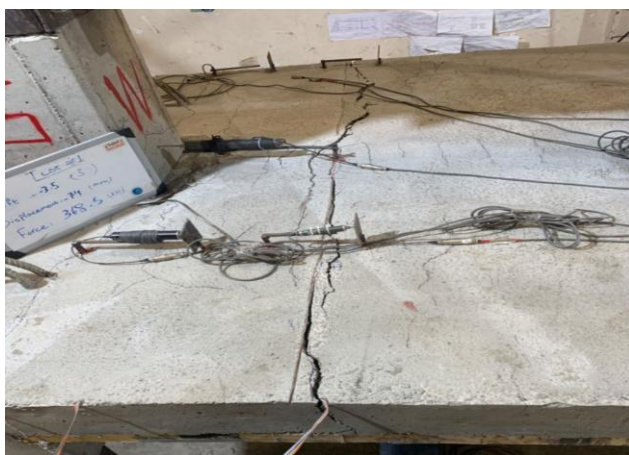
c) Mesh Failure at 3.5% Drift (West Side)

At a  $3.5\%$  drift ratio, failure of the slab mesh at the west end and at the ends of the starter bars occurred, accompanied by the development of negative bending in the ribs. As a result, separation of the clay plank in the ribs was observed, exposing the prestressing wires.

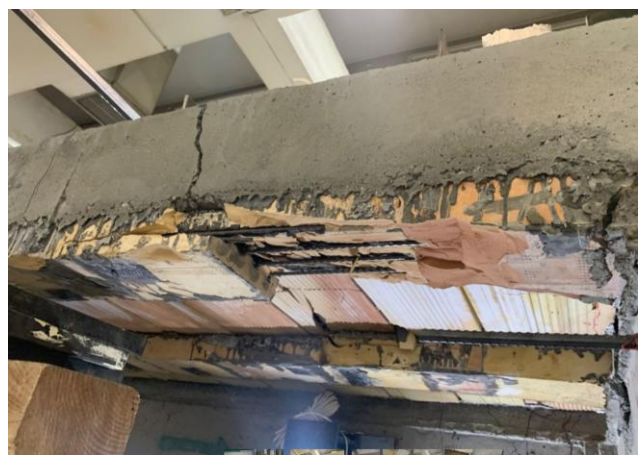
d) Rib Negative Moment Failure and Prestressed Plank Separation at 3.5% Drift (West side)

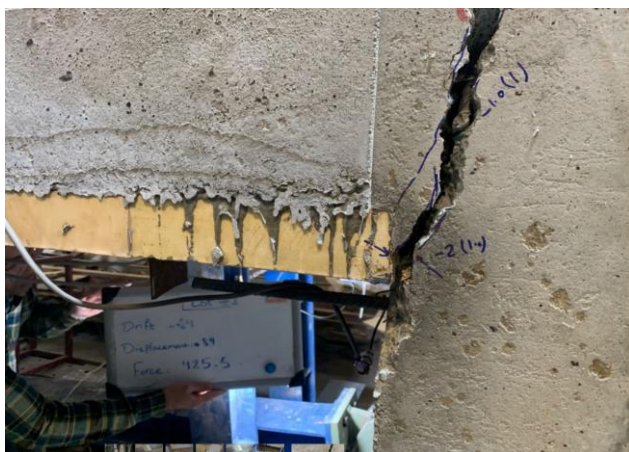
e) Negative Moment Failure at Rib Ends (East Side)

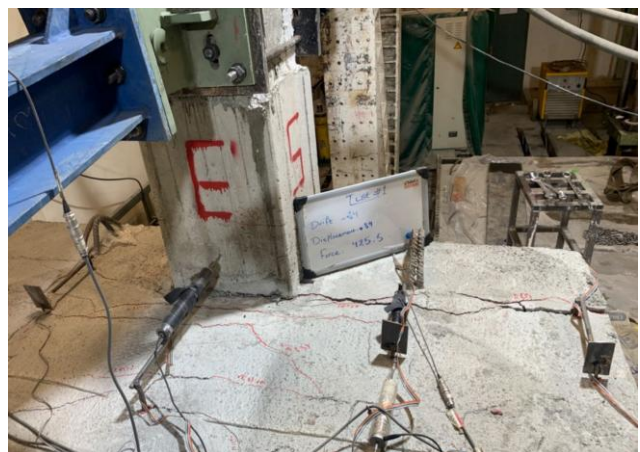
f) Beam–Slab Interface Crack at 4% Drift (East Side)

At a  $4\%$  drift ratio, the crack at the beam–slab interface on the east side widened to approximately  $5\text{--}6\text{ mm}$ , and a vertical offset of about  $5\text{ mm}$  was observed in the topping. The test was terminated at this drift level due to safety concerns.
