# Post-damage Repair of Radiata Pine CLT Panel-to-panel Connections Using Additional Fasteners

Cross-laminated timber (CLT) is increasingly used as a sustainable and efficient construction material, particularly in earthquake-prone regions. In CLT structures, seismic damage concentrates in panel-to-panel connections, while the CLT panels generally remain intact. This study investigates whether damaged central spline CLT panel-to-panel connections can be repaired by installing additional fasteners adjacent to the original ones.

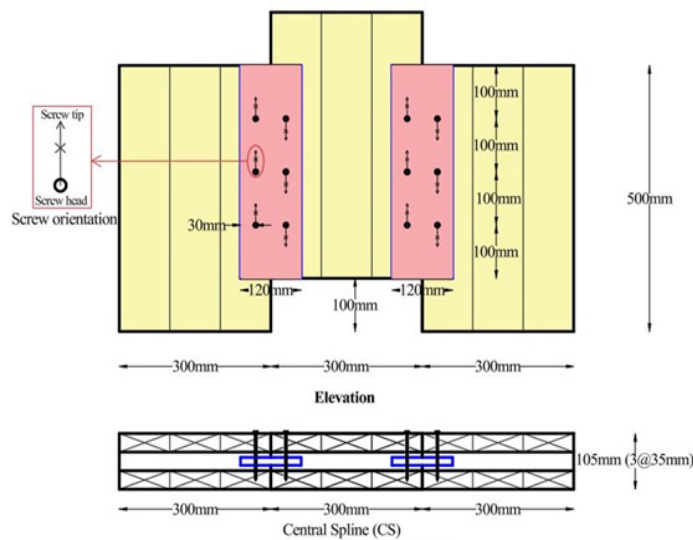
*Figure 1: Test setup: a) layout of connection test specimen for screws inserted at 45° angle in central spline (CS) connection configuration (blue rectangles represent splines), b) Instrumentation of original splines, c) test specimen showing the spacing between original and repair fasteners: 50 mm in the Y-axis (loading) direction and 15 mm in the X-axis, and d) installation process.*

the outer veneer grain oriented parallel to the loading direction, with thickness of 21 mm. These splines created two shear planes in each setup. The middle panel was offset by 100 mm to allow for appropriate clearance during testing (Figure 1a).

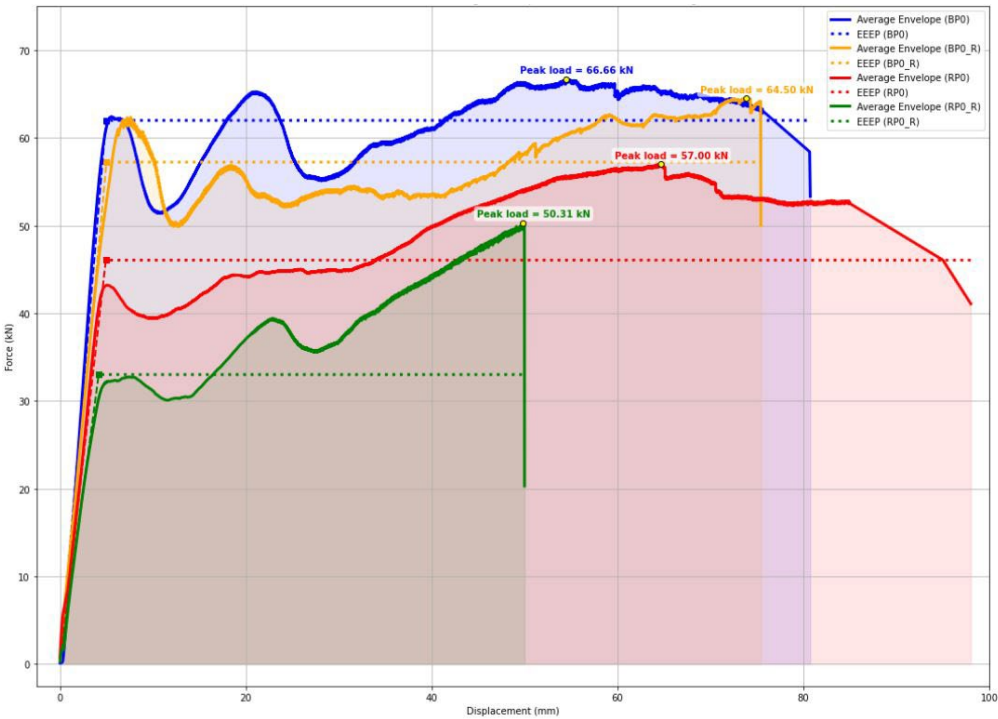
Figure 2: Monotonic test results of the CS radiata pine CLT panel-to-panel connection using birch plywood (BP0) and radiata pine (RP0) as spline material. The blue curve represents the average force vs displacement response of the two undamaged original specimens using BP0 splines; the orange curve represents the response of the repaired specimen using BP0 splines. The red curve represents the average force vs displacement response of the two undamaged original specimens with RP0 spline, while the green curve represents the response of the repaired specimen using RP0 spline.

Table 2 and Figure 2 present the monotonic test results, while Figure 3a shows the damage caused by monotonic loading for the original and repaired specimens using birch (BP0) and Figure 3b demonstrates the damage in repaired radiata pine (RP0) plywood spline due to monotonic loading.

Stiffness recovery for the radiata pine (RP0) connections was satisfactory, with the repaired specimens regaining approximately 87% of the original stiffness (Table 2 and Figure 2). Although the strength recovery was also around 87%, the repaired specimen failed immediately after reaching peak load, exhibiting no post-peak resistance. Consequently, yield capacity recovery was limited, reaching only about 60% of the original value, showing a substantial reduction to resistance to plastic deformation. This indicated that the damage in the RP0 splines, where a crack approximately 50 mm long had formed along the loading direction during the initial testing, influenced the performance of the repaired connection. As the crack in the repaired specimens propagated and intersected with the pre-existing crack from the original testing, the connection was unable to sustain additional load, resulting in abrupt failure immediately after reaching peak capacity (Figure 2 and Figure 3b). This may be mitigated by increasing spacing between fasteners as well as end and edge distance to avoid interaction of cracks in the spline which occurred before and after repair (Abdoli et al., 2023).

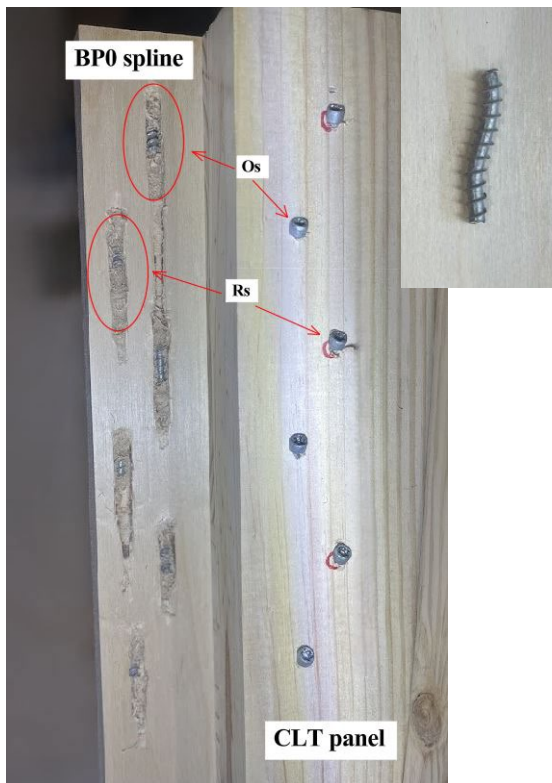
a)

*Figure 3: Damage in the central spline radiata pine CLT panel-to-panel connections of repaired specimens after monotonic loading using (a) birch plywood (BP0) with location of screw in original testing (Os) and testing after repair (Rs) (part of a failed original screw in inset) and (b) radiata pine plywood (RP0) as spline material.*

The repaired birch plywood (BP0) central spline (CS) CLT connections performed, consistent with monotonic loading, comparably to the undamaged specimens (Table 3, Figure 4a and b, and Figure 5). Yield and peak load capacity recovery of repaired specimens even slightly exceeded the performance of the undamaged specimens; by 3% and 4%, respectively. This may be explained by the failure mode. The failure in BP0 spline connections was due to the screw head being pulled into the CLT panel with minimum damage to BP0 spline. The deformed but still intact original screws remained in the specimen after the repair, able to take up load once the connection entered the plastic stage. However, in contrast to the original test the original screws failed catastrophically in repaired specimens (Figure 3a). Increased performance in cyclic

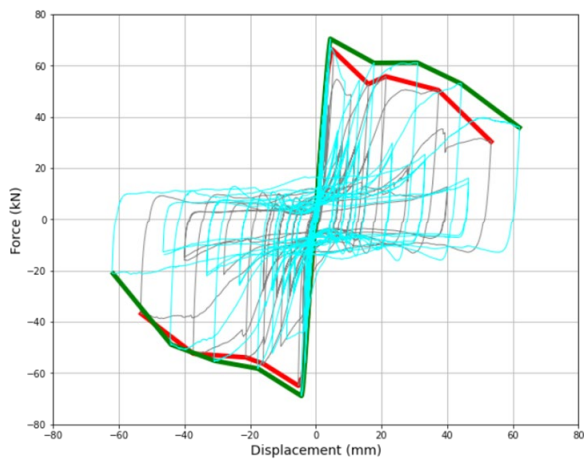
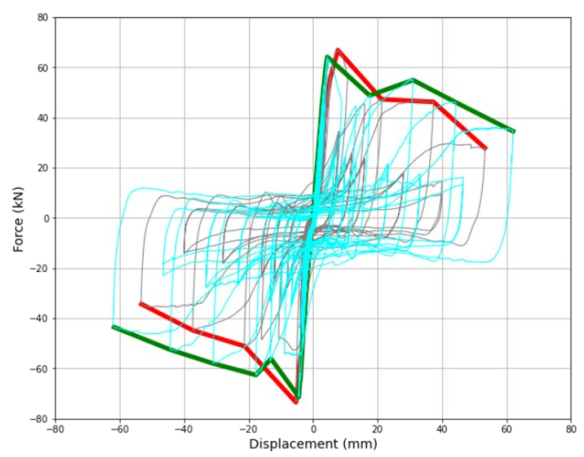
*Figure 4: Hysteresis loops and envelope curves from the cyclic tests of CS radiata pine CLT panel-to-panel connections using BP0 and RP0 as the spline material. The grey and cyan hysteresis curves represent the responses of the original and repaired specimens, respectively, while the red and green curves represent the corresponding envelope curves for: a) Test 1 with BP0 splines, b) Test 2 with BP0 splines, c) Test 1 with RP0 splines, and d) Test 2 with RP0 splines*

Cyclic test results for the undamaged and repaired BP0 and RP0 radiata pine CLT central splines specimens are tabulated in Table 3; the associated hysteresis and envelope curves are depicted in Figure 4 and the resulting average envelope and EEEP curves in Figure 5.

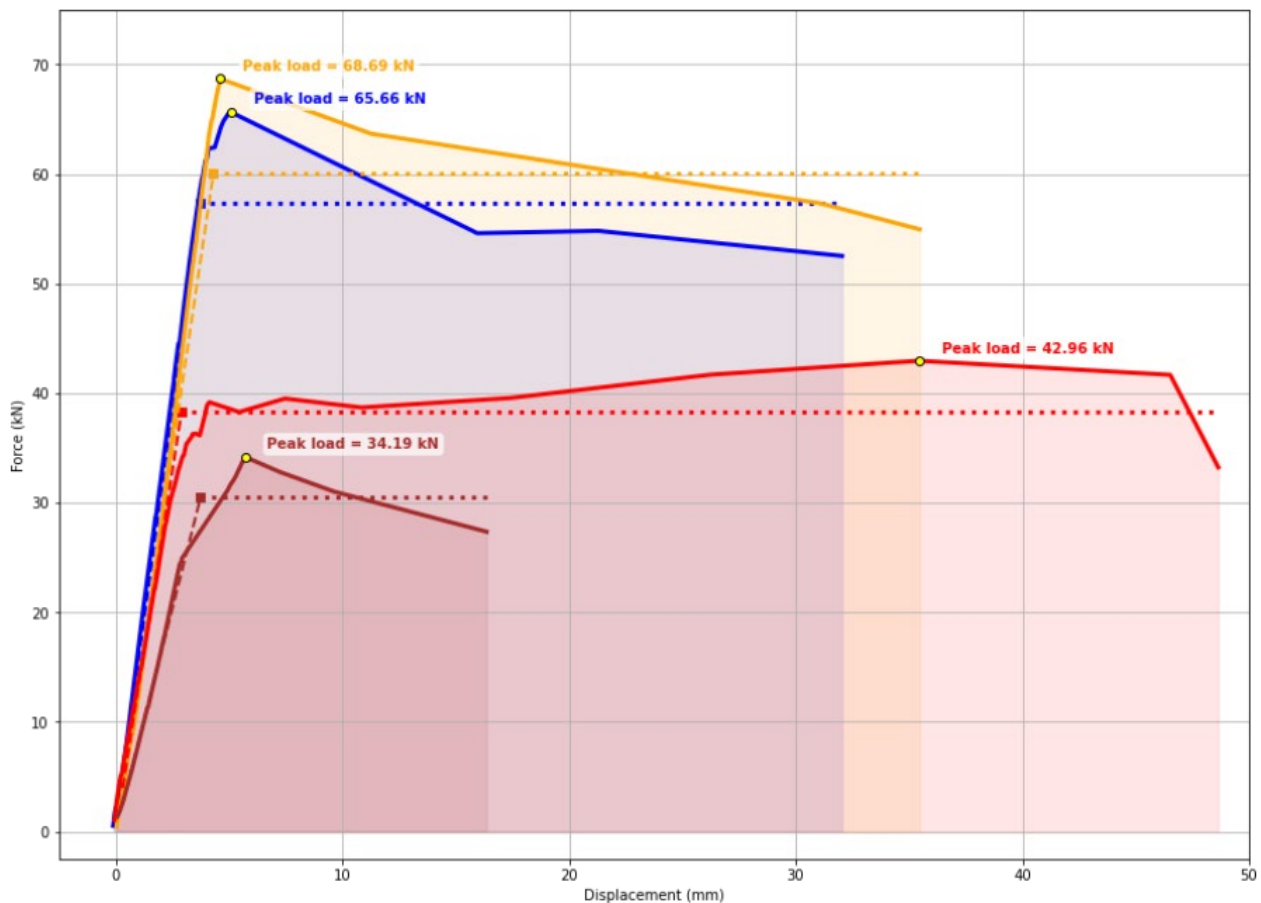
Figure 5: Average envelope curve and EEEP curve of BP0 and RP0 splines in CS radiata pine CLT panel-to-panel connections due to cyclic loading; blue and yellow solid and dotted line represents average envelope curve and EEEP curve of BP0 splines CLT connection respectively for original (blue) and repaired (yellow) specimens; red and brown solid and dotted line represents average envelope curve and EEEP curve of RP0 splines CLT connection respectively for original (red) and repaired (brown) specimens.

Repaired RP0 CS CLT connections showed a marked reduction in structural performance compared to the undamaged connection. Around 40% stiffness was recovered from the original, while approximately 75% of the yield and peak capacity was recovered (Table 3, Figure 4c and d, and Figure 5). This may be explained by the significantly more pronounced wood fibre crushing of the radiata pine plywood spline in the initial test. Damage after cyclic loading matched that observed under monotonic loading (Figure 3). At the end of the test CLT panels of the repaired connections separated from each other as a crack had propagated through the entire the length of the RP0 spline (Figure 3b).

While the repaired BP0 central spline connections regained 70% of their limited original ductility ( $\mu$ ) = 2.5, the high ductility of the undamaged RP0 connections ( $\mu$  = 12.2) was lost in the repaired state ( $\mu$  = 1.5) (Table 3 and Figure 5). This was because the damage to the spline allowing for the original ductility allowed intersection of old and new cracks after repair. RP0 spline connections might still be repairable, if enough undamaged spline material remains between the fasteners, for connection with wider fastener spacings.
